OFFICIAL COORDINATION REQUEST FOR NON-ROUTINE OPERATIONS AND MAINTENANCE

COORDINATION TITLE- 16BON49 summer spill change COORDINATION DATE- 29 June 2016 PROJECT- Bonneville Lock and Dam RESPONSE DATE- 7 July 2016

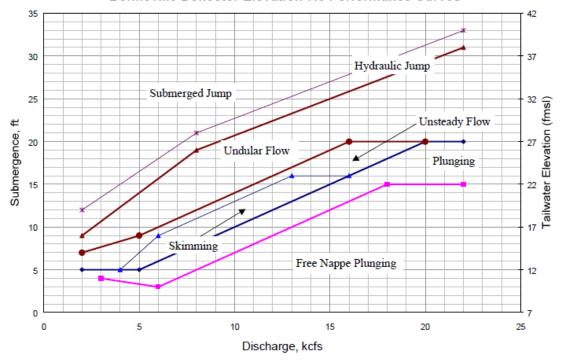
Bonneville Deflector Elevation 7.0 Performance Curves

An investigation as to the cause of the erosion has just begun but there is too much energy being dissipated at the erosion locations. The attached diagram is from the Bonneville Deflector DM (2001). The diagram shows that the flow conditions off of the 7 foot deflector are unsteady (turbulent) for the conditions that have existed much of the past month (17 foot tailwater and about 6600 cfs through Bay 18). Tailwater is expected to drop as we move into July and August; the lower tailwater should help with the unsteady flow. Any change in discharge through Bay 18 also causes an increase in turbulence (energy dissipation). Using a constant spill operation eliminates the additional turbulence associated with gate changes.

In order to minimize the current rate of erosion, the Corps plans to modify the current summer spill operation (alternate every two days between 85 kcfs day/121 kcfs night and 95 kcfs 24 hours per day) to a constant 95 kcfs 24 hours per day effective 8 July through 31 August. Changing to a constant spill operation of 95 kcfs 24 hours per day is needed for the following reasons:

- 1) The expected effect of switching to a constant spill level will be the stabilization of hydraulic conditions that will likely minimize the rate of erosion and;
- 2) Stable hydraulic conditions are required for the Corps to evaluate and monitor the situation.
