**U.S. Army Corps of Engineers
Steve Burrell, CENWD-PDW-RC**

18 August 2010

SUBJECT: Lower Snake Project - Navigation Issues Associated with Late Season Spill Operations

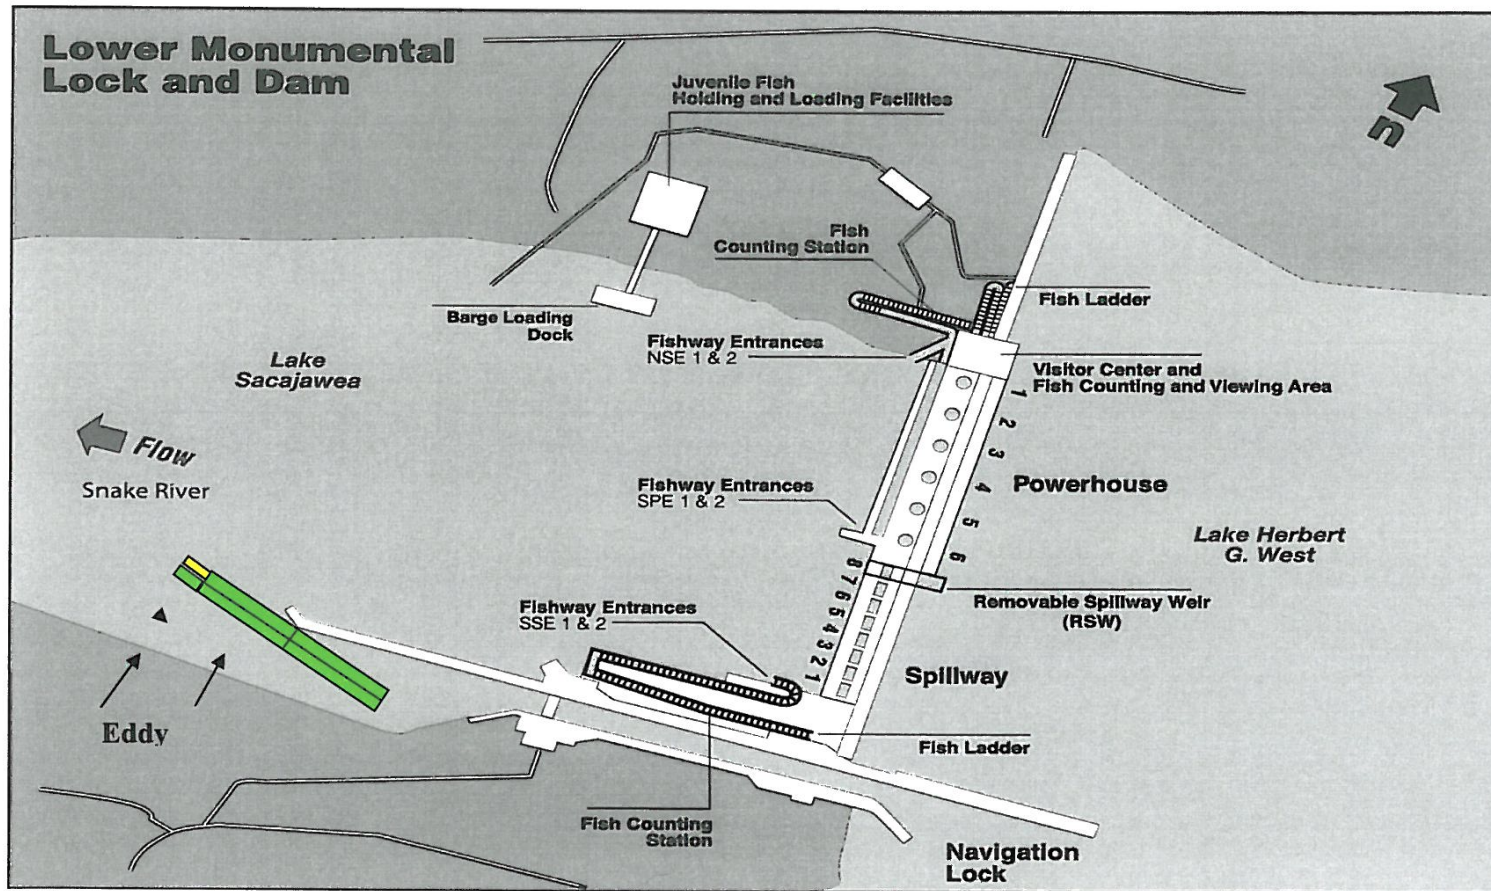
Figure 1. Lower Monumental Incident Diagram.

1. Upon approach to the lower basin (lock entrance), eddy currents forced the bow of the tow towards the outer (north) guide wall. The tug had to burn to get the tow around the corner of the guide wall and safely into the lower basin. Figure 1 shown on page 4 shows the angle of the barges on the approach.

2. Tug Capt. Bob also had a full tow but with a loaded chip barge (wood product). Capt. Bob had basically the same approach as Defiance incident in 1.), above. The operator had to steer towards the south bank to keep the bow of the tow on the good side of the lower basin. This action forces the stern section of the tow to swing to the north which produces the angle you see in the diagram (Figure 1).

3. Similar set by eddy towards guide wall 2 and 3 above, but no difficulty in entering lower basin.
4. On approach, the tow was pulled into the guide wall by eddy current. The port bow of the barge sustained a seven-inch long puncture, but proceeded through lockage for repairs at destination. No damage reported to guide wall. Angle of approach similar to Figure 1, but with tow bow impacting guide wall before entering.

Tug Defiance/Lower Monumental Dam
Near Miss on 8-5-10 at 1910

Incident Details: The tug Defiance was making an approach into the lower basin of Lower Monumental Dam. Total flow was 34 kcfs with 17.40 spill. The tow consisted of 5 barges, one being a loaded fuel barge. As the tow was lining up to enter the lower basin the eddy created by the low flow and spill gate configuration began pulling the bow of the tow towards the end of the guide wall. The tug (in yellow) had to bend the tow around the end of the guide wall to get into the lower basin. The barge directly in front of the tug was the loaded fuel barge. The operator had to make an evasive maneuver to keep the fuel barge from coming into contact with the wall and get safely into the lower basin.

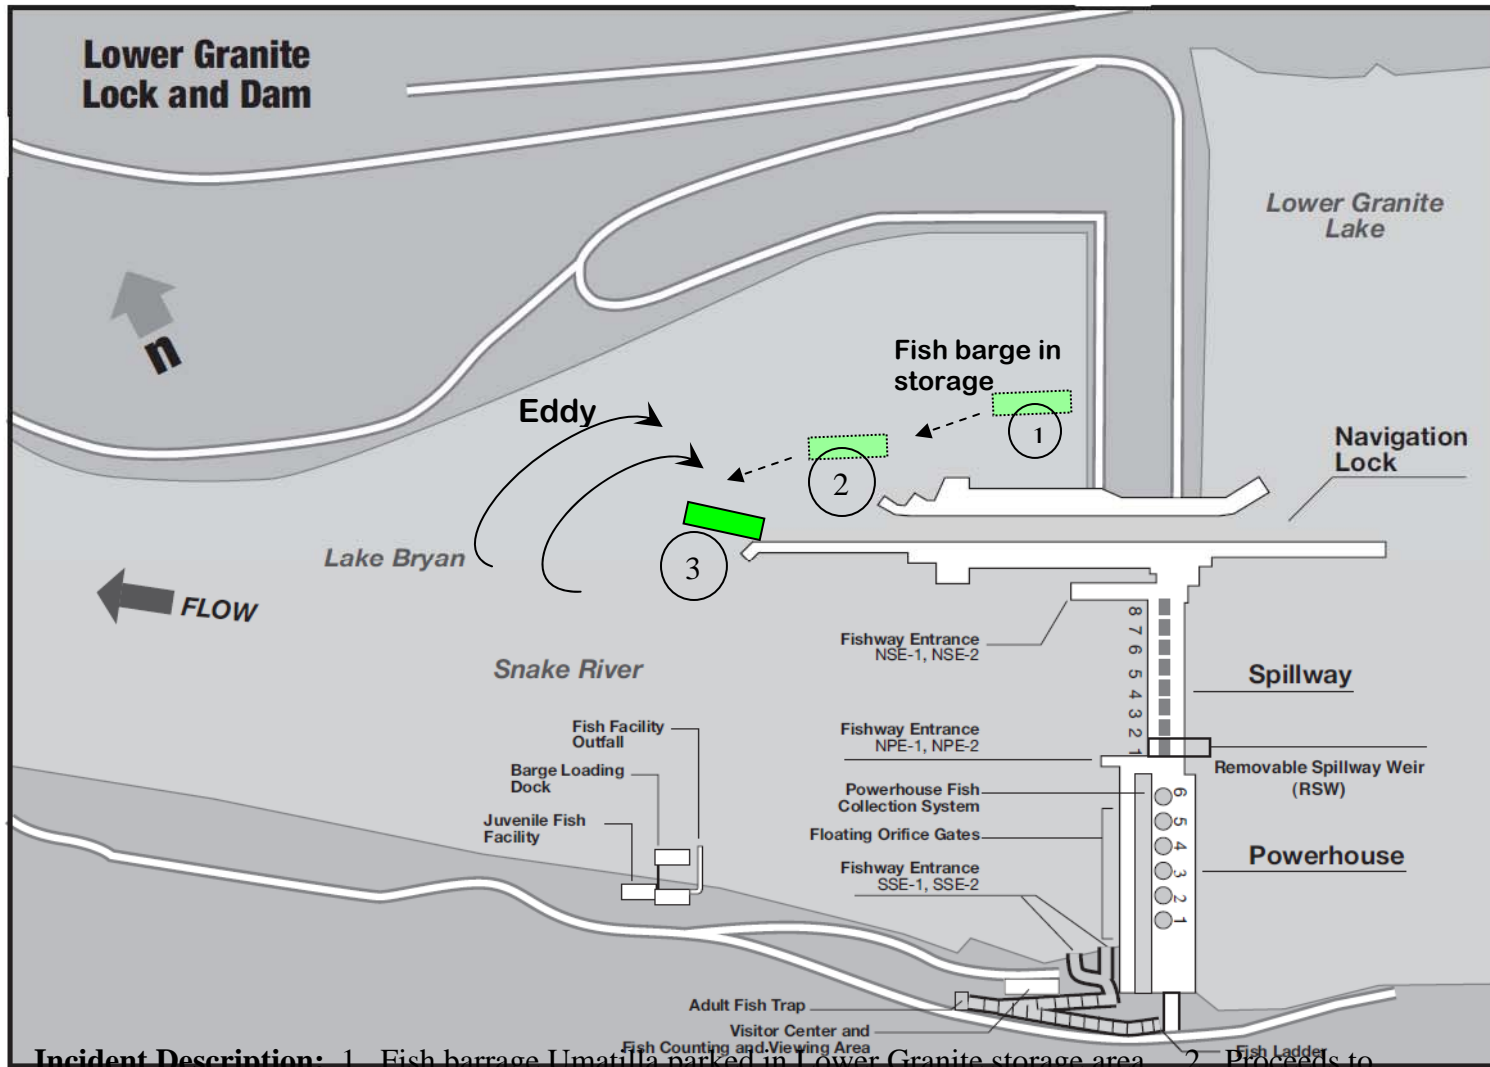
Figure 2. Lower Granite Incident Diagram.

1. Umatilla 8106 fish barge backing out of storage area at Lower Granite collided with guide wall when rounding corner tip of wall (See Figure 2 on page 5). Note that incident details were compiled from dam operator, awaiting official incident report.
2. Cruise vessel possibly entering upper navigation lock and struck guide wall. Details will be finalized after official incident report is completed.
3. No known difficulties.

Incident Description: 1. Fish barge Umatilla parked in Lower Granite storage area. 2. Proceeds to back out of storage area and maneuver to juvenile fish facility on south shore. 3. Eddy current forces starboard side bow into guide wall, dislodging 12”X12”X4” piece of concrete guide wall.
