Bonneville Spillway Rock Removal

PM: Matt Cutts, Tech Lead: Laurie Ebner
05 January 2012

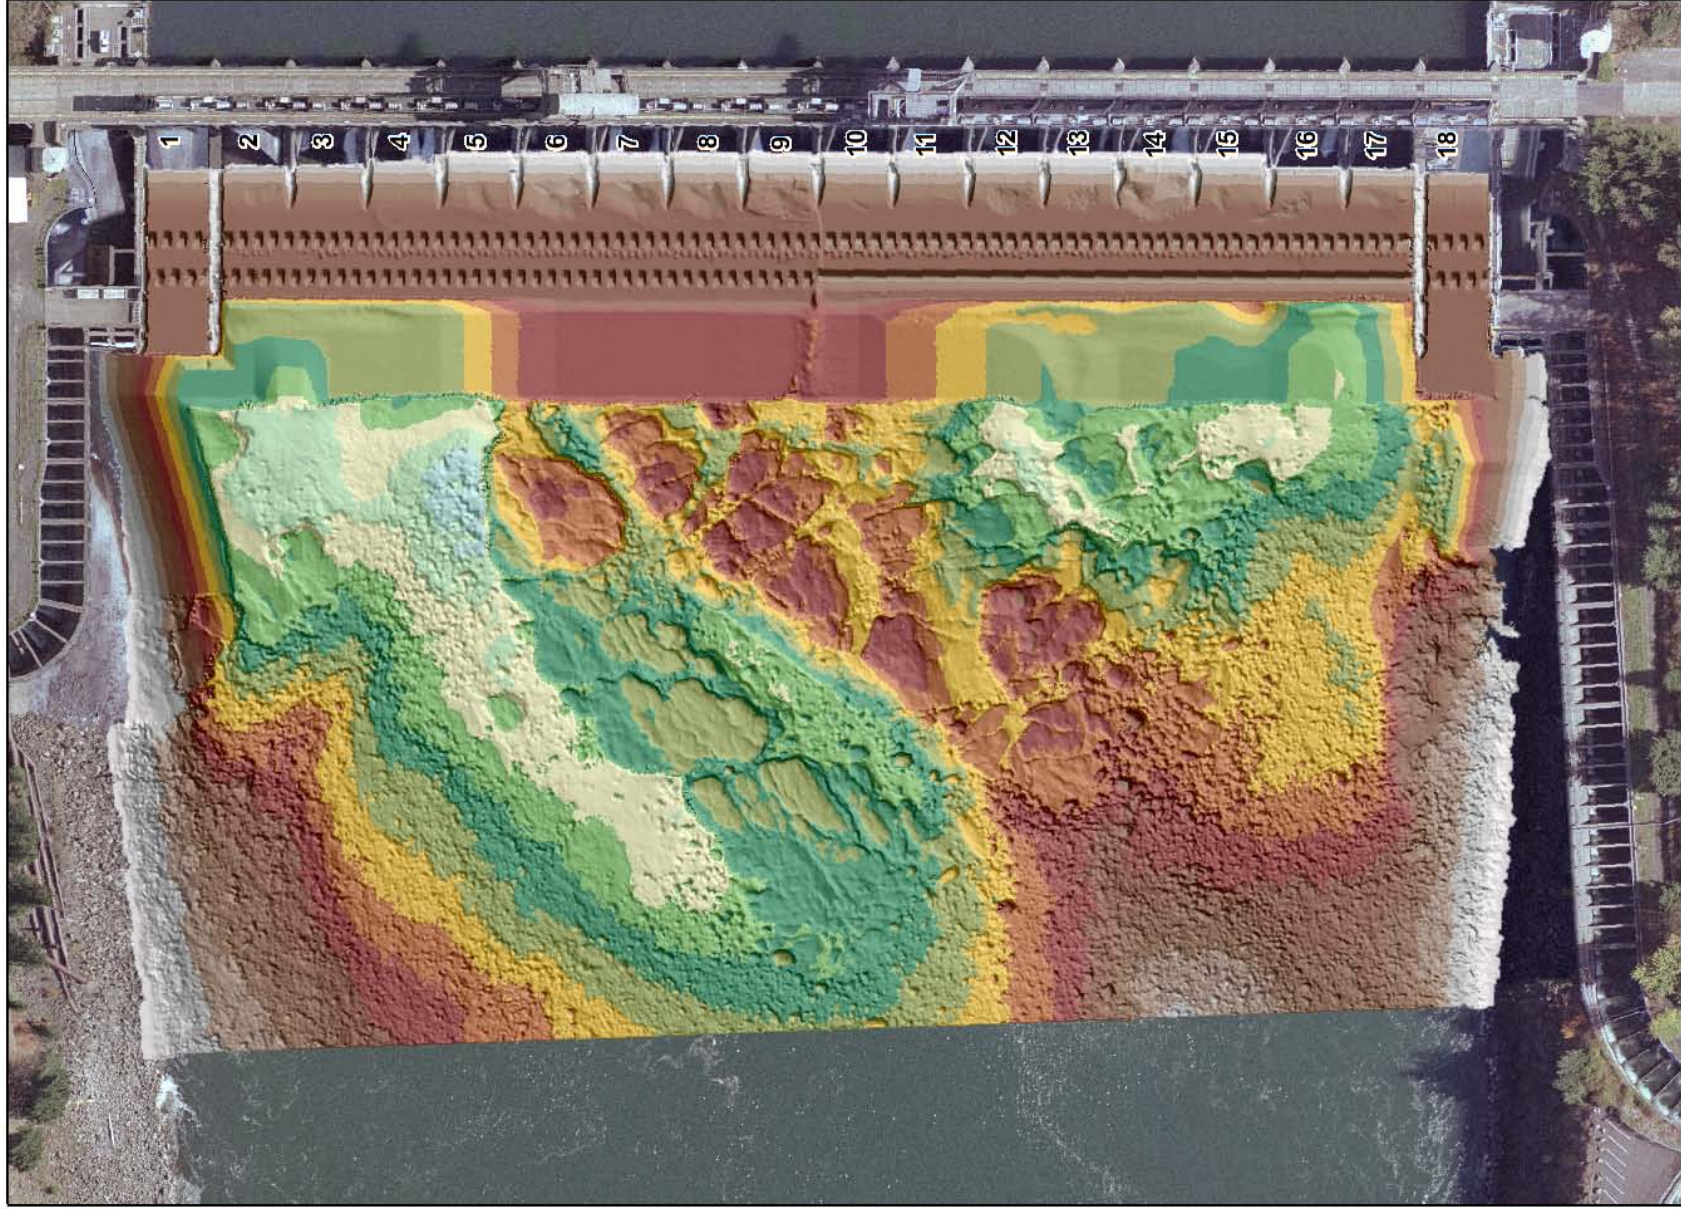
2011 Hydrosurvey

Bonneville Dam Spillway Stilling Basin

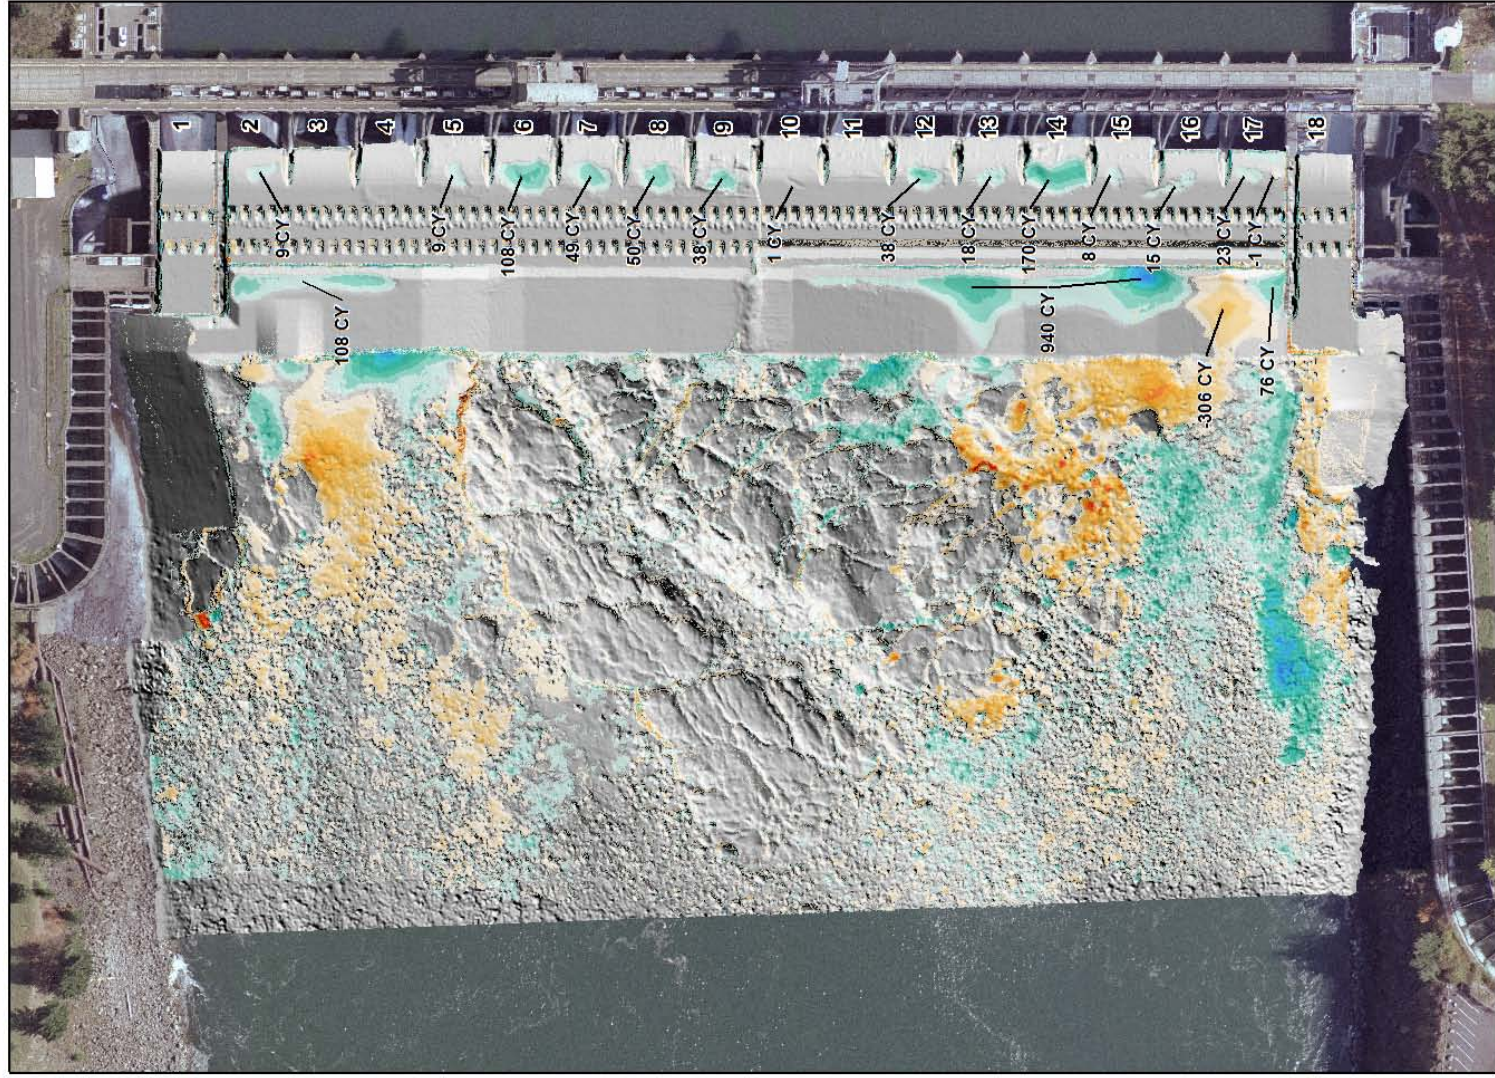
Difference Plot 2011 vs. 2010

Change in surface elevations between September 2010 and October 2011. Warm colors show a loss in elevation, cool colors show a gain in elevation. During this time period, there was approximately 11,600 cubic yards of cut and 10,300 cubic yards of fill for a net flux of -1,300 cubic yards through the study area. 536 cubic yards of material has been recruited into the stilling basin (upstream of the baffle blocks), 1,166 cubic yards of material has been recruited onto the apron, and a 306 cubic yard pile of material on the apron downstream of bay 17 has been removed.
