**US Army Corps
of Engineers**

Portland District (CENWP)

**BRADFORD ISLAND
FISHWAY MODIFICATION EDR
FINAL SUBMITTAL**

August 2012

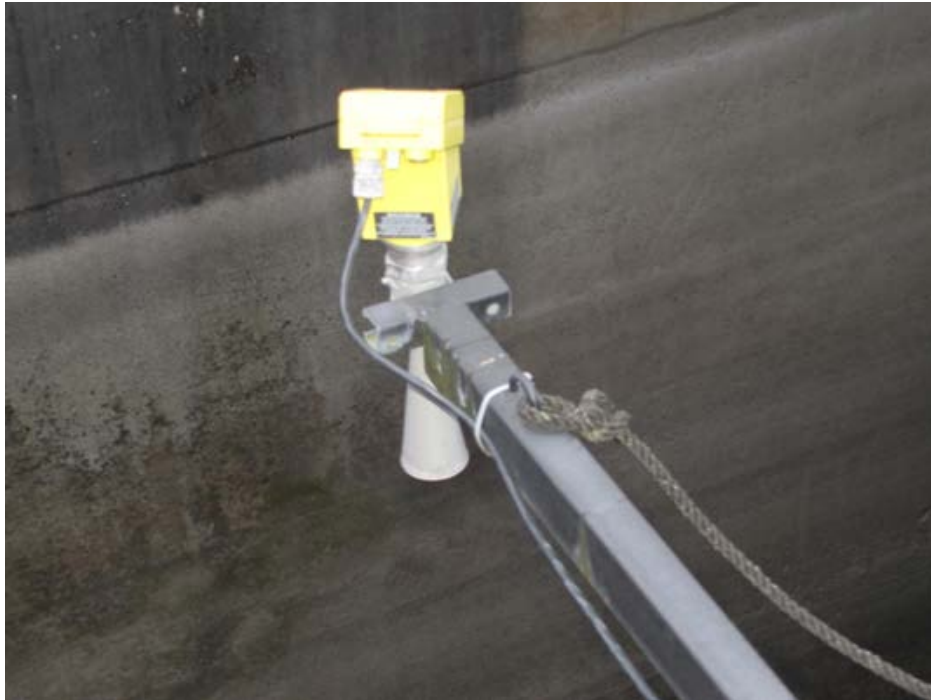
The radar level sensor was inspected from the catwalk area and appears to be in very good condition. It is in operation (see level display in HMS photograph in paragraph B1.6.3.3, Figures B1.6.10 and B1.6.11). Additionally, there was no indication of a feedback to the PLC to indicate gate positions.

Figure B1.6.1 Radar Level Transmitter/Receiver

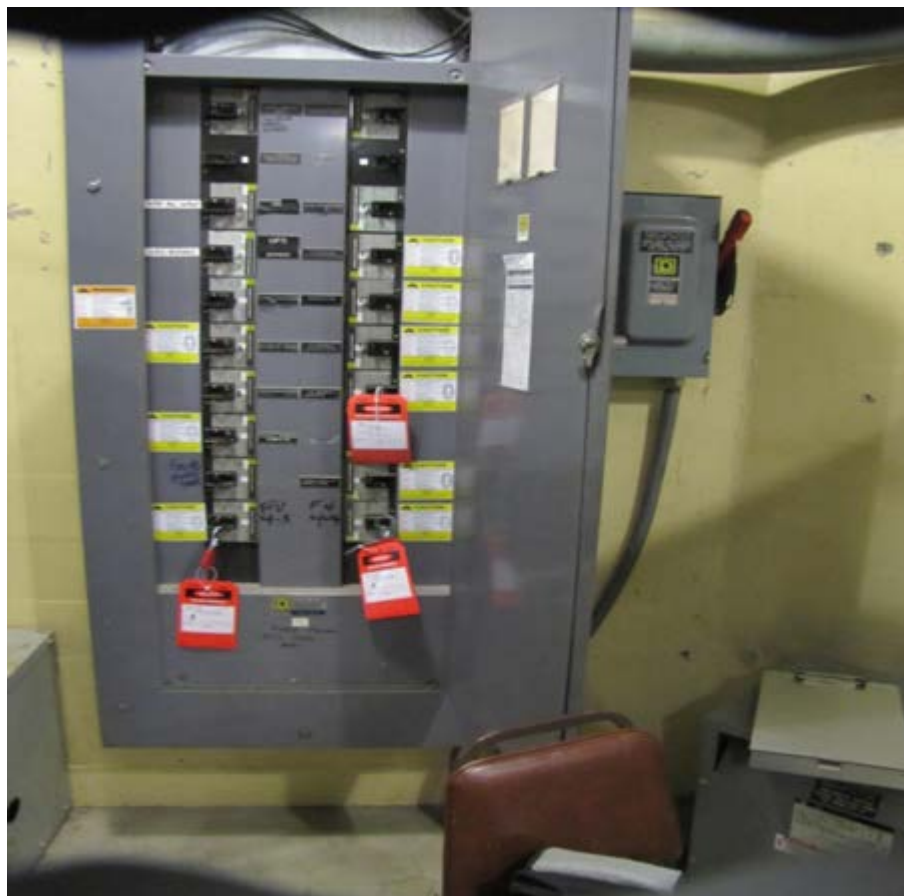
This is a Square-D, I-Line panelboard in good condition. This panelboard contains circuit breakers for the gate operators along with various other circuit breakers. The panelboard is a recent design and is in very good condition. We could not operate any of the gate operator circuit breakers as they were tagged out, but all indications are that they operate properly.

Figure B1.6.14 Panelboard FP-3.
(Note tag-out tags for gate operator power.)

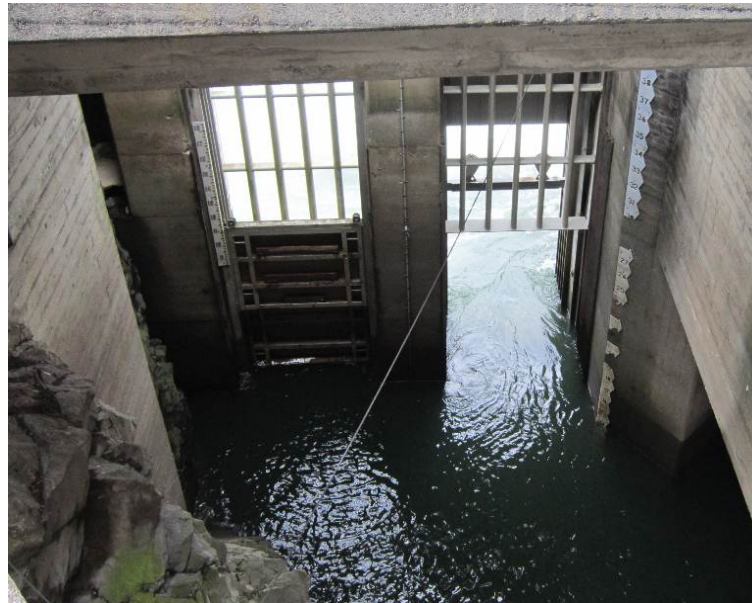
Figure B2.4.1 WG-1 and WG-2

There is a lot of turbulence in this area, however, Weir Gate 1 seems to be in good condition (see Figure B2.4.1). A close inspection could not be conducted since the area was not dewatered. The sea lion exclusion device (SLED) shows no indication of damage at this time.

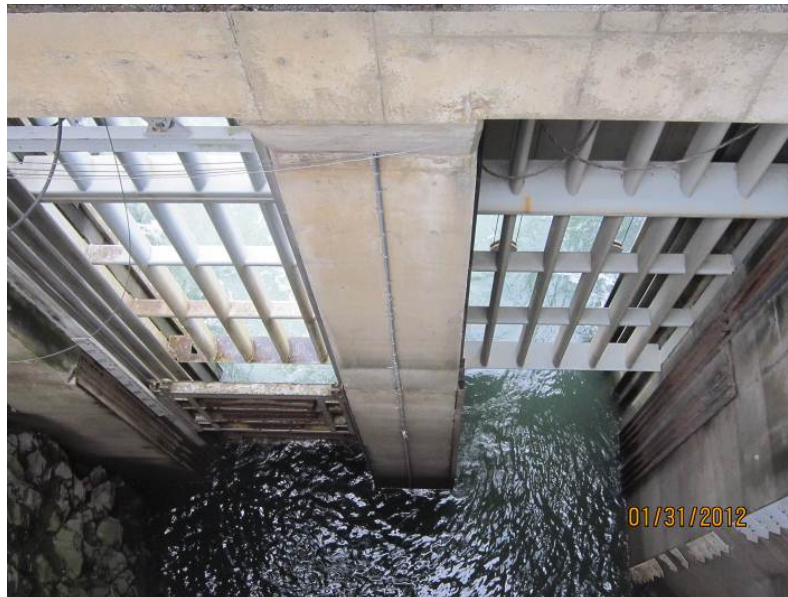
Figure B2.4.2 WG-1 and WG-2

There is a lot of turbulence in this area, however, Weir Gate 2 seems to be in good condition (see Figure B2.4.2). A close inspection could not be conducted since the area was not dewatered. The sea lion exclusion device (SLED) shows no indication of damage at this time.

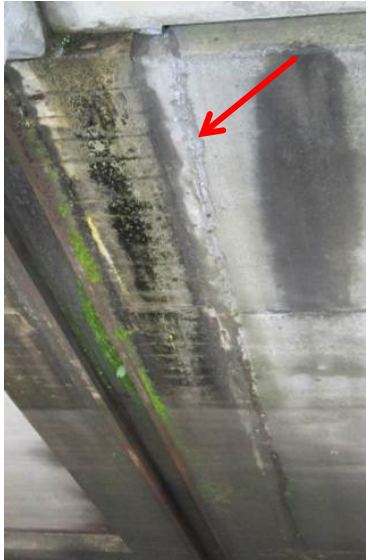
There are a few vertical cracks in the walls of the diffuser structure as seen in Figure B2.4.4. There are also some areas along the walls where new concrete can be seen; see Figure B2.4.5 and Figure B2.4.6. The AWS cannot be drained if one of the gates fails and breaks loose. Vertical cracks are beginning to appear in the walls along the collection channel.

Figure B2.4.4 Cracks in Walls of Diffuser Structure

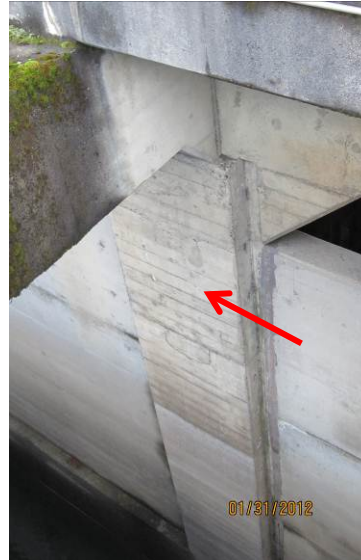
Figure B2.4.5 New Concrete Below Joint

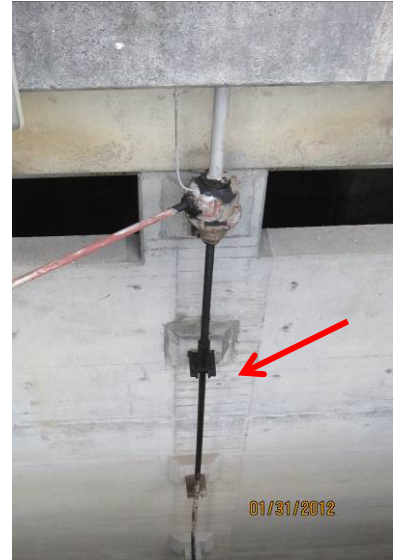
Figure B2.4.6 New Concrete

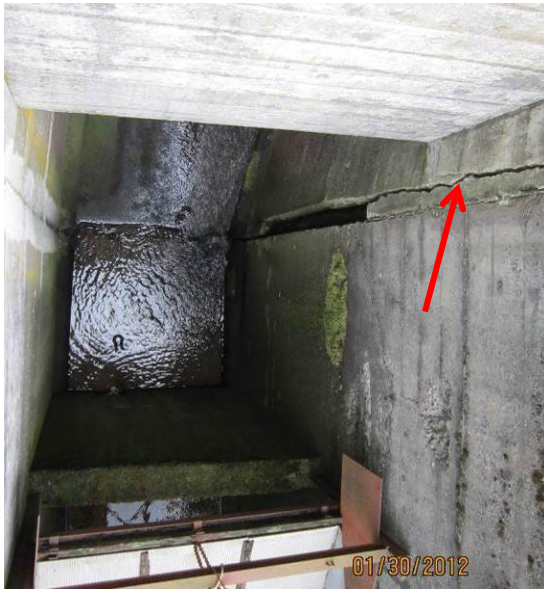
Cracks are appearing along the inside and outside of the walls on the structure (see Figures B2.4.8 and Figure B2.4.9).

Figure B2.4.8 Cracks in Walls of Fish Lock Structure

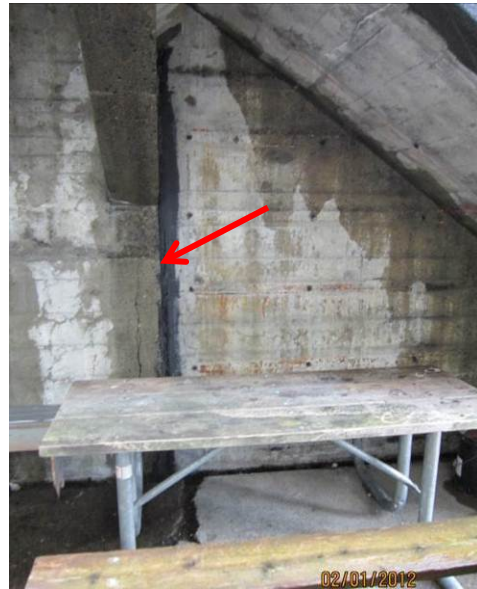
Figure B2.4.9 Cracks in Walls of Fingerling Bypass Structure

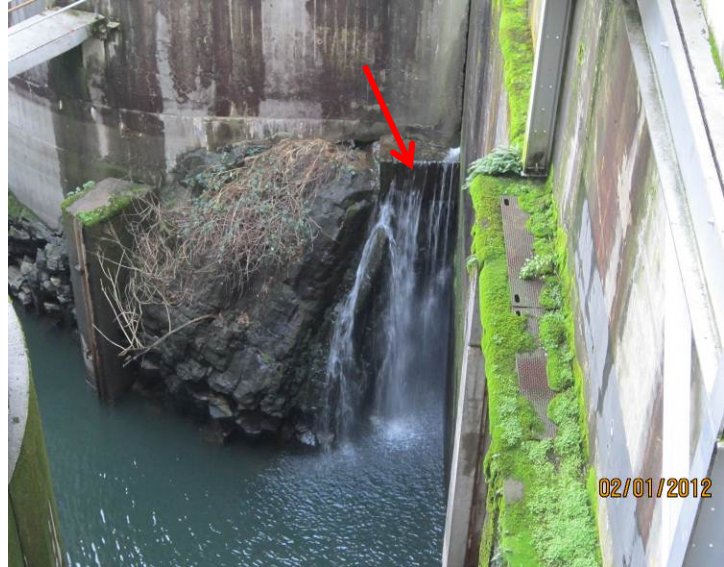
There are also significant leaks appearing in the actual channel around the rocky areas as seen in Figure B2.4.11.

Figure B2.4.11 Channel between Fish Lock and Collection Channel

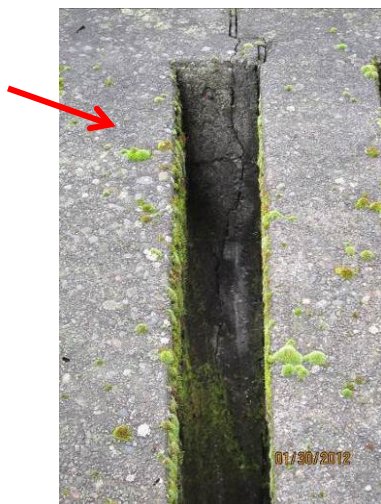
Figure B2.4.12 Crack between Expansion Joints at Weir 43

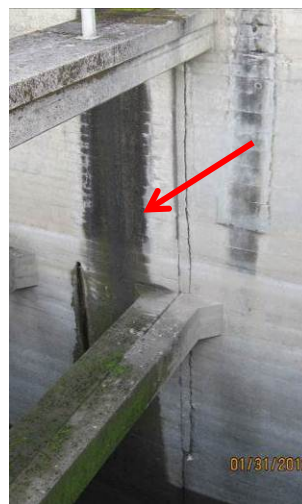
chamber between FG3-8. At FG3-9 there is a large vertical crack in the structure that is slightly offset from the center of the expansion joint (see Figure B2.4.13). A replacement concrete floor slab has been placed between Weirs 46 and 47. This slab has become slightly lifted and uneven. When looking down at the slab from behind the handrail, the top left corner is raised 2.25 inches, the top right corner is level with the ground, the bottom left corner is raised 1.5 inches, and the bottom right corner is raised 0.25 inches (see Figures B2.4.14, B2.4.15, and B2.4.16). Weirs 46 – 49 are showing significant corrosion. There are bushes and blackberries growing through the joint. The joint between Weirs 36 and 37 has broken open along the wall.

Figure B2.4.13 Crack in Wall

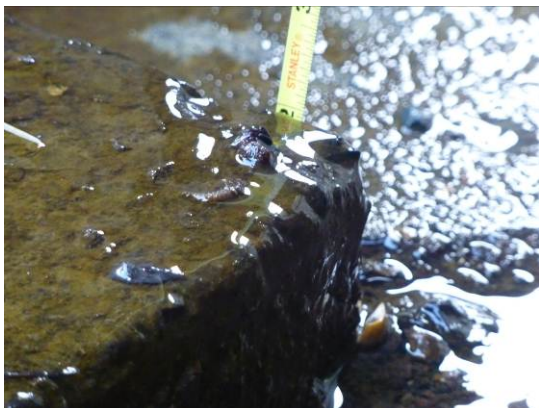
Figure B2.4.14 Raised Replacement Concrete Slab

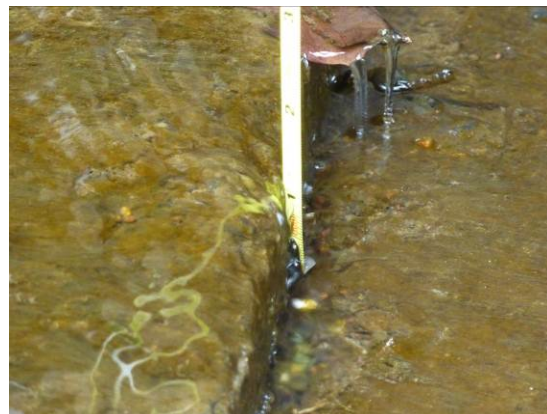
Figure B2.4.15 Raised Replacement Concrete Slab

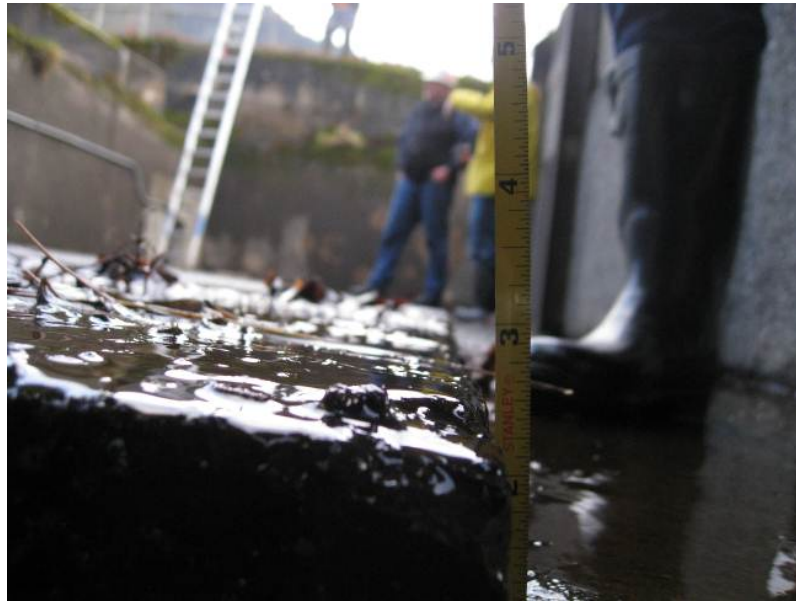
Figure B2.4.16 Raised Replacement Concrete Slab

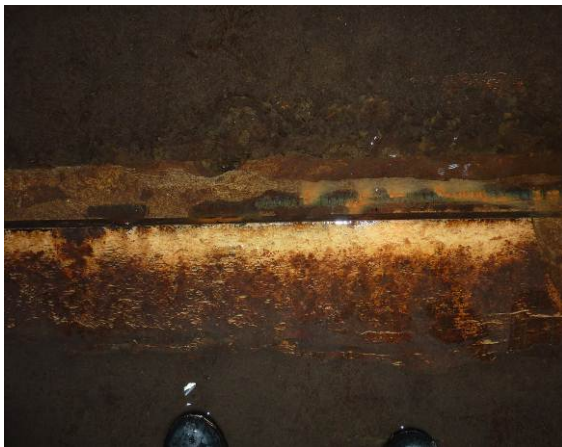
No changes from the Phase 1 inspection. (See Figures B2.4.17, B2.4.18 and B2.4.19 for current state of joints).

Figure B2.4.17 Joint with Exposed Rebar and Waterstop along Floor

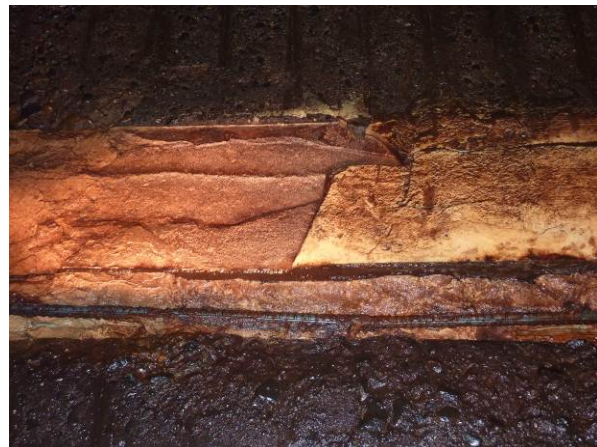
Figure B2.4.18 Joint with Exposed Rebar and Waterstop along Ceiling

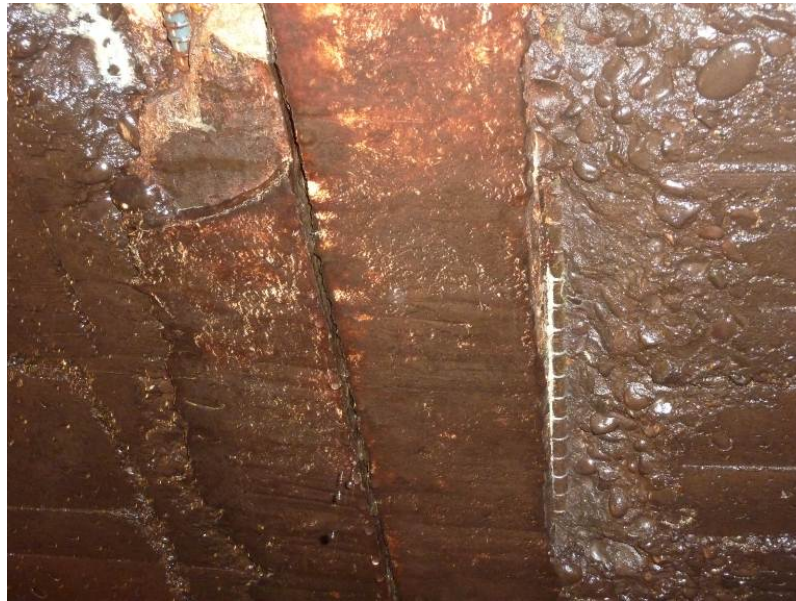
Figure B2.4.19 Joint with Exposed Rebar and Waterstop along Ceiling

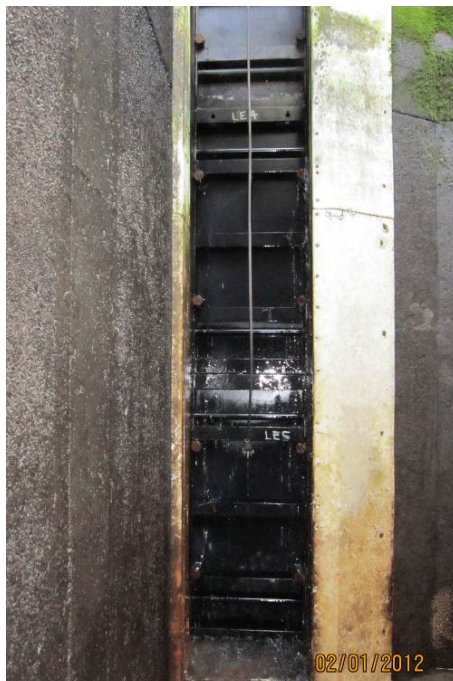
Figure B2.4.20 Fish Exit Gate

There is a significant leakage at the exit gate as seen in Figure B2.4.20. Additionally, a couple of cracks have appeared in the walls around the channel leading up to the gate (See Figures B2.4.21 and B2.4.22)

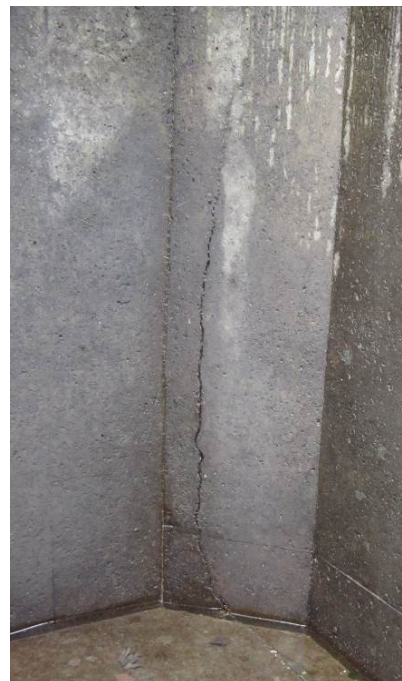
Figure B2.4.21 Crack in Channel Leading Up to Exit

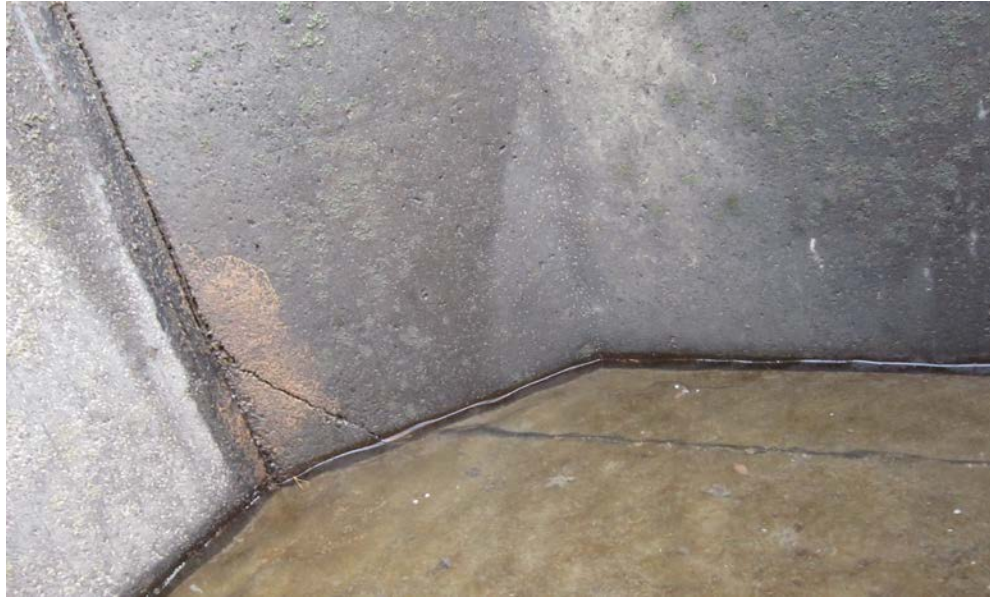
Figure B2.4.22 Crack in Channel Leading Up to Exit

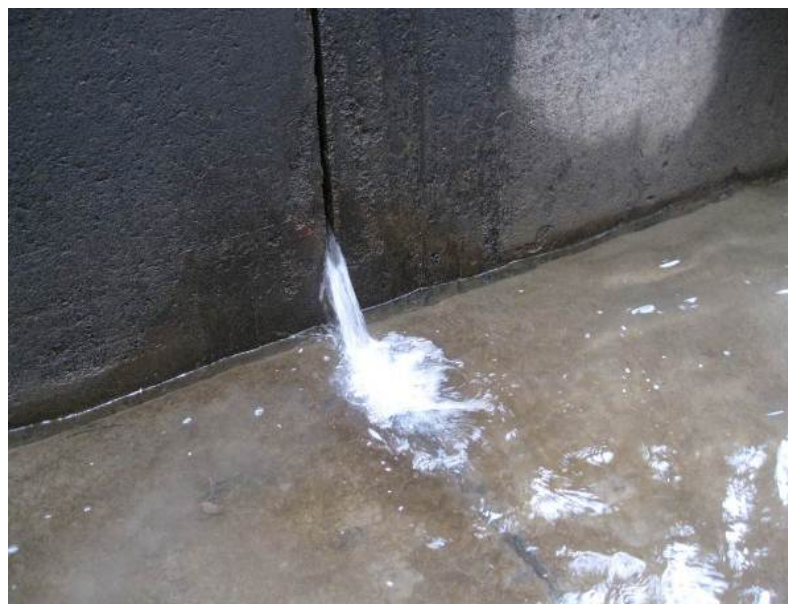
A leak in the water stop at the joint immediately upstream of the lamprey bypass system was observed and can be seen in Figure B2.4.24. Based on the location of the joint, the water is coming from the collection channel leading from the forebay to FV3-7.

Figure B2.4.24 Leak in the Waterstop

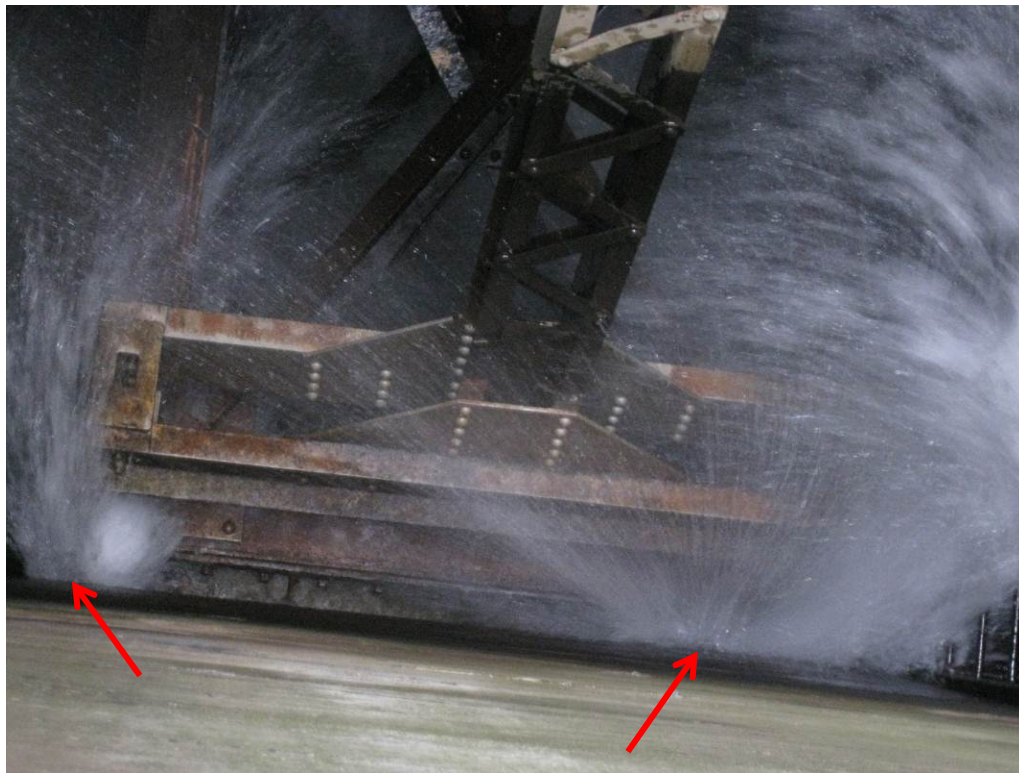
Figure B2.4.25 FV1-1

FV1-1 is the primary supply valve for the AWS supplying the collection channel portion of Branch A Bradford Island fishway. According to project personnel FV1-1 is difficult to maintain. At the time of inspection, the AWS conduit supplied by FV1-1 was not dewatered and considerable amount of leakage can be seen around the valve in Figure B2.4.25. Project personnel have said that it is difficult to insert the bulkheads to dewater this area.

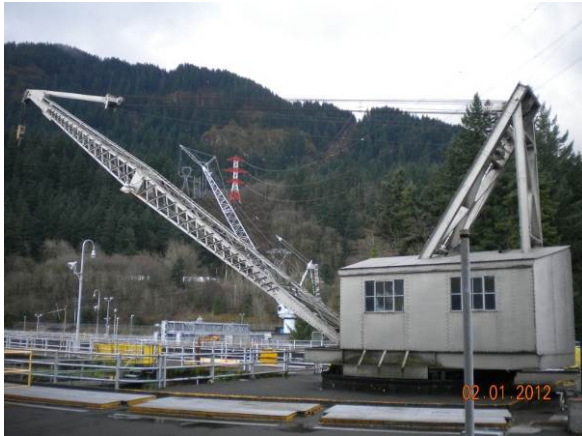
concern is that the aging crane will not be able to remove a bulkhead after maintenance has been performed on FV1-1.

Figure B2.4.26 Crane at South AWS Intake

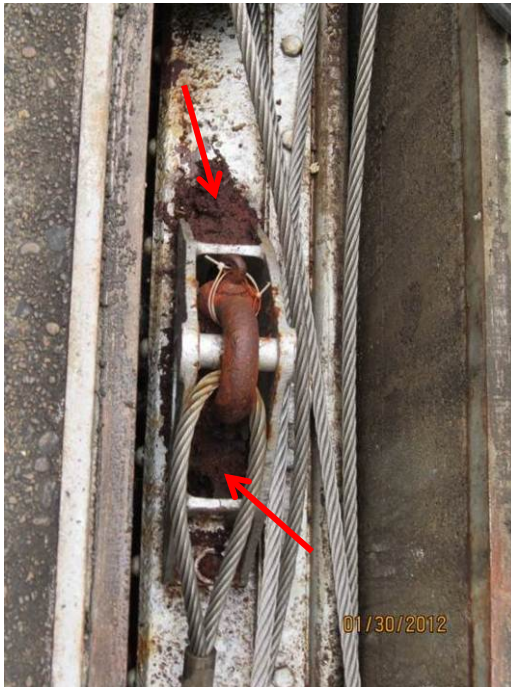
Over time the bulkheads have gradually become more difficult to remove from their slots. The cranes originally provided to remove the bulkheads are no longer capable of this function and have been derated. There are leaks through the J-seals at the top and bottom of the valve along with a fair bit of corrosion as seen in Figure B2.4.28 and B2.4.29. The valve is left partially open to control the flow but this causes vibrations in the valve.

Figure B2.4.28 Corrosion around Bulkhead.

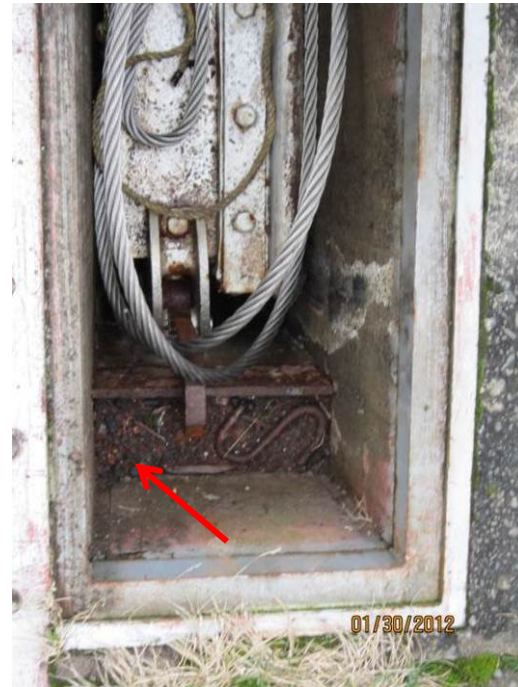
Figure B2.4.29 Corrosion around Bulkhead.

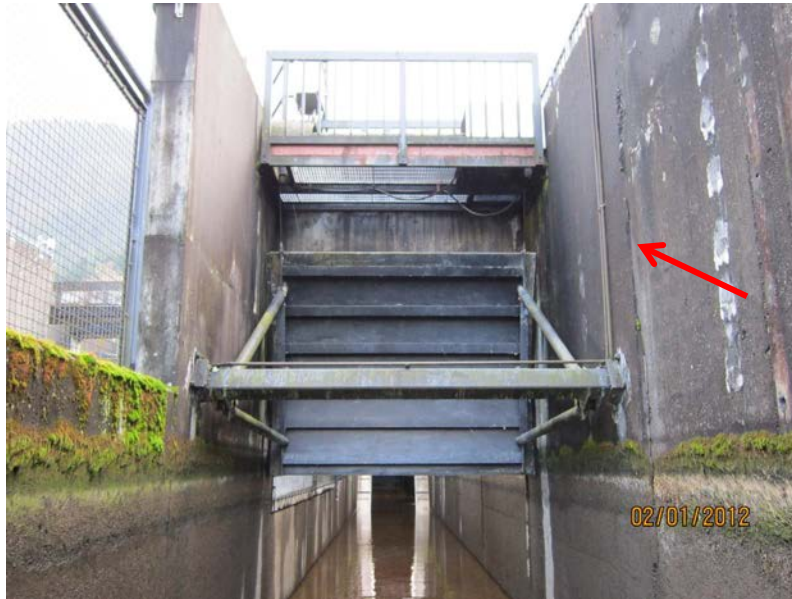
Figure B2.4.31 Backwash Valve

The valve appears to be in good condition but has not been used in years. An HSS inspection is recommended if it is to be used again. Some cracks are showing up in the walls around the valve as seen in Figure B2.4.31.

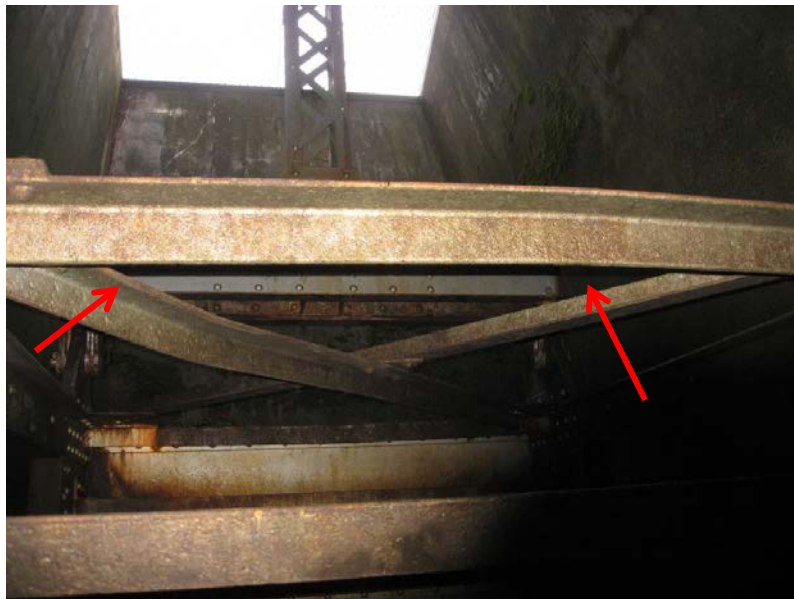
Figure B2.4.32 FV3-7

On further inspection, it was discovered that two of the cross beams were bent as seen in Figure B2.4.32. The cross member that was mentioned in the previous report runs horizontal through the photo. The newly discovered bent member runs diagonally from the top left to the bottom right in the photo. It is uncertain whether the diagonal member buckled recently or was missed in the previous inspection. A possible cause for these bent members is large debris being wedged between the gate and the wall in the conduit but a definite reason cannot be determined at this time. Figures B2.4.33 and B2.4.34 show that the seals are becoming worn out as well.

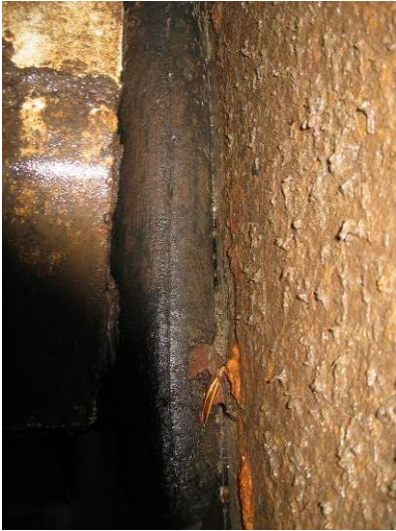
Figure B2.4.33 FV3-7 Seals

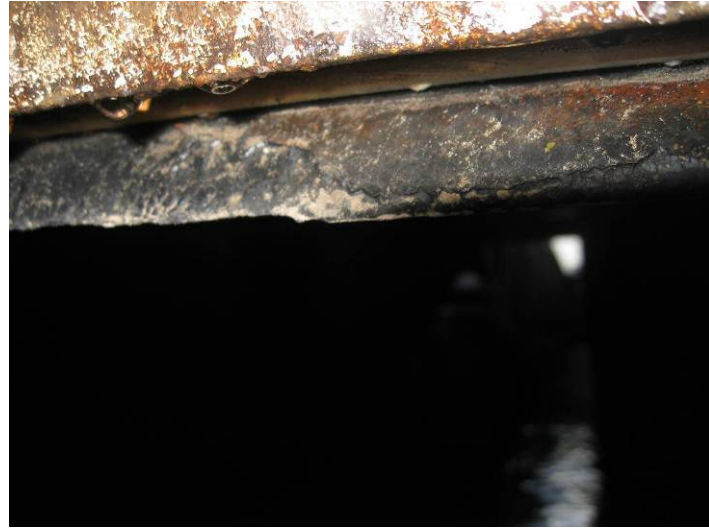
Figure B2.4.34 FV3-7 Seals

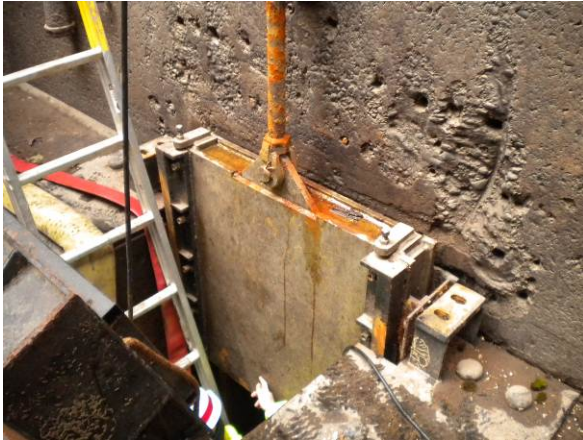
Figure B3.3.8 FG3-28

secure the guides to the concrete, resulting in over-drilling and thus compromising the integrity of the concrete. It is recommended that the gates are either modified to eliminate the vibrational issues or a new design is implemented.
