## **CENWP-OD-JD**

## MEMORANDUM FOR THE RECORD

**SUBJECT:** *15JDA01 MFR* – Three Adult Steelhead Mortalities during Dewatering of JDA South Fishway, SE Entrance Diffuser Area.

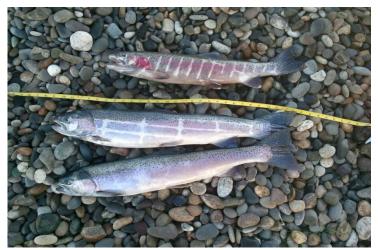
- A. Species 3 Adult Steelhead
- **B.** Origin 2 unclipped, 1 clipped
- C. Length 2 Steelhead at 26" and 1 at 23"
- **D.** Marks and tags 2 Clipped Adipose Fins
- E. Marks and Injuries found on carcass none

**F. Cause and Time of Death** – Based on previous experience with the drain for SE-1, Operators opened the drain valve before Fisheries personnel were on-site. In the past, the area had drained very slowly so there was the belief that draining would take at least a couple of hours. These fish died due to lack of water. The SE1 diffuser area was dry before Fisheries could be on-site and ready for fish salvage activities. Fisheries personnel were on-site by 0700 on 18 February.

**G. Future and Preventative Measures** – JDA Policy requires that Fisheries personnel is at work/ available to monitor water levels before the draining of fishways channels can commence, but occasionally, and due to very slow draining rates, Operations starts the draining process a few hours before 0700 hrs to save time. To prevent this from occurring again, Fisheries has updated dewatering SOPs to better reflect the requirement to have Fisheries personnel on-site and ready to salvage fish prior to dewatering fishways. A copy of the updated SOP is attached to this MOC. In addition, JDA is exploring options of having Fisheries take clearances for fish related structures. This would provide an additional layer of protection so areas may not be accidentally dewatered without Fisheries' knowledge. The JDA OPM has also had conversations with Project personnel stressing the importance of following dewatering protocols and not putting the Project in the position of drying up fishways without Fisheries personnel on-site to salvage fish. JDA recognizes the seriousness of this incident and acknowledges that is likely could have been avoided. The Project is committed to doing all they can to make sure mortalities of this nature are not repeated in the future.
