Trip report - The Dalles Dam - Feb. 23, 2015.

Visual observations of modified Fish Unit and ladder entrance operations with reduced flow.

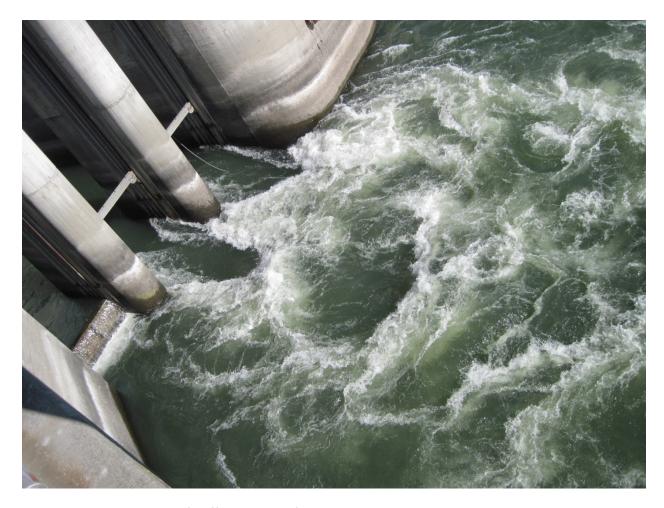
- 3. E2 and E3 were adjusted open after observations made during Operation 2 due to the 2.0 ft differential. Operation 3 had 10.7 ft gate openings and 1.5 ft differential, well within Fish Passage Plan criteria for east entrance gate operation and differential maintaining 8.0 ft or greater below tailwater with 1 2 ft head at entrances (1.5 ft optimum).

Figure 1 - East entrance 2.0 ft differential, 8.5 ft gate open

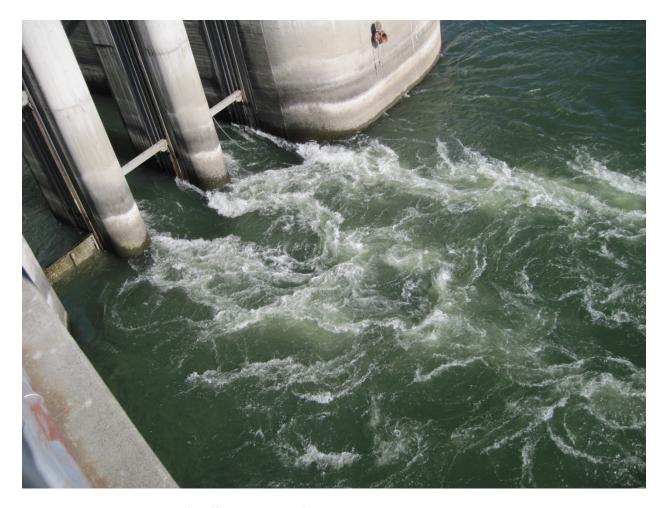
Figure 2 - East entrance 1.5 ft differential, 10.7 ft gate open
