**MEMORANDUM FOR THE RECORD – 16 MCN 018 MFR McNary Side Brush**

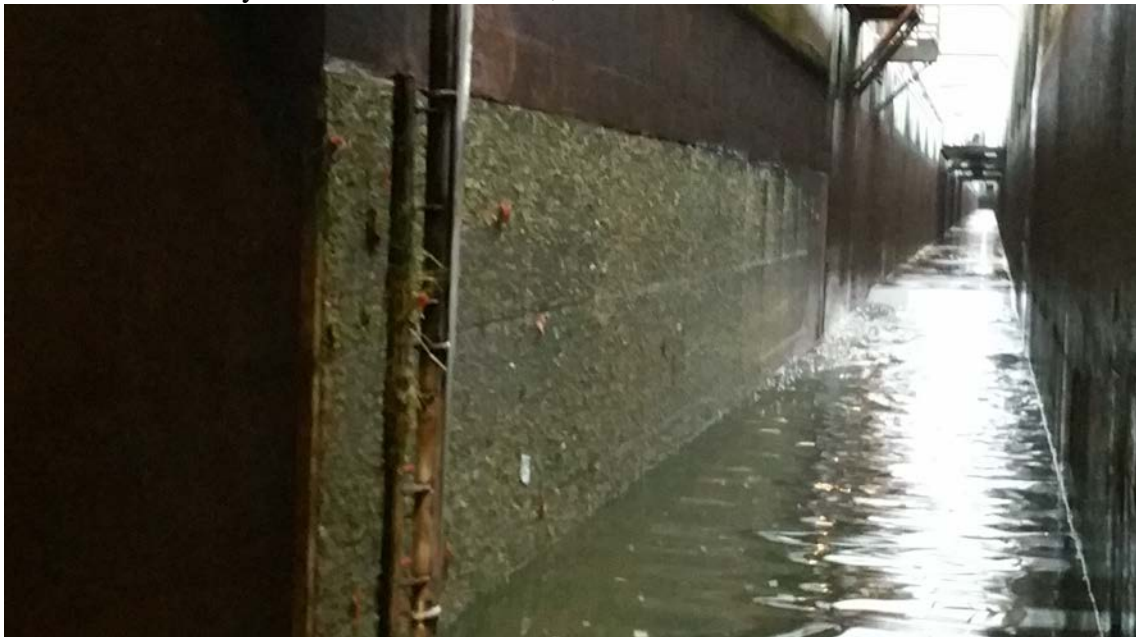
The side brush was operated at 1630 hours on November 28 and again on November 29 at 0700 hours, just before the switch to emergency bypass. Following the switching operation, the side screen was found somewhat obstructed with debris as seen in the attached photos. The screen should not have been this dirty and it appears the brush was not making full contact with the screen. It is fortunate that this switch to emergency bypass occurred before the situation became worse.

Figure 1. View of obscured side dewatering screen from floor of the Juvenile Collection Channel at McNary Dam on November 29, 2016.

- F. Cause and Time of Death – Not Applicable.
- G. Future and Preventative Measures – This winter all efforts will be made to resolve the issues with the side brush and dewatering valves. Two extra weeks are available to work on these issues. During the winter of 2016 or 2017, a contractor will replace the side brush and/or other systems but the valve are not on this contract.

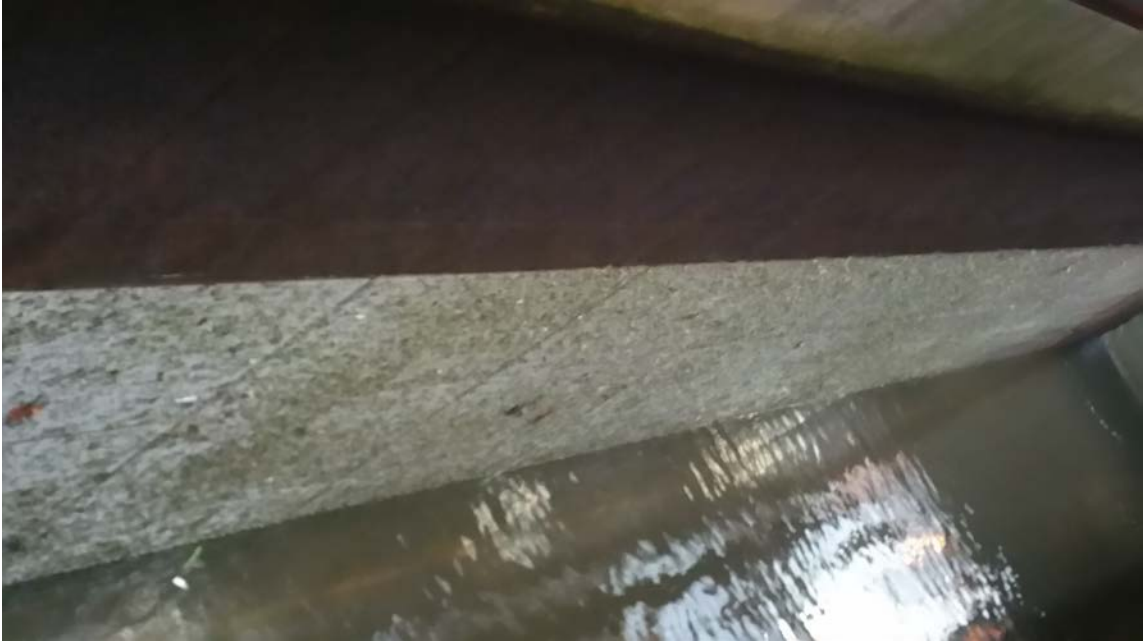
Figure 2. View of obscured side dewatering screen from access walkway, Juvenile Collection Channel at McNary Dam on November 29, 2016.
