OFFICIAL COORDINATION REQUEST FOR NON-ROUTINE OPERATIONS AND MAINTENANCE

COORDINATION TITLE- 16BON122

COORDINATION DATE- 27 December 2016

PROJECT- Bonneville Dam

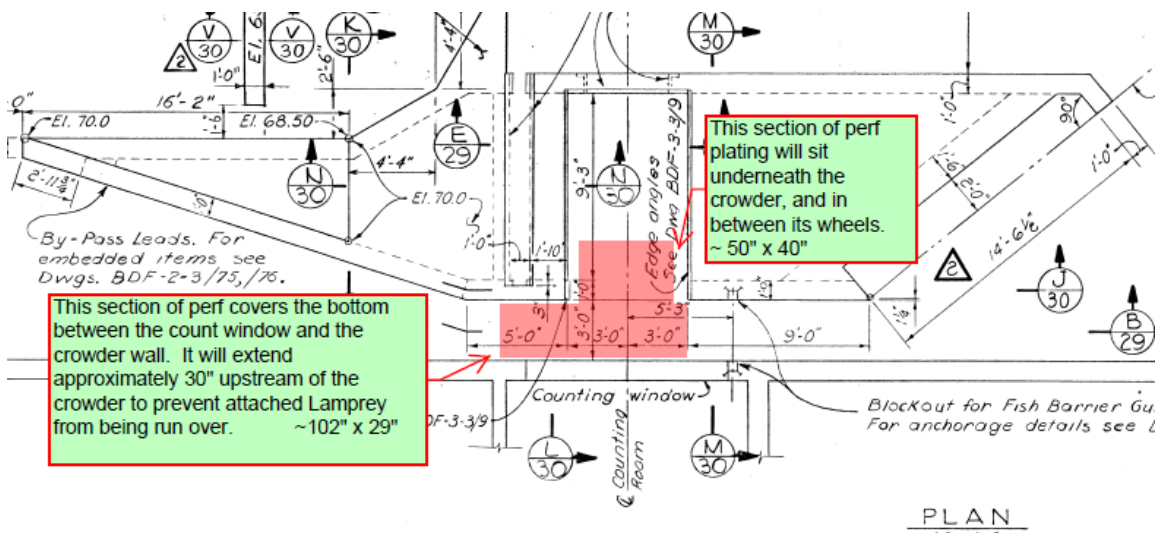
Description of the problem- The crowder at Bonneville's Washington Shore Count Station has a gap of approximately 1.5" underneath it. The crowder is cycled through its range daily and operated by the counters on an as-needed basis during passage season. Lamprey have regularly been observed suctioned to the ladder floor immediately in front of the crowder. They then get run over by it during routine crowder operations, causing injury or death. Lamprey have a tendency to wiggle under the crowder and then get trapped. In addition to injuring lamprey, fish counters report that lamprey suctioned to the ladder floor in the crowder area interfere with their ability to count accurately.

Figure 1. Area where the Washington Shore count station modifications will be occurring.

To address these issues, we will be installing 1/8" thick perforated aluminum plating to the bottom of the fishway in front of the crowder, and a plastic strip to the forward bottom and downstream edges of the crowder. The plating prevents lamprey from being able to suction to the bottom. Thus they will have to swim through the counter window area, ameliorating the counting issue and preventing lamprey from laying in the path of the crowder. The plastic strip will prevent lamprey from getting underneath the crowder.

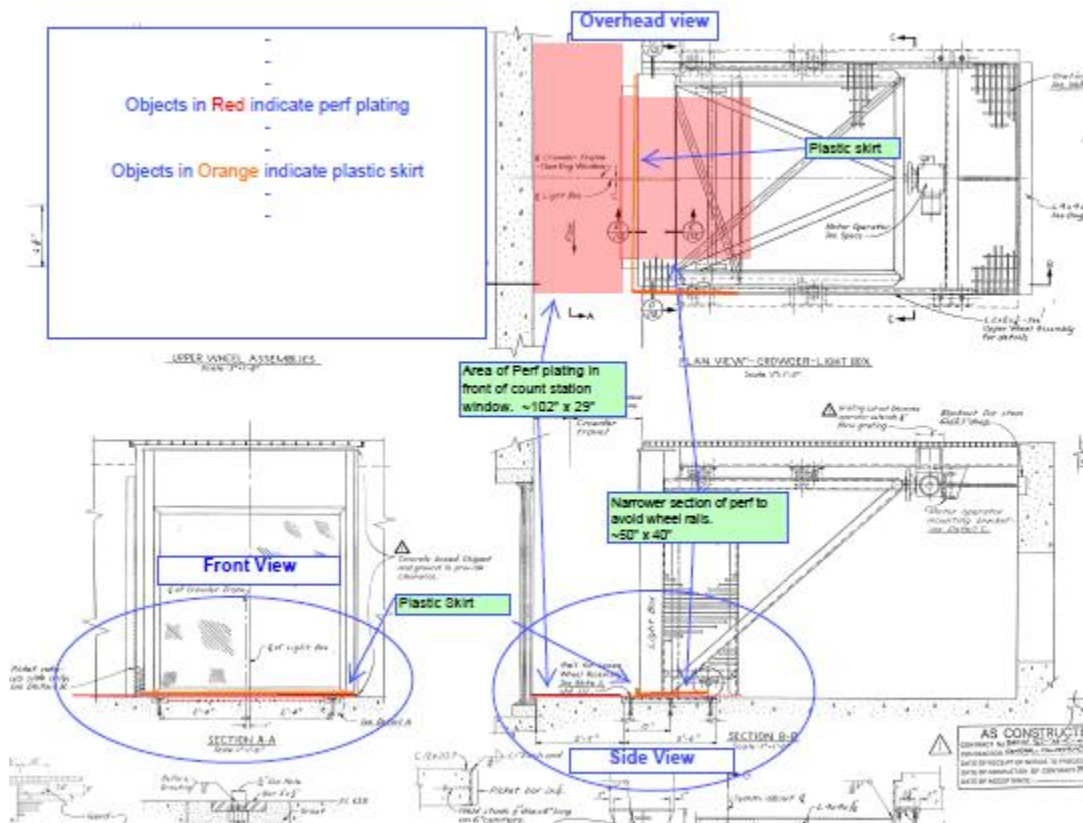
Figure 2: Close-up view of the proposed count station modifications.
