MEMORANDUM FOR THE RECORD

SUBJECT: 17JDA08 MFR – Two dead adult and three dead juvenile chinook found on the PH tailrace deck next to spillway # 20, within the last 4 days.

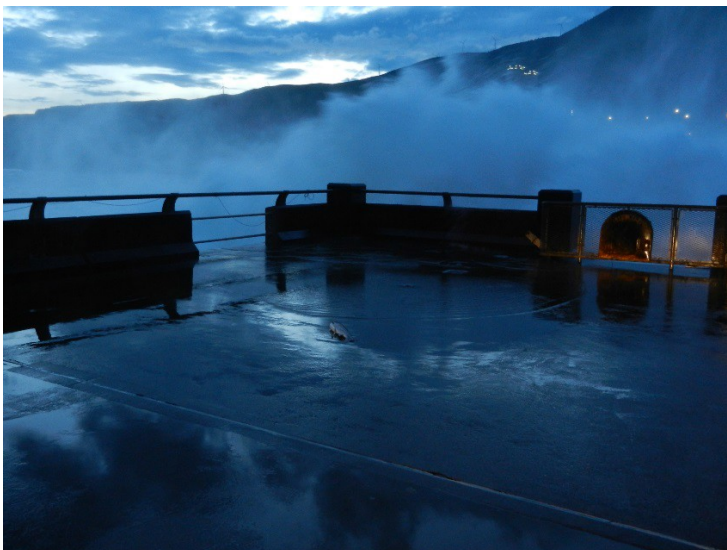
- E. Marks and Injuries found on carcass – All fish fresh, in good condition, without any visible marks or injuries on the body with an exception of adult clipped chinook which had a half-dollar size wound on the belly, between the ventral fins.

- F. Cause and Time of Death – Asphyxiation due to stranding on deck
- G. Future and Preventative Measures – After the second adult chinook mortality was found today, 23 May PM, the JD Fisheries imposed an immediate 3 stop limit at spill bay 20 to reduce its excessive and violent flows. A long term measure could be adding a small size mesh's screen on top of the hand rail. Probably up to extra 10 feet in height should be sufficient in preventing fish from being thrown over the current, low hand rail (pictured below.)

Photo is from the previous JD MFR03 to show the area.

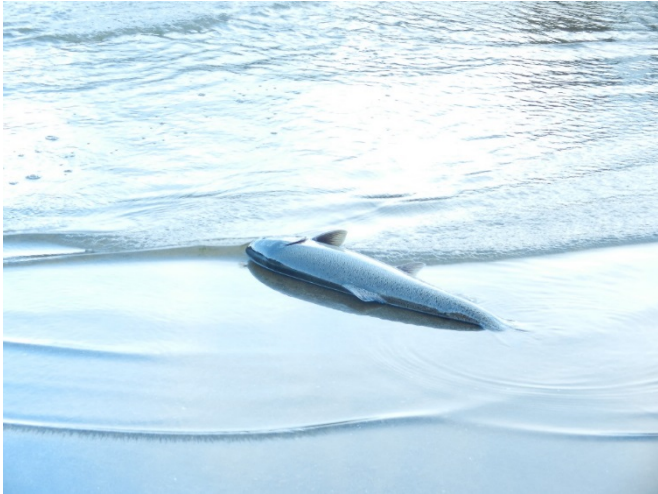
On May 23, AM, one dead adult, clipped chinook was found on the PH tailrace deck, next to spillbay 20. Another adult, unclipped chinook was found in the same spot, same day early PM. Additionally, 3 juvenile chinook mortalities were found there over the weekend: one clipped on May 19, another clipped plus one unclipped on May 20. Plus, there was one clipped juvenile steelhead mortality found in late April as well. All fish appeared to have come from spillbay 20, which is currently discharging a high volume of turbulent flows. JD Fisheries inspects this area at least twice per day and is able to detect mortalities in that area quickly. There had been similar mortalities, one adult steelhead (JD MFR 3) and one juvenile chinook mortality (JD MFR 4) found next to spill bay 20 in April.

Current photo from 23 May 2017.
