MEMORANDUM FOR THE RECORD 19 LGS 02 Sample Holding Tanks

SUBJECT: Holding Tanks for Condition Sampling

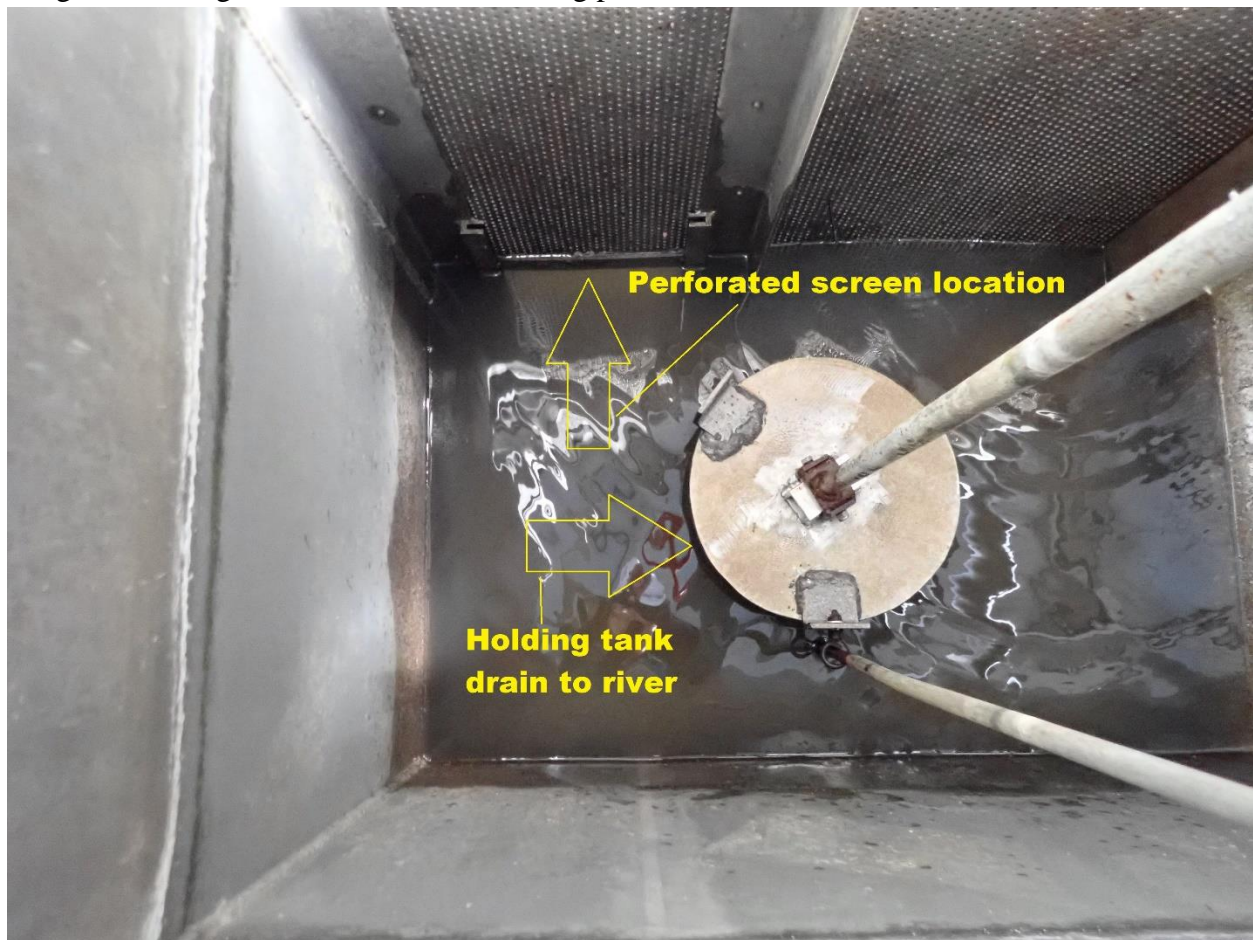
Image 1: Holding tank “B” drain and missing perforated screen.

The perforated screens that were not replaced will be added to the initial water up SOP at Little Goose. These screens are only removed to thoroughly clean holding tanks and had not been removed in previous years.

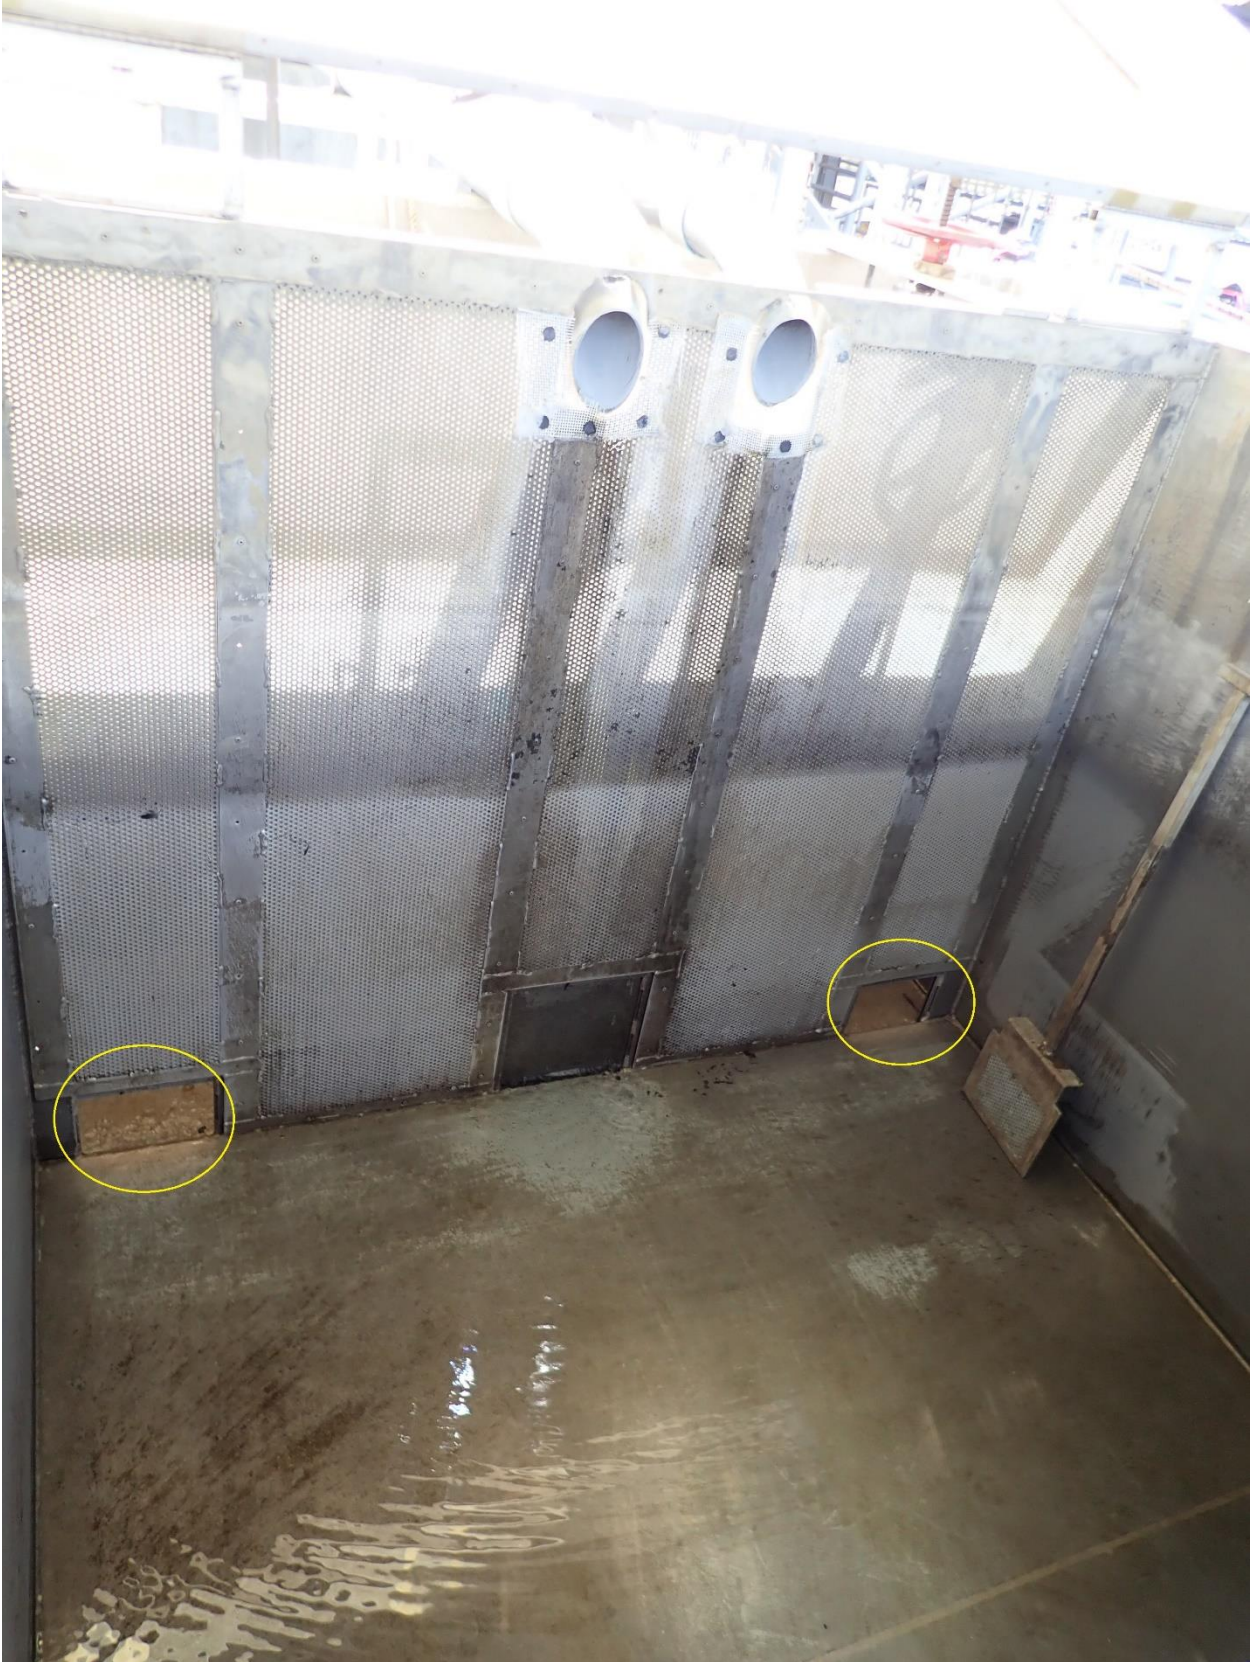
Image 2: Missing perforated screens in sample tank "B".

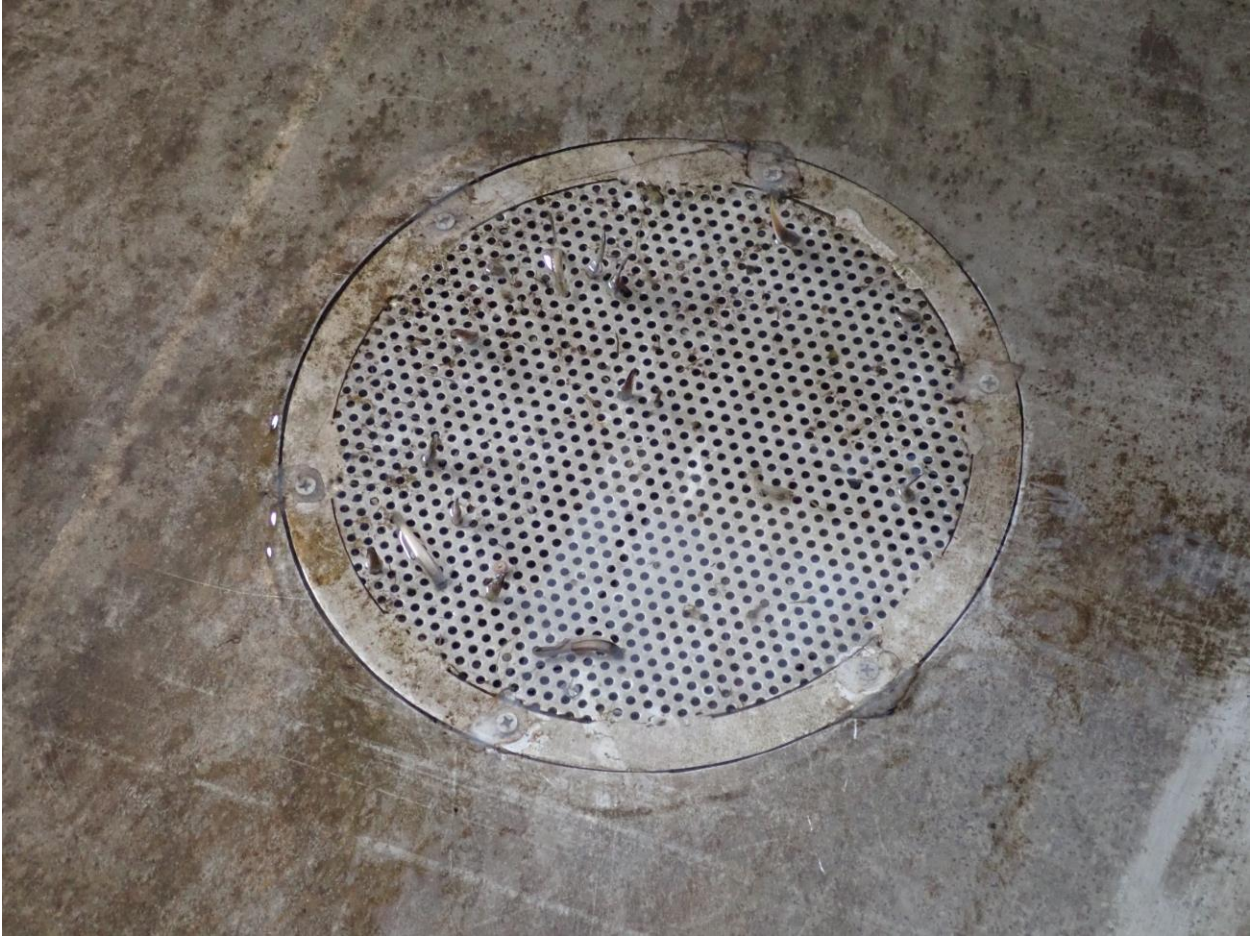
When the holding tanks were drained for inspection, numerous Pacific lamprey macrophthalmia were noticed beneath the supply water perforated plate in holding tank "B". The perforated plate was removed and 16 macrothalmia mortalities were removed. We determined that the lamprey macrophthalmia were transported through the supply water and were forced against the perforated plate. Both supply pipes were flushed thoroughly and no additional lamprey were recovered.

Image 3: Perforated plate covering holding tank supply water with juvenile lamprey mortalities.

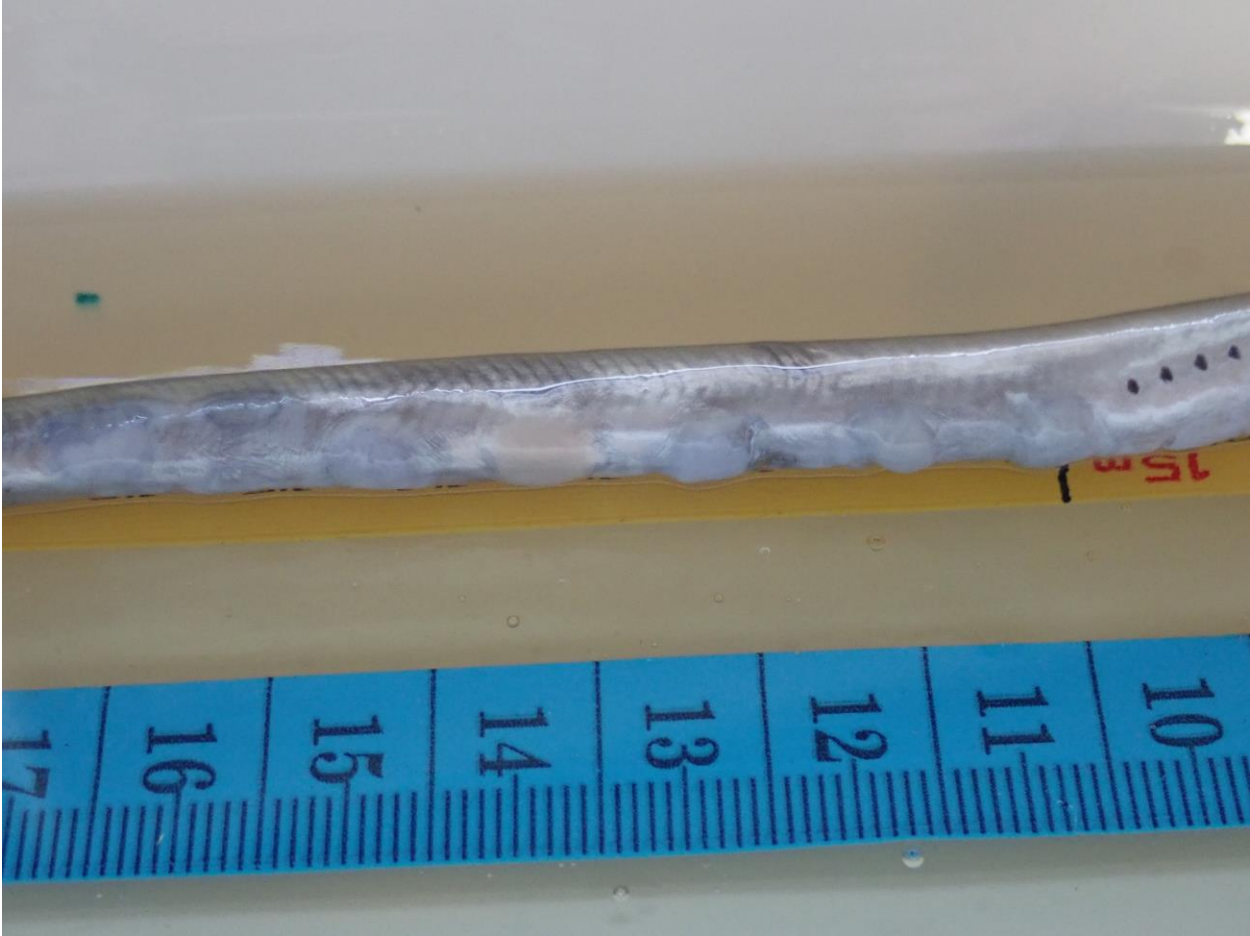
- A. Species – Pacific lamprey *Entosphenus tridentatus*
- B. Origin – N/A
- C. Length – N/A
- D. Marks and tags – N/A
- E. Marks and Injuries found on carcass – Numerous round shaped lesions were found from water pressure forcing the macropthalmia against the perforated plate.
- F. Cause and Time of Death – Could have occurred between March 27 and April 02 while the facility was fully watered up and operating.
- G. Future and Preventative Measures – An additional step for initial water up at the Little Goose JFF will be added to the O&M manual.

Image 4: Round lesions observed on lamprey macrophthalmia.

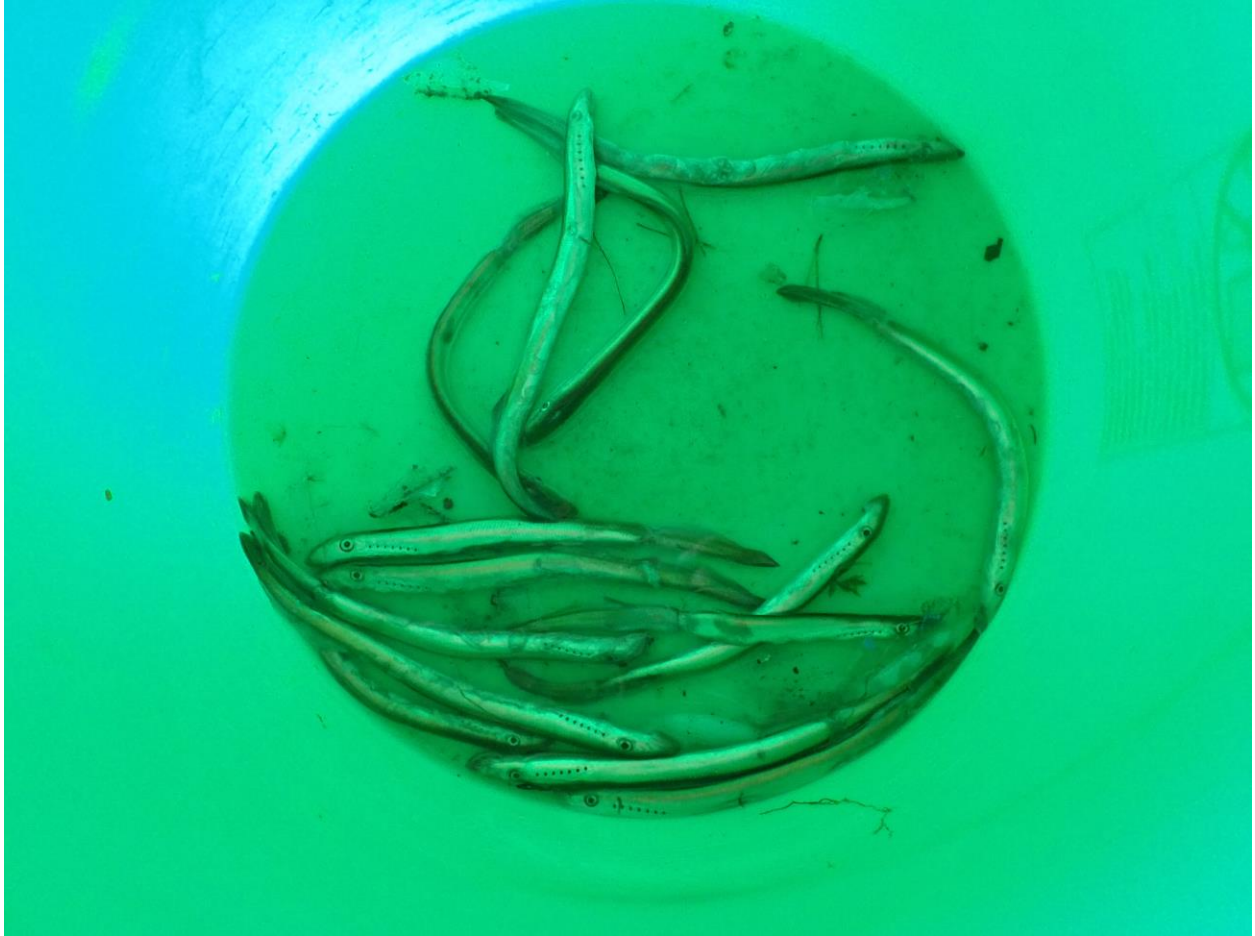
Image 5: Lamprey macrophthalmia mortalities.
