**MEMORANDUM FOR THE RECORD 19MCN007**

**SUBJECT: Spillbay 1 repair**

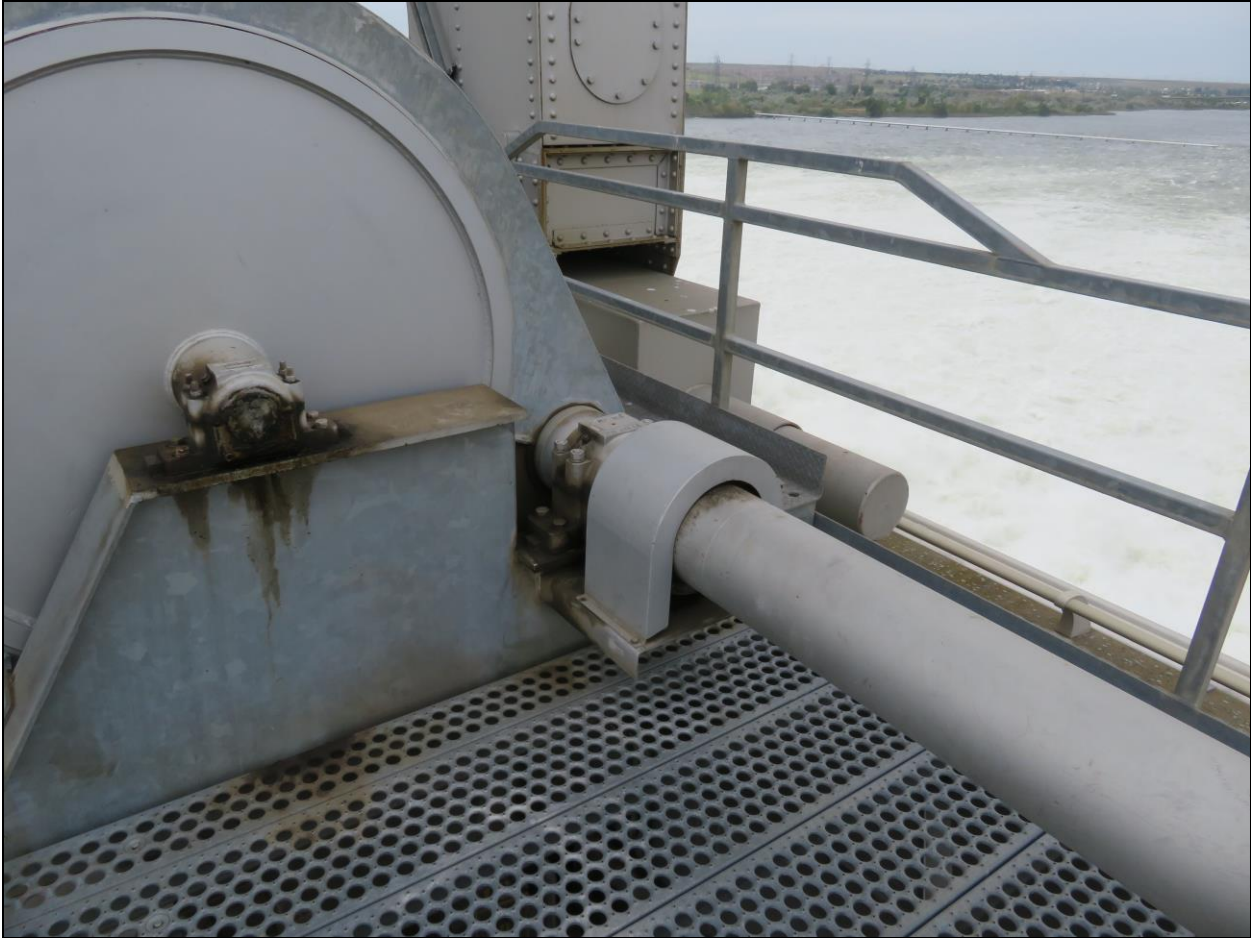
On May 14, project engineers performed spillbay hoist inspections. At spillbay 1, the engineers found cracks in the hoist pillow block around the bolts. Please see attached photos below. The request to remove the hoist from service occurred at 1337 hours. The bay was closed by 1430 hours. Project staff estimated it would take 13 weeks to buy a replacement block. However, the engineers now believe the broken part can be braced. The bracing would be completed within the next couple of scheduled working days. Until that time, after discussion with district personnel, the gate in bay 1 will be dogged off on the 5<sup>th</sup> stop. This operation should be completed by COB today. With the current flow volume, this gate stop setting will closely match FPP spill patterns.

Photo 1. General photo of area.

- A. Origin – NA
- B. Length – NA
- C. Marks and tags – NA
- D. Marks and Injuries found on carcass – NA
- E. Cause and Time of Death – NA
- F. Future and Preventative Measures – Continue periodic inspections by the project engineers and insure replacement parts are on hand.

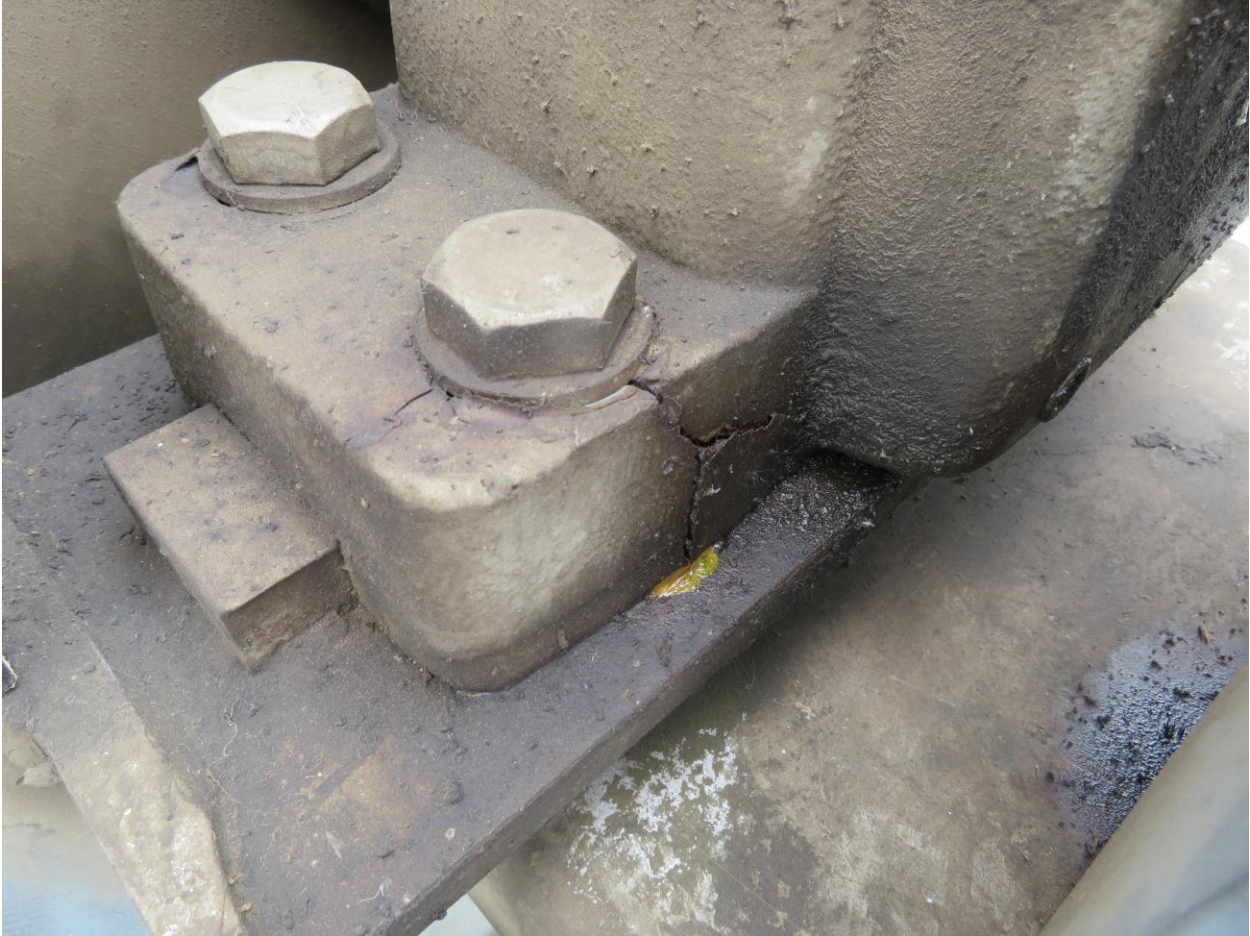
Photo 2. Close up of cracks.
