2018 BON Spillway Apron ROV Inspection Report

Inspection date: 12/13/2018;

Inspection location: Bonneville Dam, Cascade Locks, OR;

Desired inspection targets: Verification of rock debris in spillbays and structural defects;

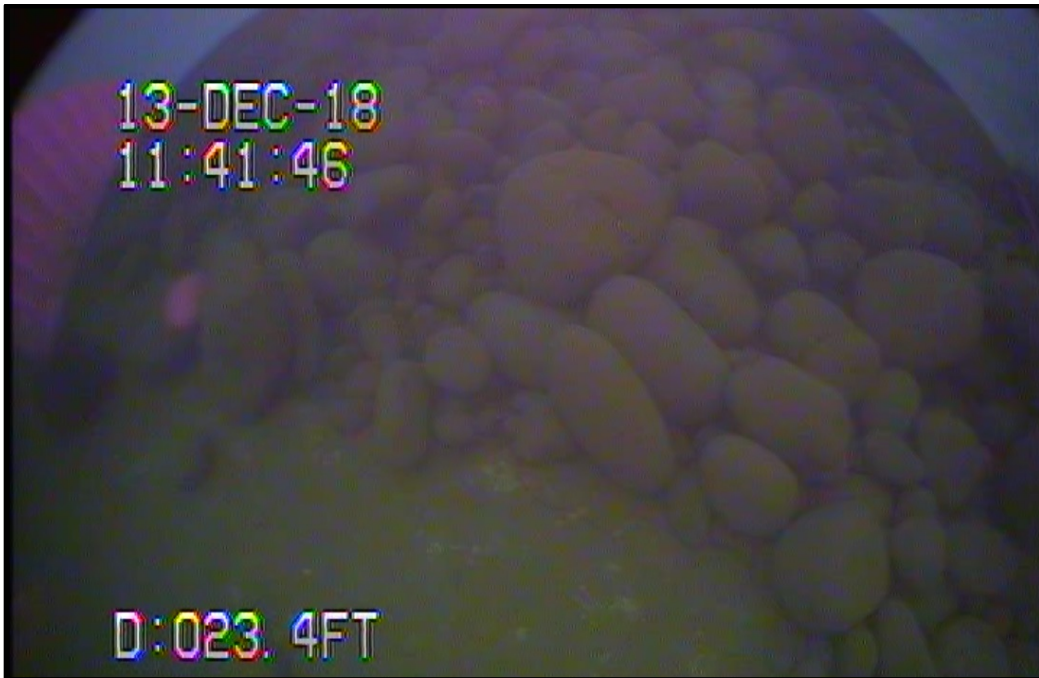
Spillbay 17- As indicated on the hydro-survey data, SB 17 has a pile of rock that covers a large portion of the entire area between the dividing piers. The rock pile is approximately 30ft by 25ft at the base of the ogee and ranges in depths from 19 to 28ft of water depth down the slope. The upper portion of the pile appears to be filling the scoured area that was found by divers during the 2017 rock removal contract. Below the apron end sill at Spillbay 17, a pile indicated on the hydro-survey is in fact river rock of various sizes. This pile is approx. 100' wide (at the widest point) by approx. 75' long and is concentrated in the corner where the apron end sill and the Spillbay 17-18 dividing pier intersect;

Figure 3 Rock found in SB 17 on the downstream side of the pile.

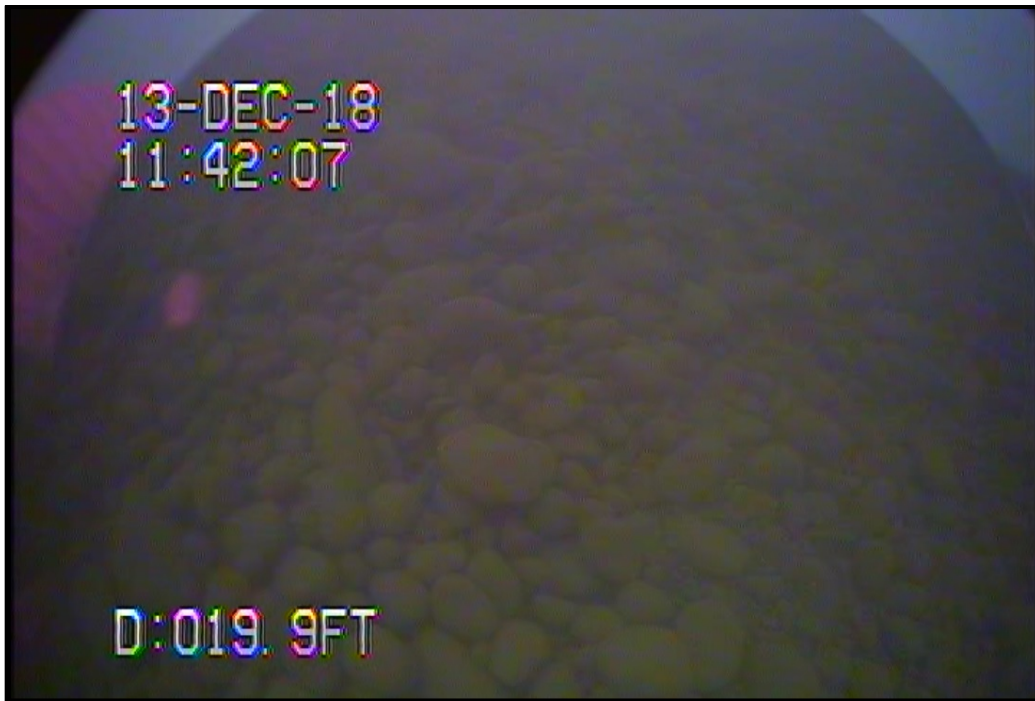
Figure 4 Rock pile in SB 17 on the shallower upstream area.

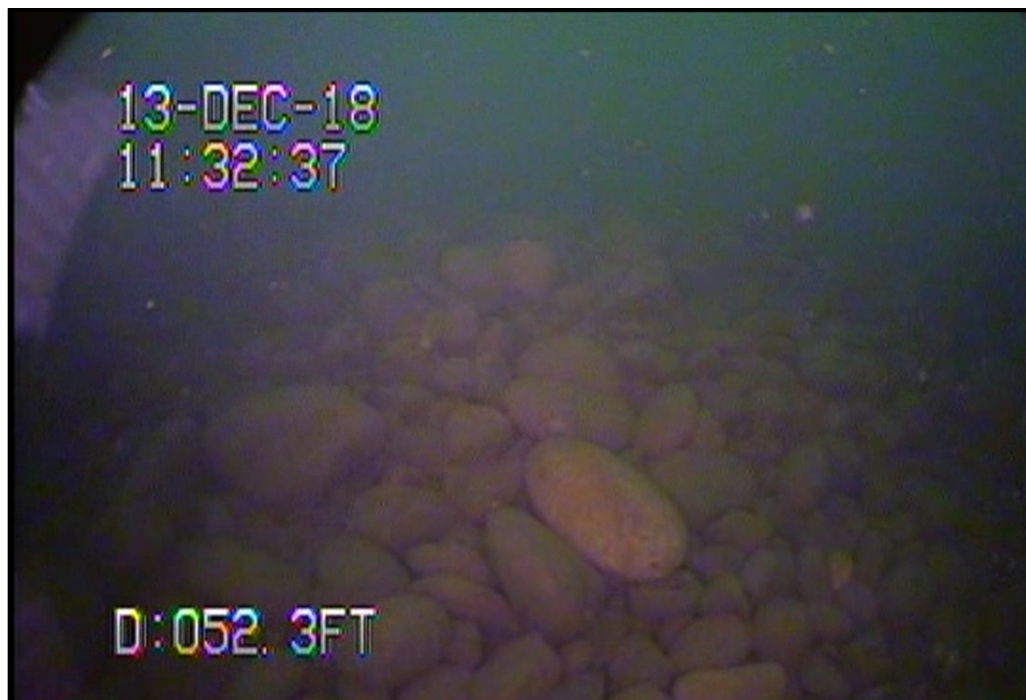
Figure 5 Rock at SB 17 End Sill.

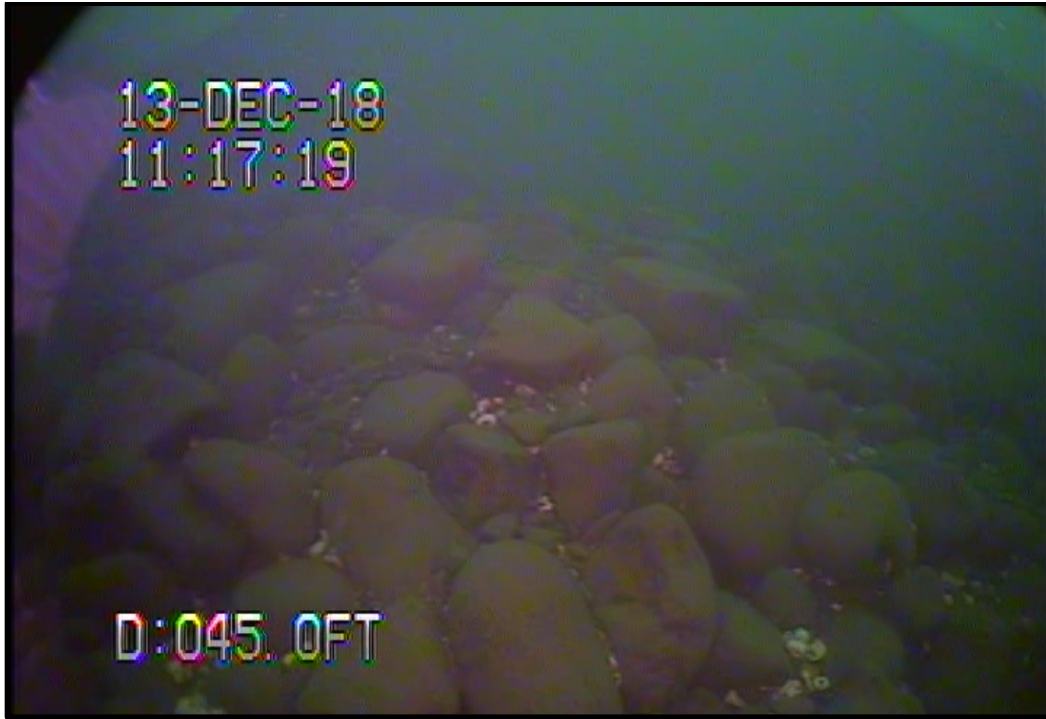
Spillbay 10-12, below the Apron End Sill- As indicated on the hydro-survey data, the pile below Spillbays 10-12 is various sizes of river rock. This pile is approx. 175' by 28' and runs north/south along the apron end sill;

Figure 6 Rock below SB 10-12 End Sill.

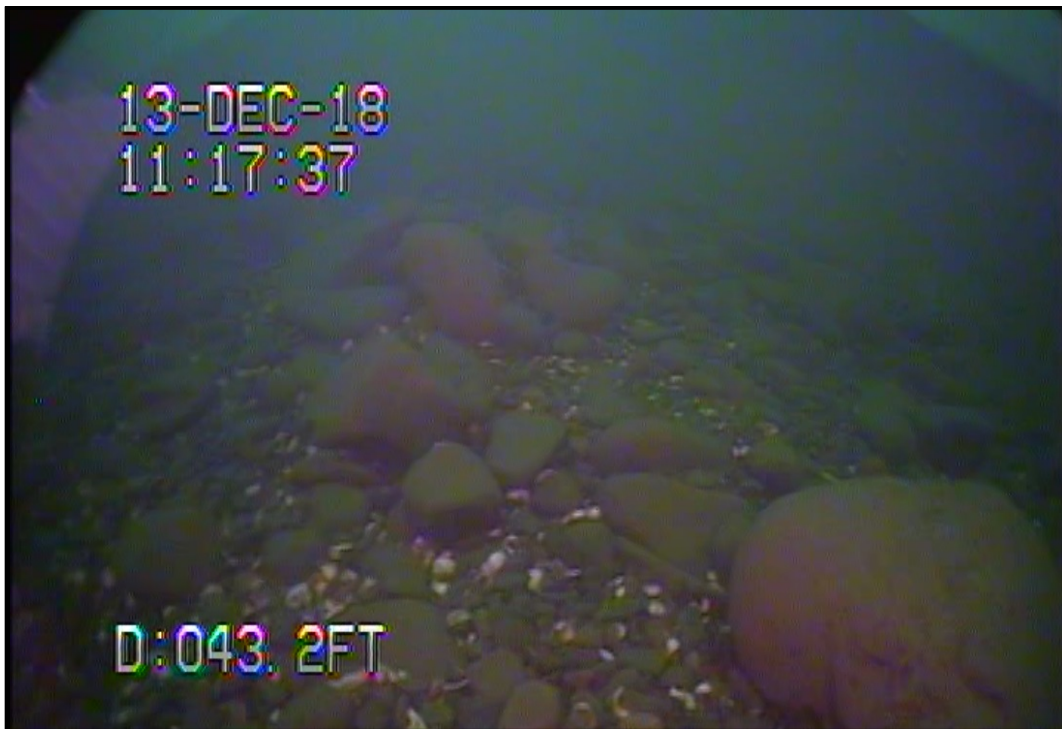
Figure 7 Another image of rock below SB 10-12 End Sill.

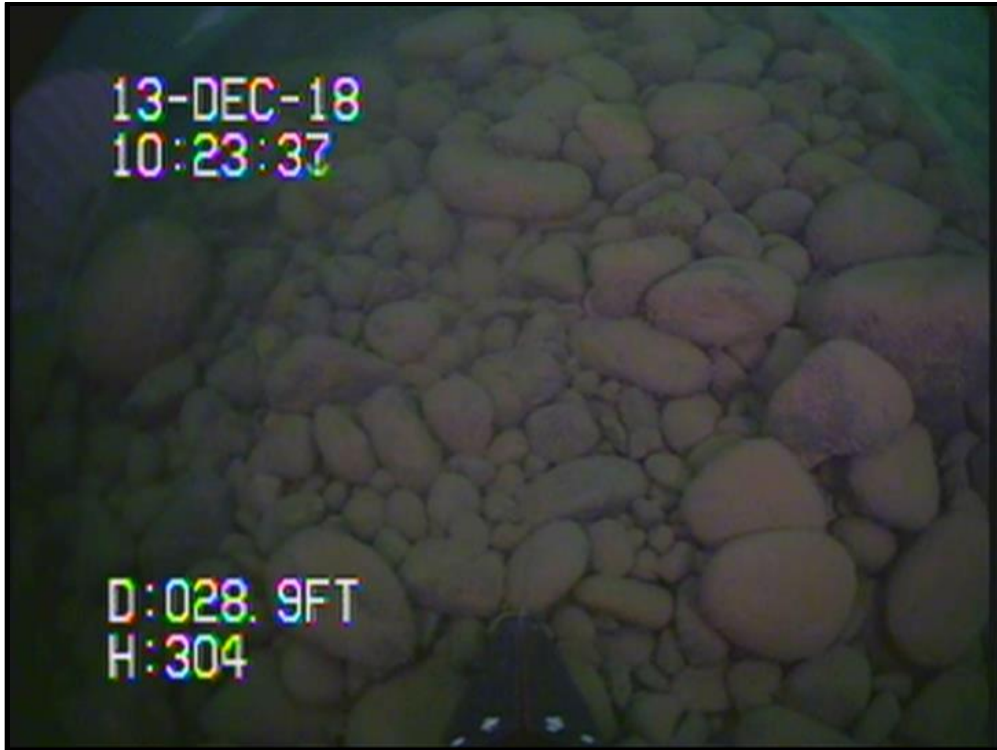
Spillbay 2- The pile of rock found in SB 2 is approximately 25 ' by 20' and composed of various size round river rock. There is also river rock below the apron end sill at Spillbay 2 that is approx. 65' wide by 25' long and concentrated in the corner where the apron end sill and the Spillbay 1-2 dividing pier intersect;

Figure 8 Rock found at SB 2.

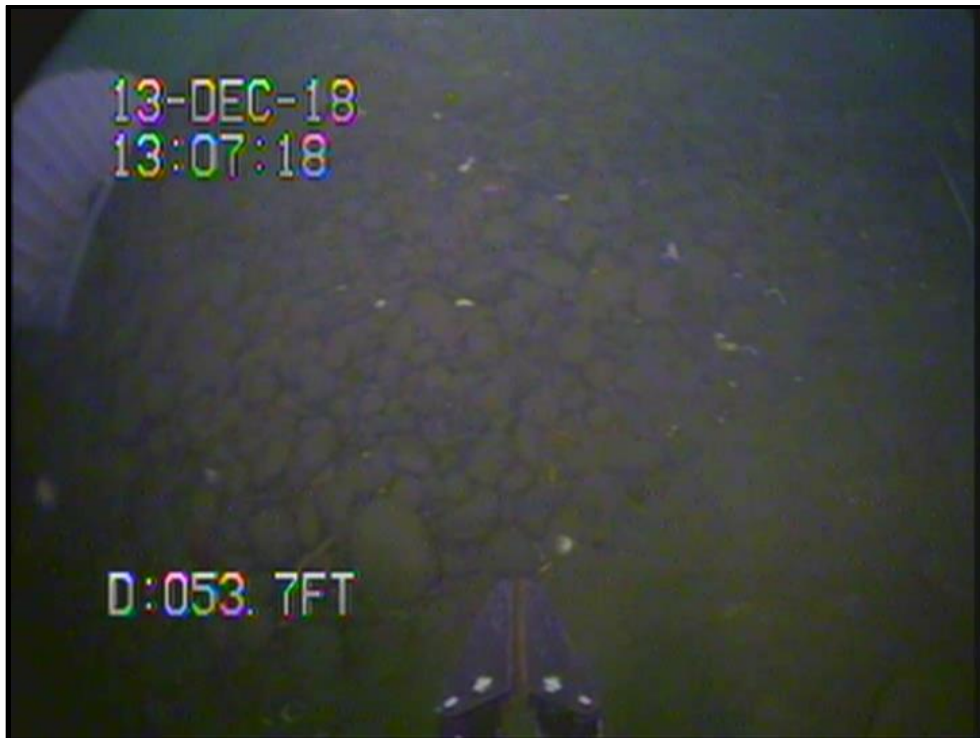
Figure 9 Additional rock at SB 2 End Sill.

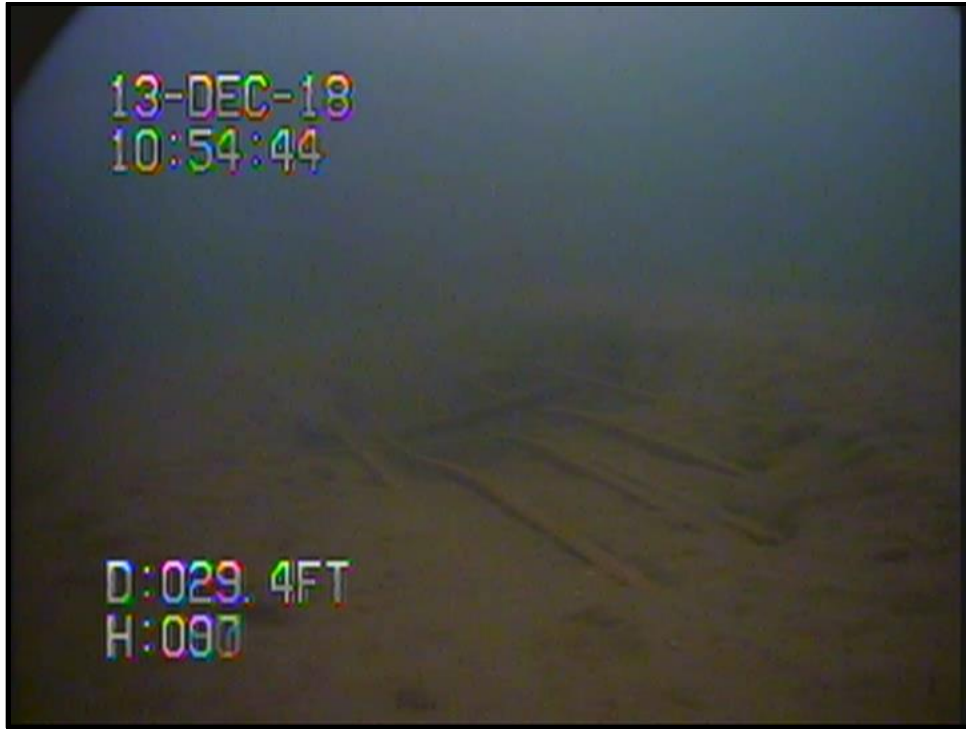
Spillbays, apron & baffle blocks- The spillway bays were inspected by BlueView sonar where able to determine the presence of rock debris as indicated by recent hydro-survey data. Once debris or structural defects were located by sonar, the ROV was piloted into the area of interest to gather video documentation. Some areas of the spillway downstream of spillbays 5 thru 9 were not inspected due to high water flow from significant gate leakage. Spillbays where previous repairs have been made appear to be in the same condition as found during last year's inspection. Significant erosion and exposed reinforcing bar was found in the area of the apron between the upstream & downstream rows of the baffle blocks. The baffle block trailing edges were found heavily eroded in these areas also.

Figure 10 Typical apron erosion damage found downstream and between baffle block rows.

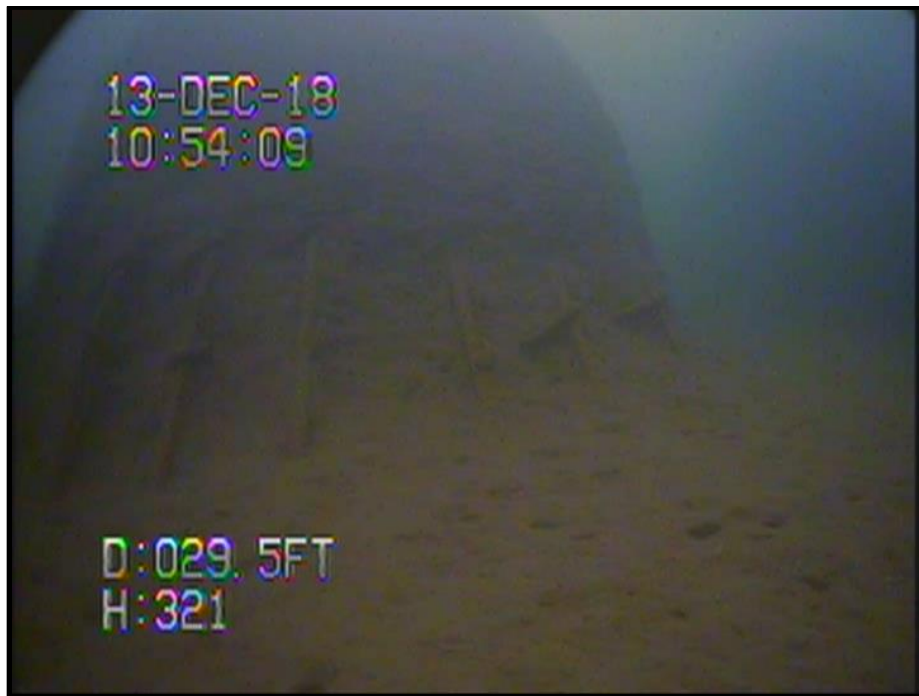
Figure 11 Erosion and rebar found on the downstream side of baffle blocks.

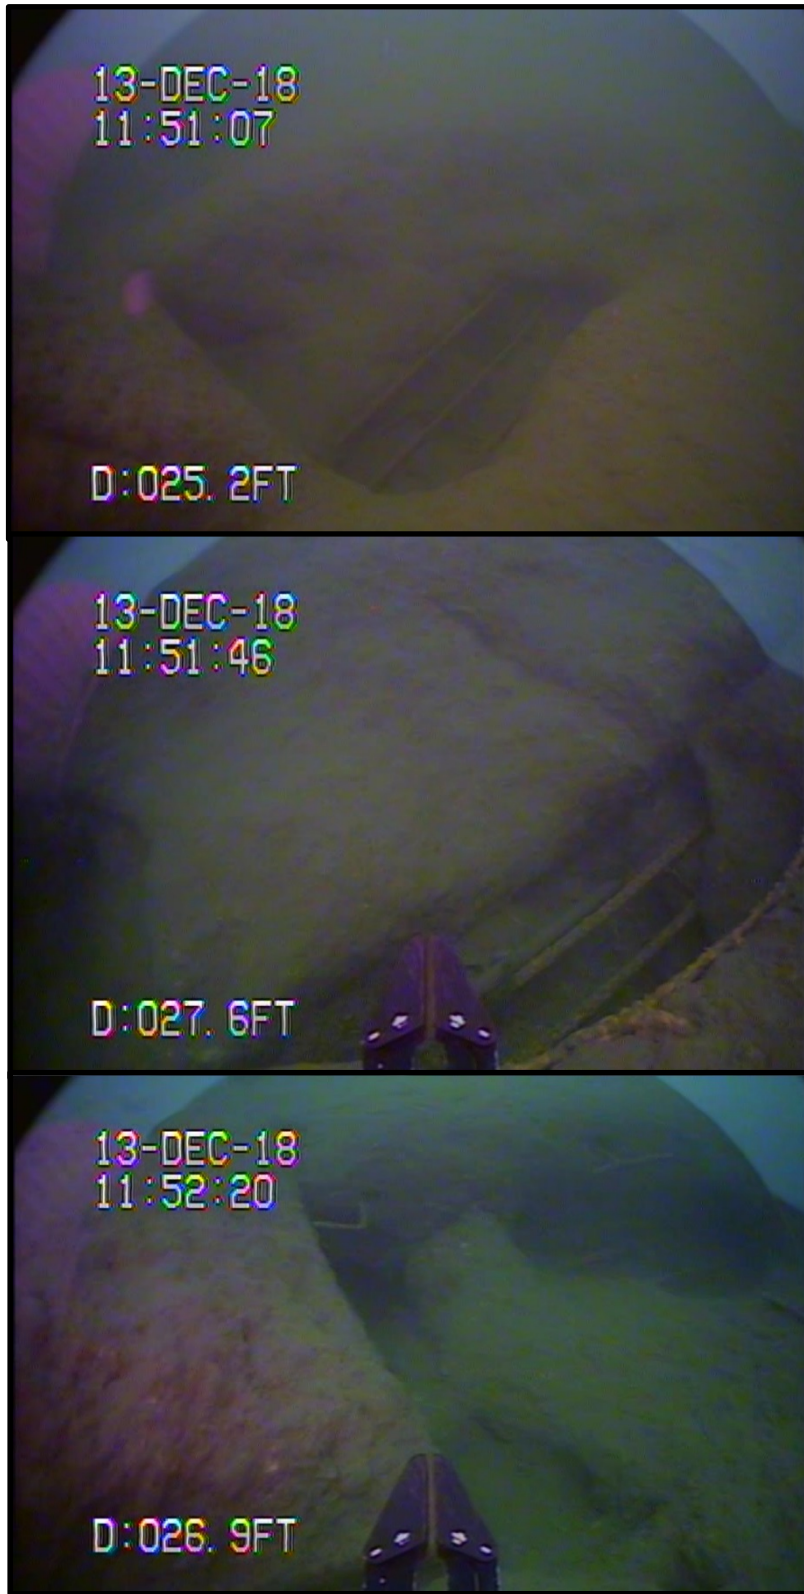
Figure 12 Images of erosion and exposed rebar of apron and baffles just downstream of SB 14-16.

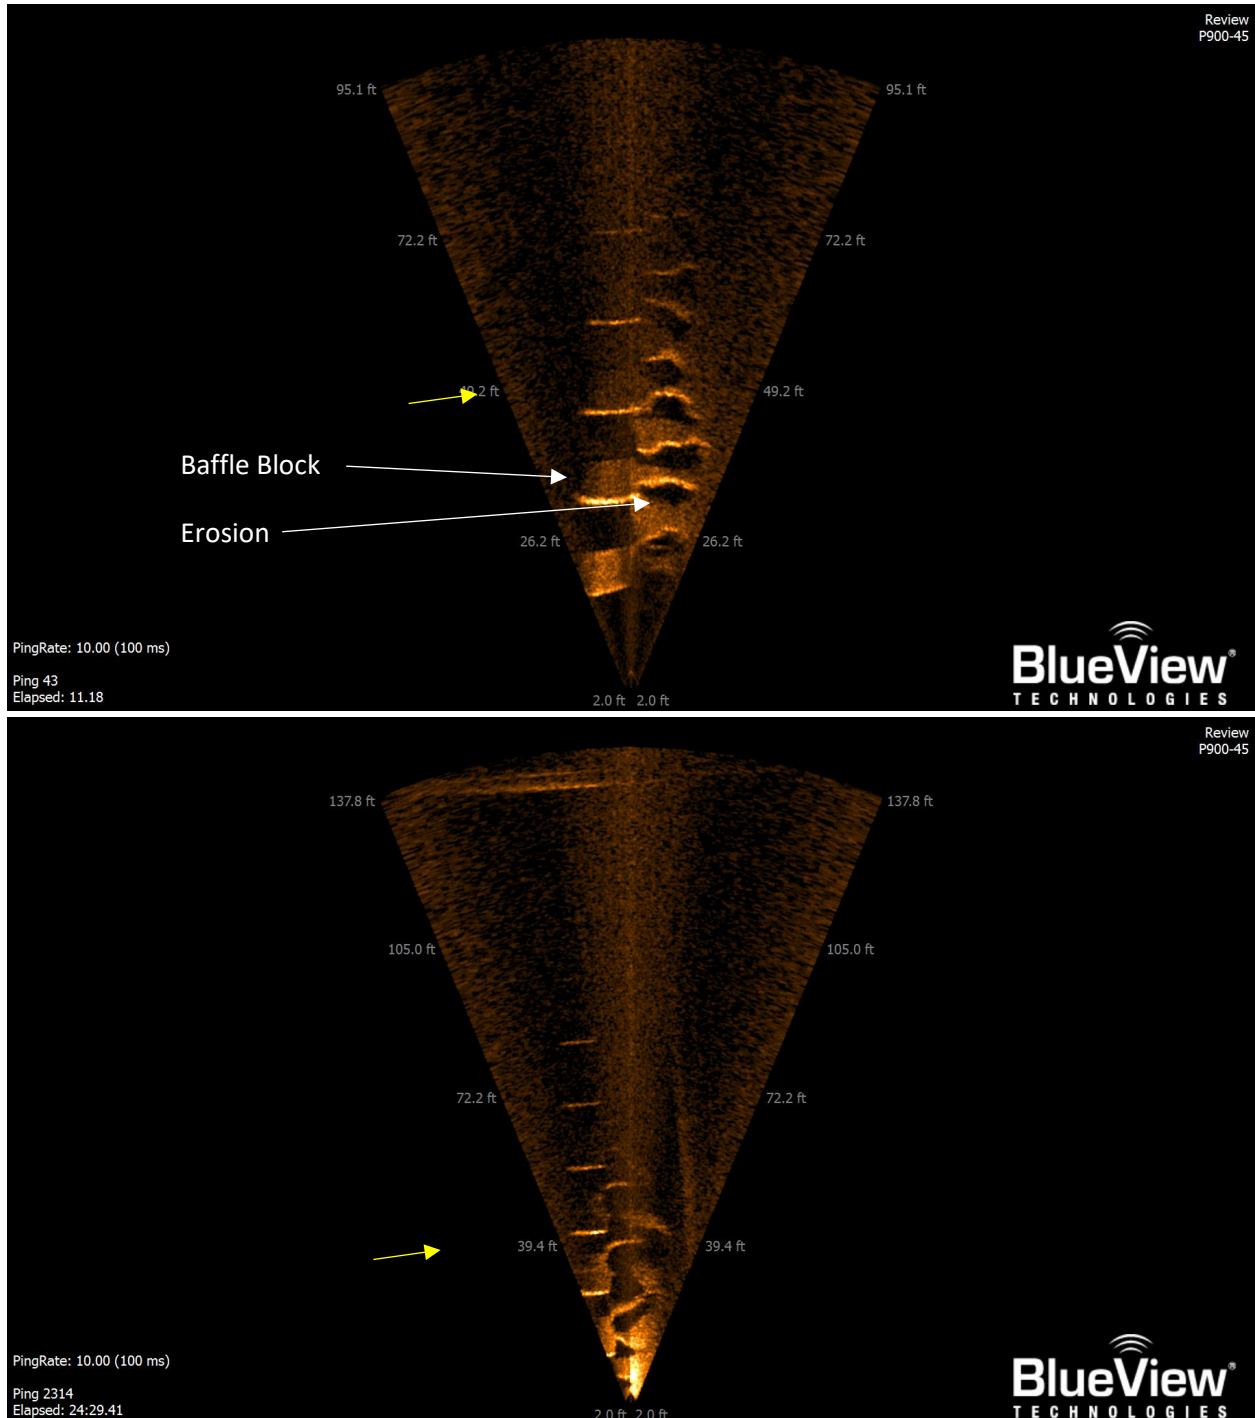
Figure 13 Sonar images showing erosion found at the downstream corners of all baffles in the first row.

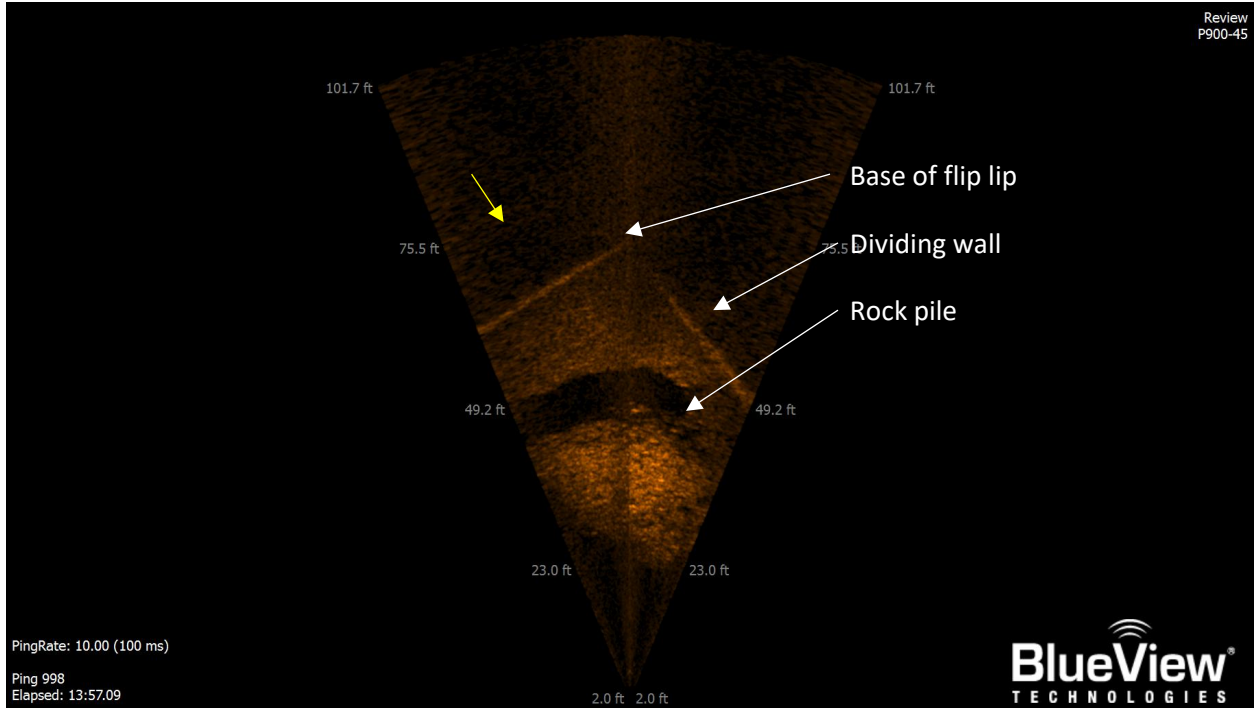
Figure 14 Sonar image of rock in SB 17.

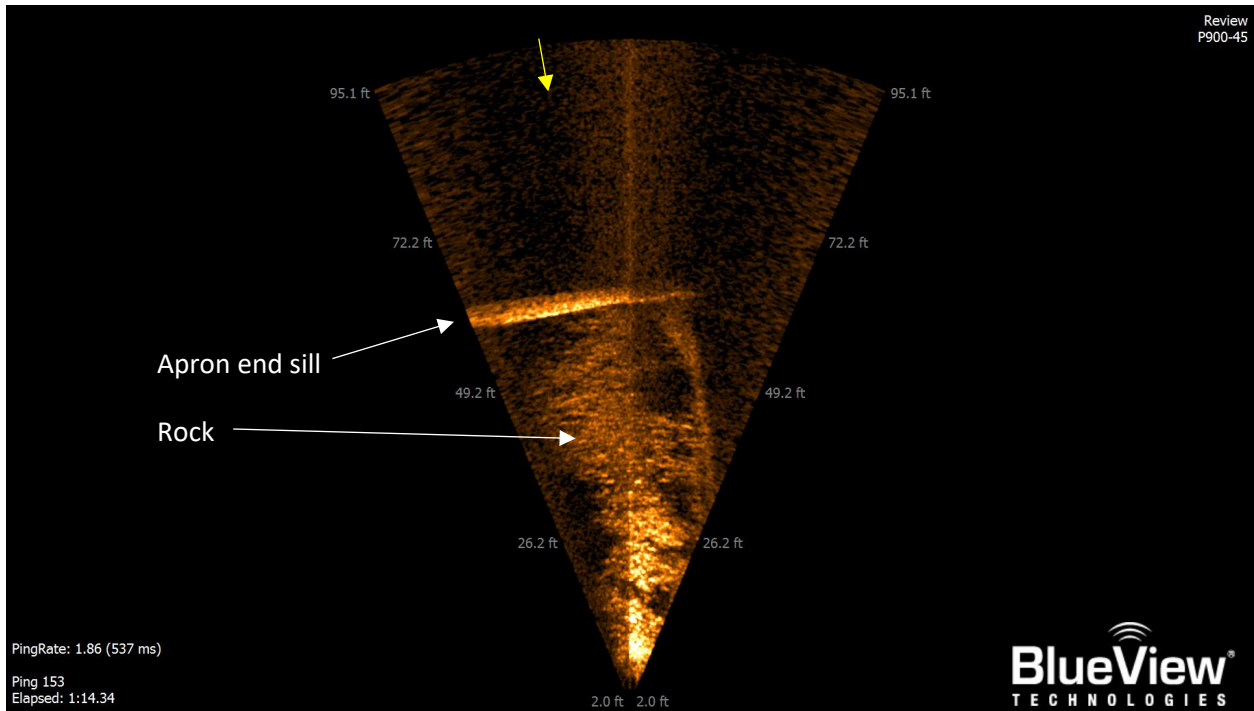
Figure 15 Rock below SB 17 End Sill.

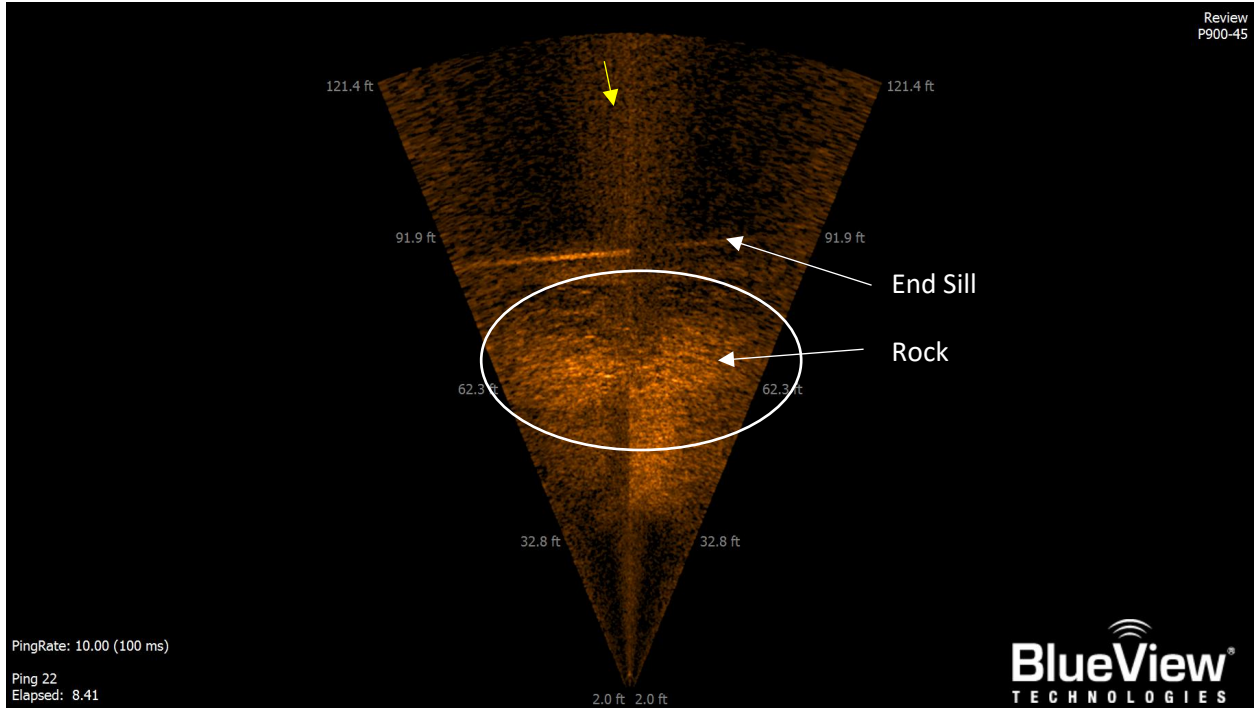
Figure 14 Rock pile below the End Sill of SB 10-12.

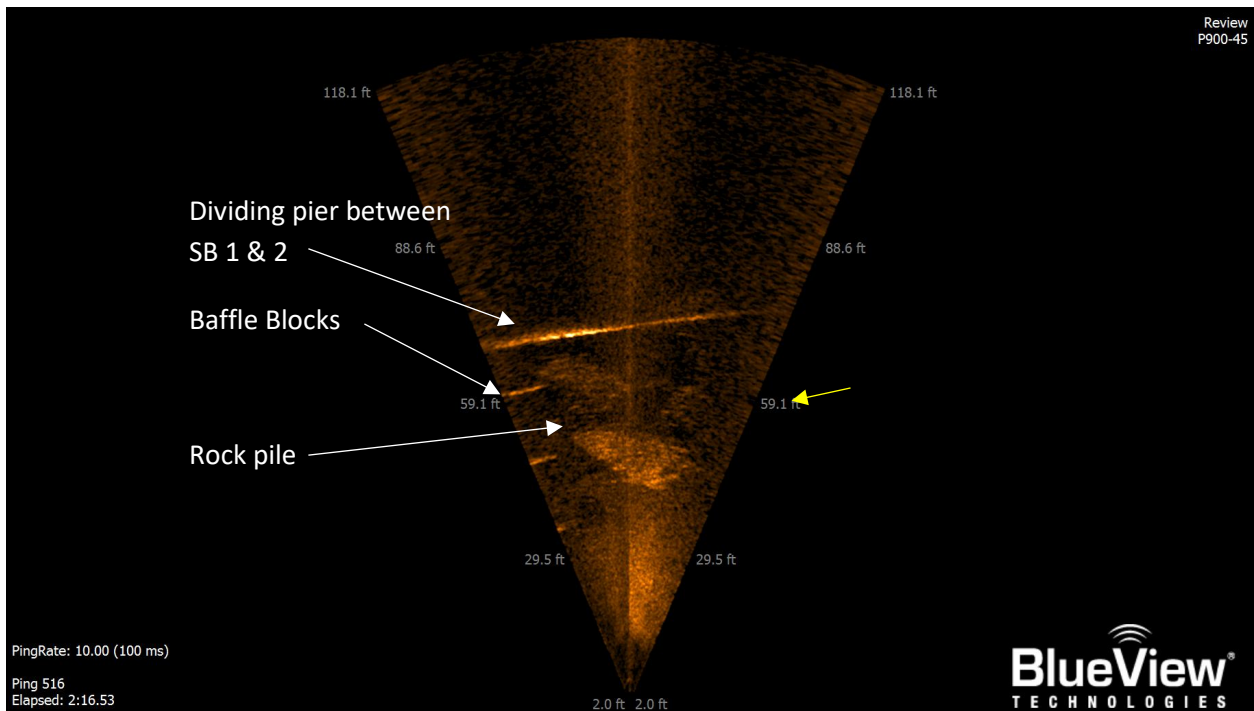
Figure 15 Rock pile in SB 2.
