2020 BON Spillway Apron ROV Inspection Report

Inspection date: 12/02/2020;

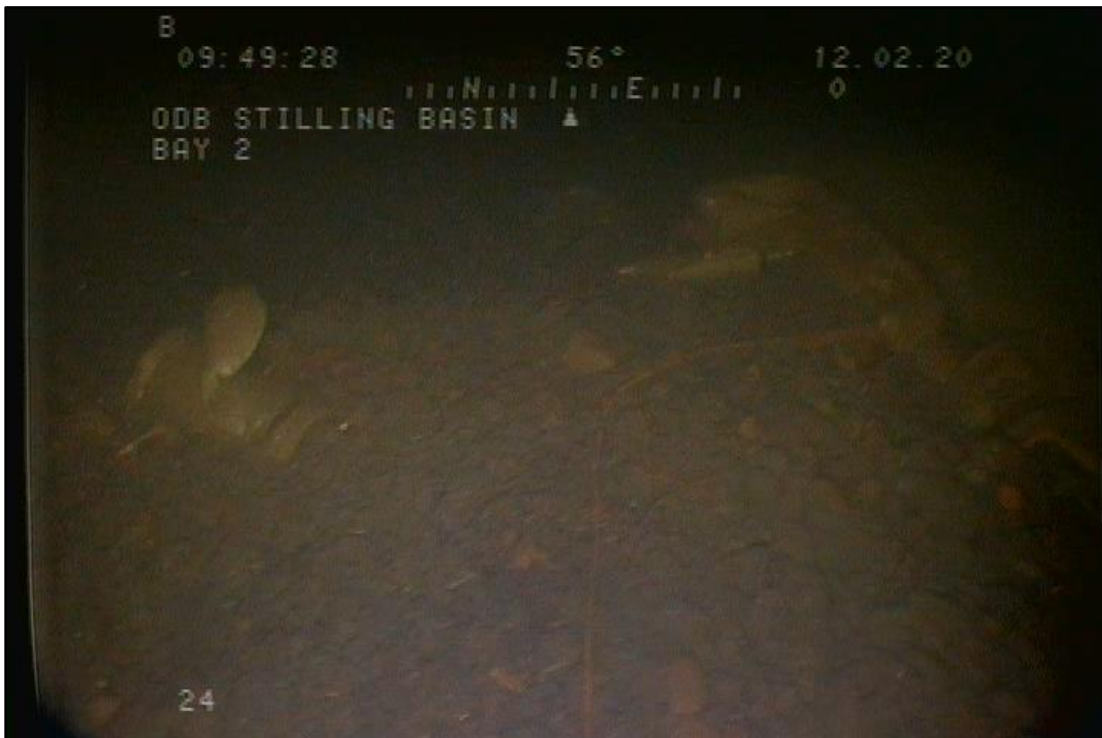
Figure 3 Small rock pile found in Bay 2 along with a boat propeller and outboard lower unit.

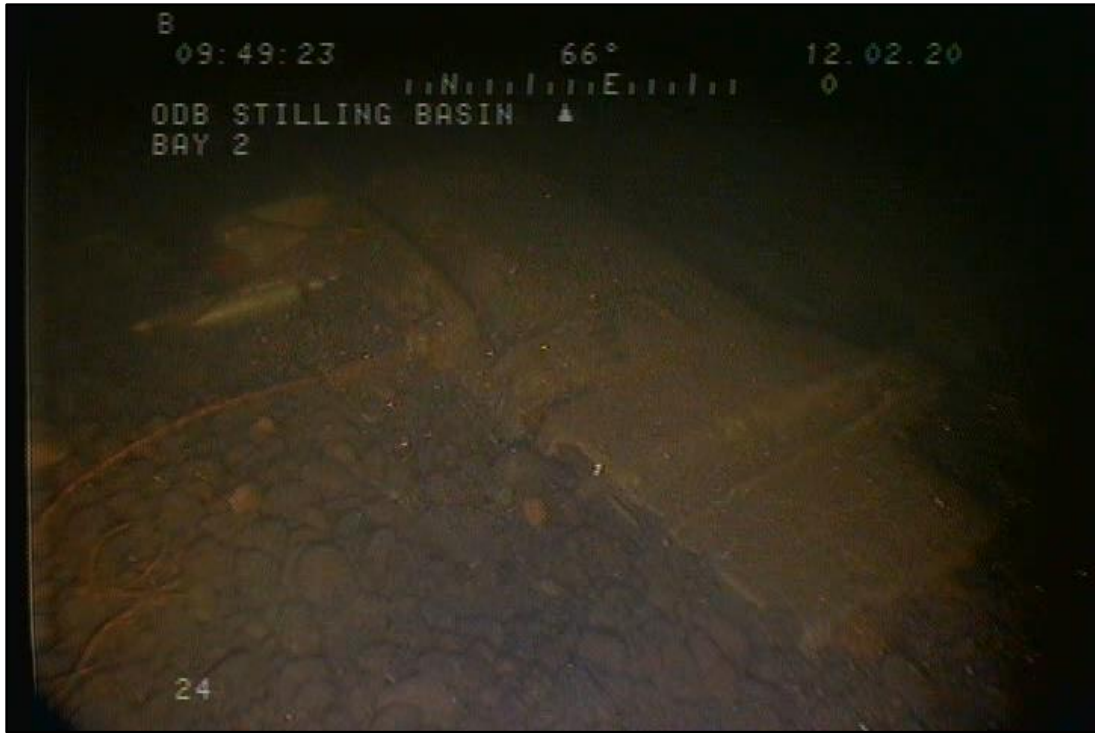
Figure 4 Bay 2 Rock pile with outboard motor lower unit.

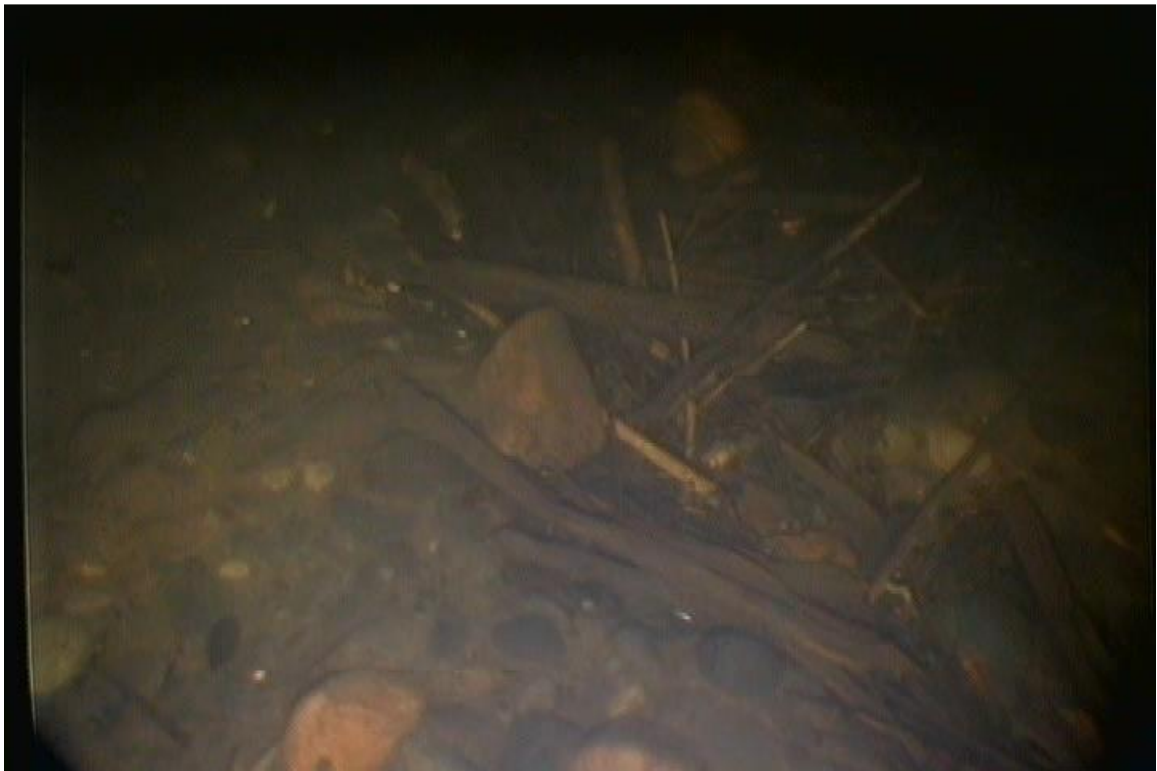
Figure 17 Woody debris in eroded area of Bay 18 ogee.

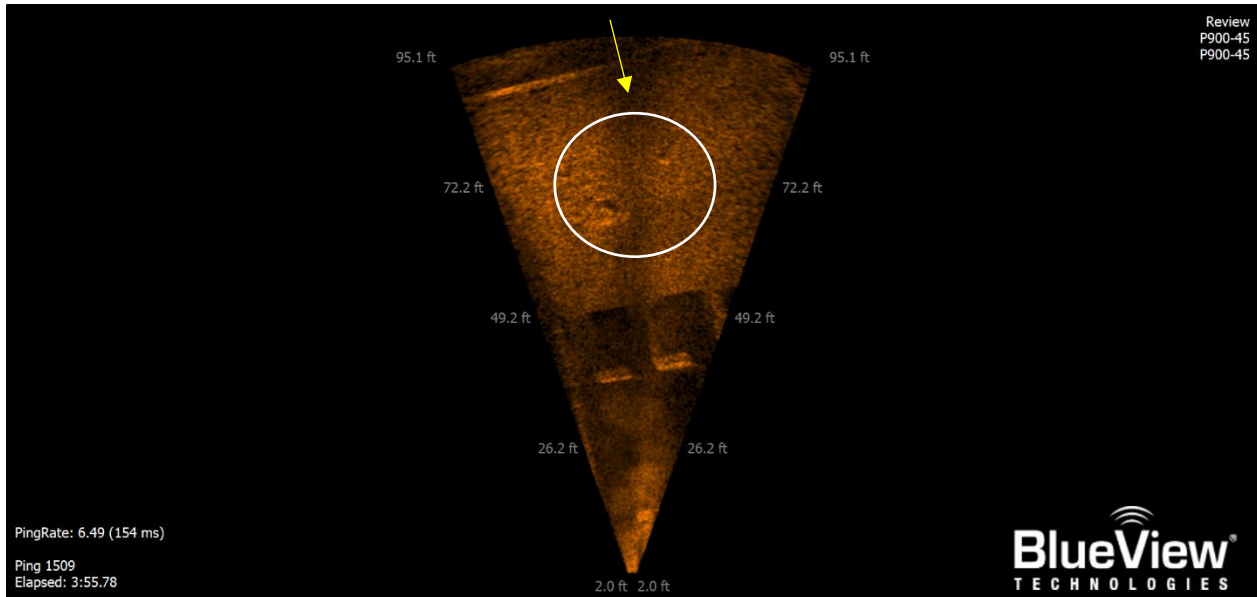
Figure 18 White circle indicates small diameter pile of rock and debris in Bay 2.

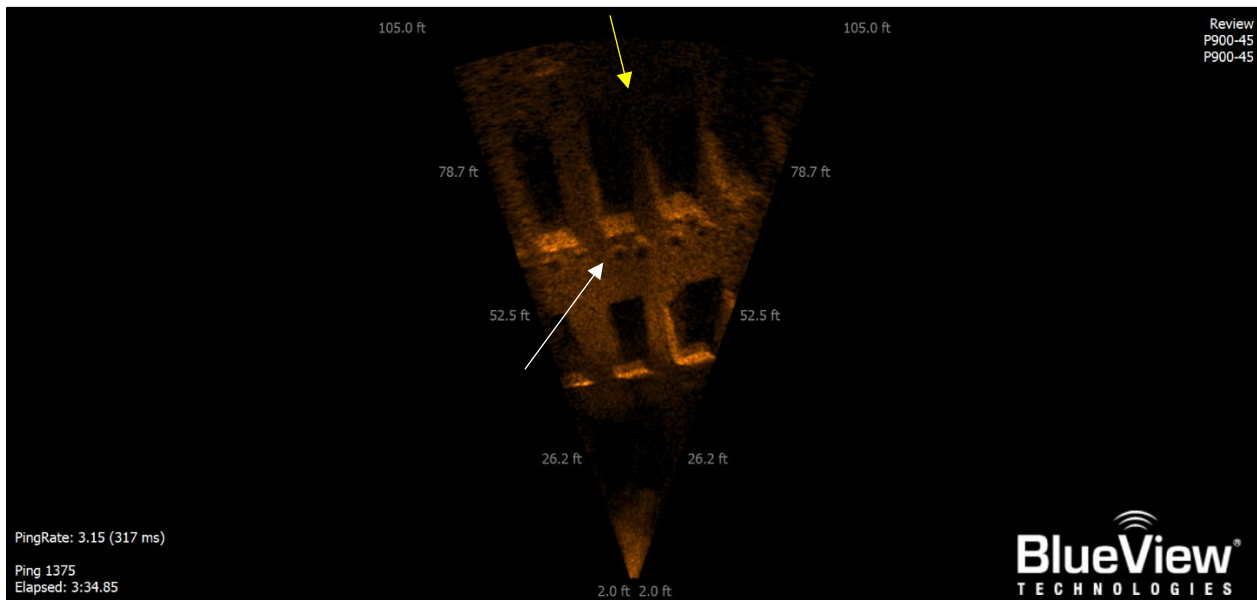
Figure 19 White arrow indicates eroded areas downstream of the first row of baffle blocks. This is found across the entire apron.

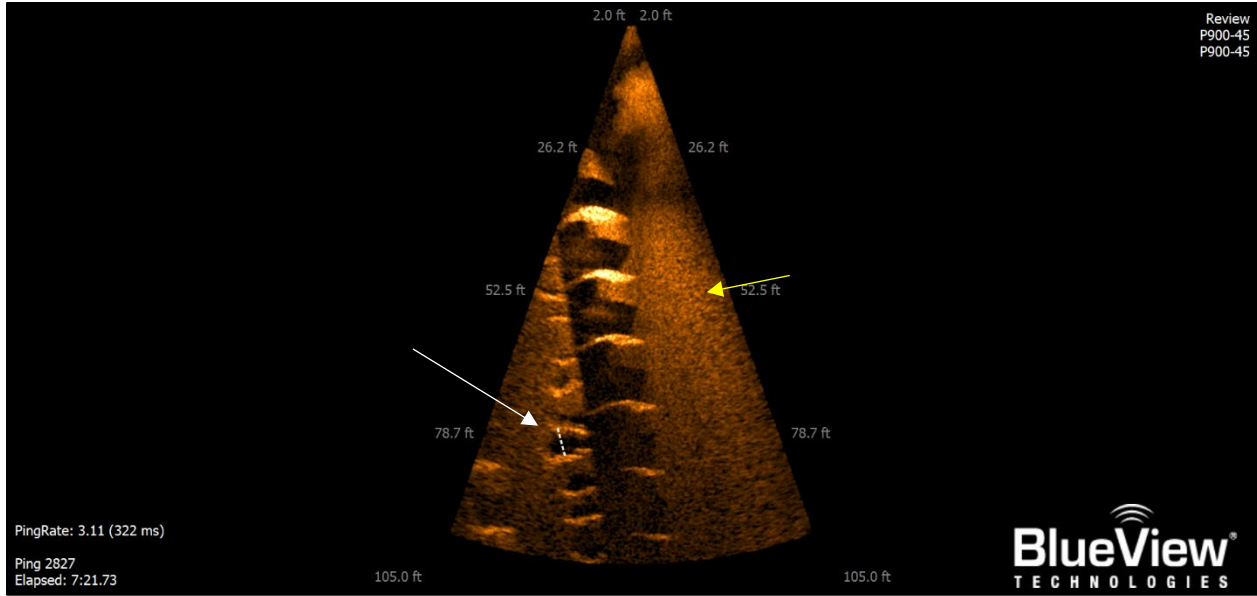
Figure 20 Additional imagery showing erosion holes downstream of the baffle blocks. This is at Bay 3. White arrow indicated eroded area 3-4' wide.

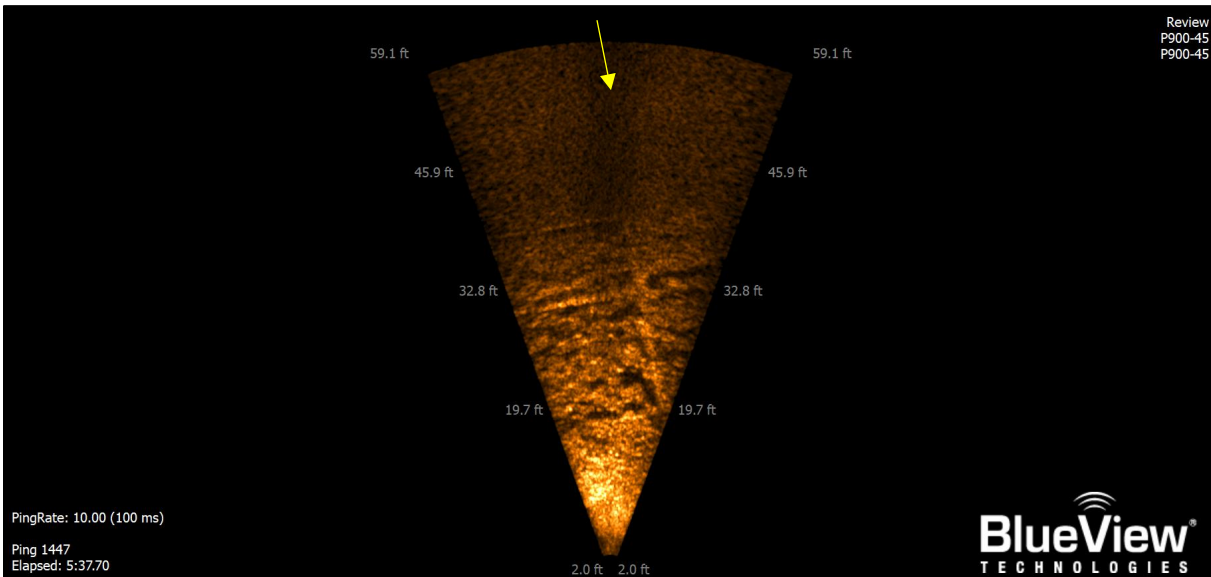
Figure 27 Sonar image of Bay 18 eroded surface and construction joints. Shadowing in the image indicates the rough, worn surface.
