**MEMORANDUM FOR THE RECORD**

**SUBJECT: 21JDA04 MFR South Fish Ladder Out of Service for Debris Removal**

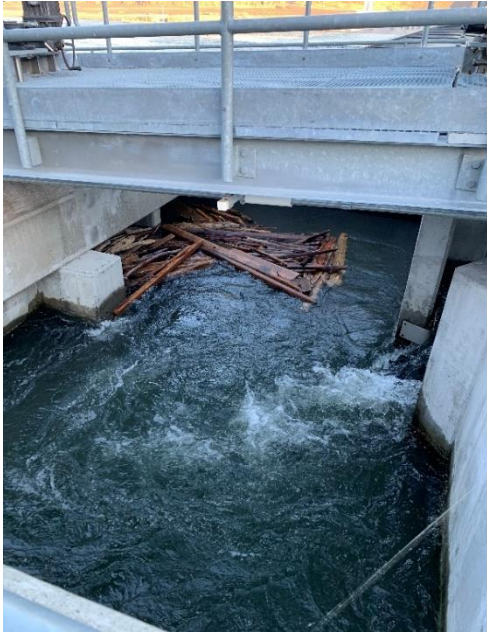
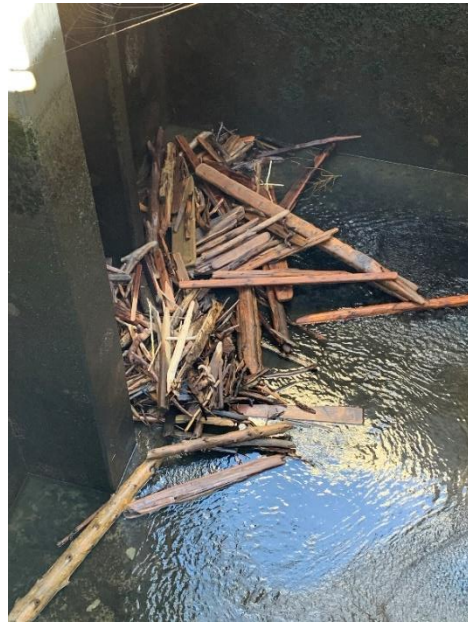
At 0900 on April 20<sup>th</sup>, 2021, the South Fish Ladder was taken out of service to remove excessive amounts of debris. The log boom at the south fish ladder exit was damaged during an east wind event the week of April 12<sup>th</sup>. The log boom was removed to inspect for damage. The damage is extensive and needs between 2 to 3 weeks for repairs. On Saturday, April 17<sup>th</sup>, during ladder inspections, it was noted that debris was accumulating in the south ladder near the exit. On Monday, April 19<sup>th</sup>, the amount of debris was unprecedented in the control section of the south ladder and the decision was made to take the ladder out of service and remove the debris. A temporary log boom is installed until the permanent boom can be repaired. Once the log boom is repaired, it can be replaced without further outages. One clipped adult Chinook, four suckers, and five smallmouth bass were successfully salvaged and returned to the river. The ladder was cleared of debris and returned to service at 1430 on April 20<sup>th</sup>.

Figures 1 & 2. Large woody debris mat in the flow control section of the South Fish Ladder.

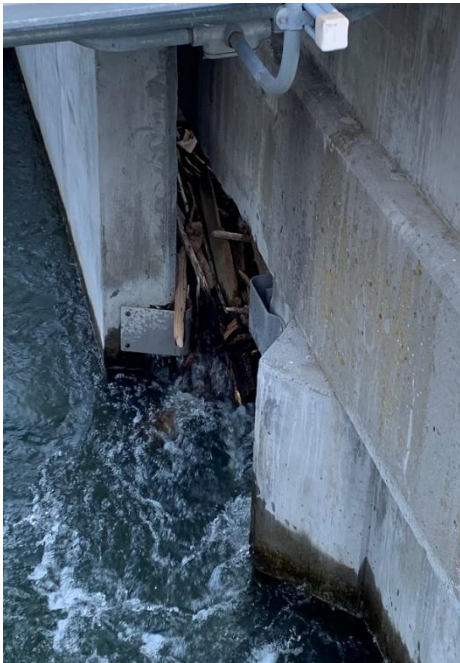
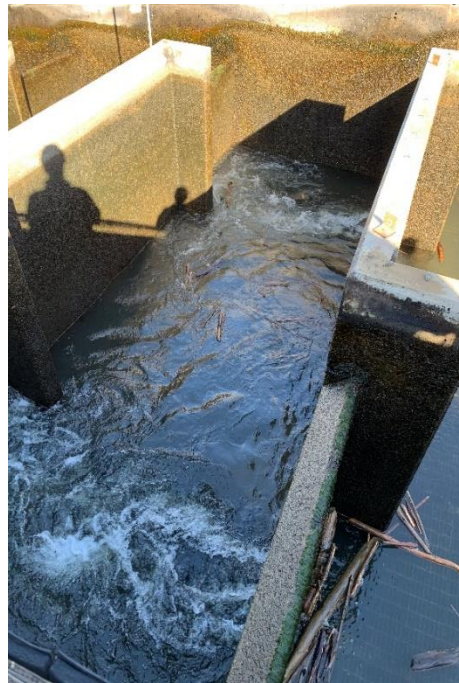
Figures 3 & 4. Large wood debris in the South Fish Ladder with the potential to stop fish passage.

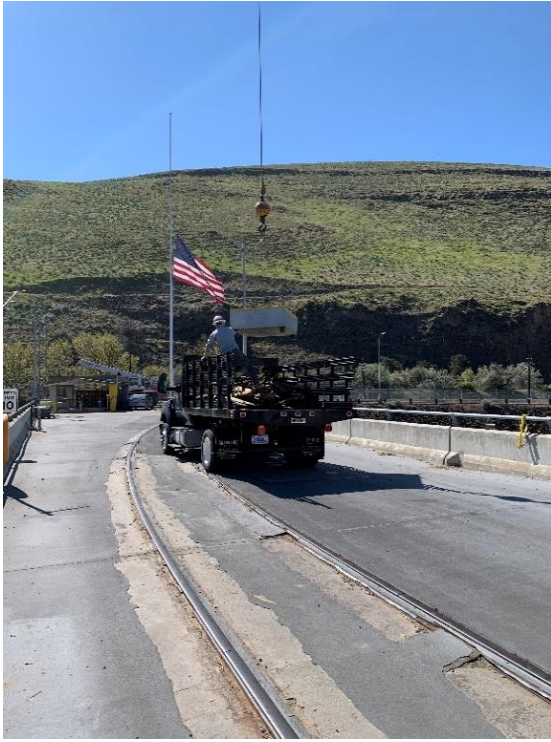
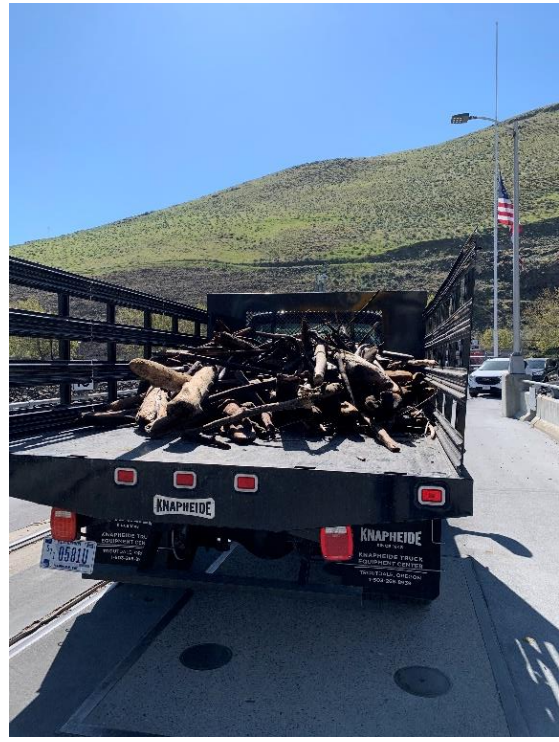
Figures 5 & 6. Tuck loads of debris removed April 20<sup>th</sup>, 2021 ladder was returned to service the same day.

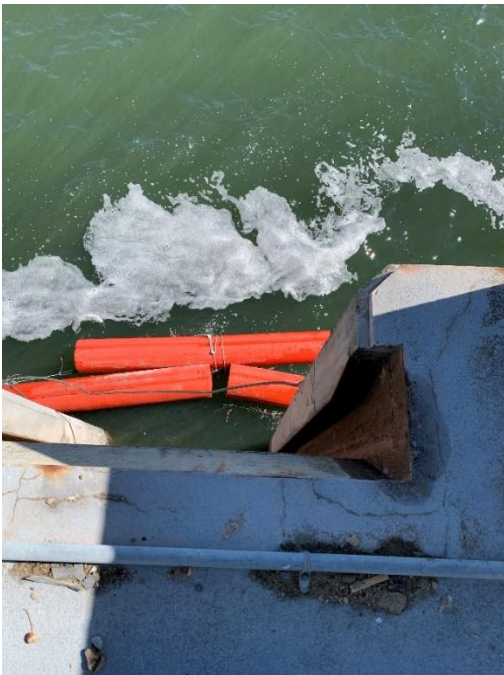
Figure 7. The first temporary debris boom installed on April 20<sup>th</sup>, 2021.

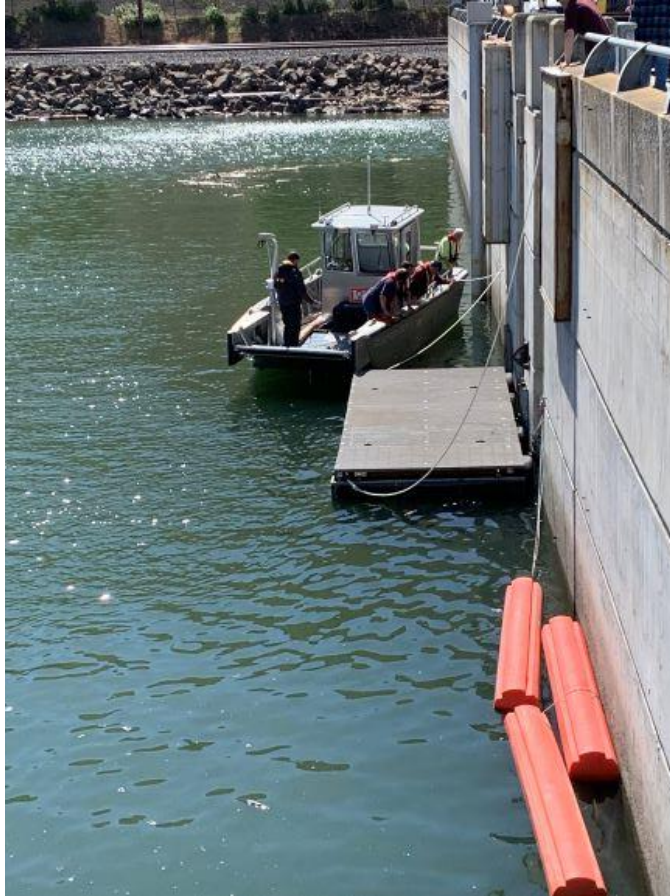
Figure 8. The second, improved temporary debris boom being installed at the south fish ladder exit on May 4, 2021. First debris boom in lower right.

On 4 May from between 1000 and 1100 a sturdier temporary debris boom was installed in the forebay in front of the South fish ladder exit at John Day dam. The previous temporary debris boom was removed and taken away from the ladder exit area. This improved upon temporary boom will allow John Day maintenance to make all necessary repairs to the permanent debris boom and will ensure its safe operation and structural integrity for many more years. A timeline of a month is expected for the repairs and reinstallation. Please see picture below for your reference.
