# Bonneville Spillway South Shore Scour ROV Inspection Report

**Inspection date:** September 27<sup>th</sup>, 2022.

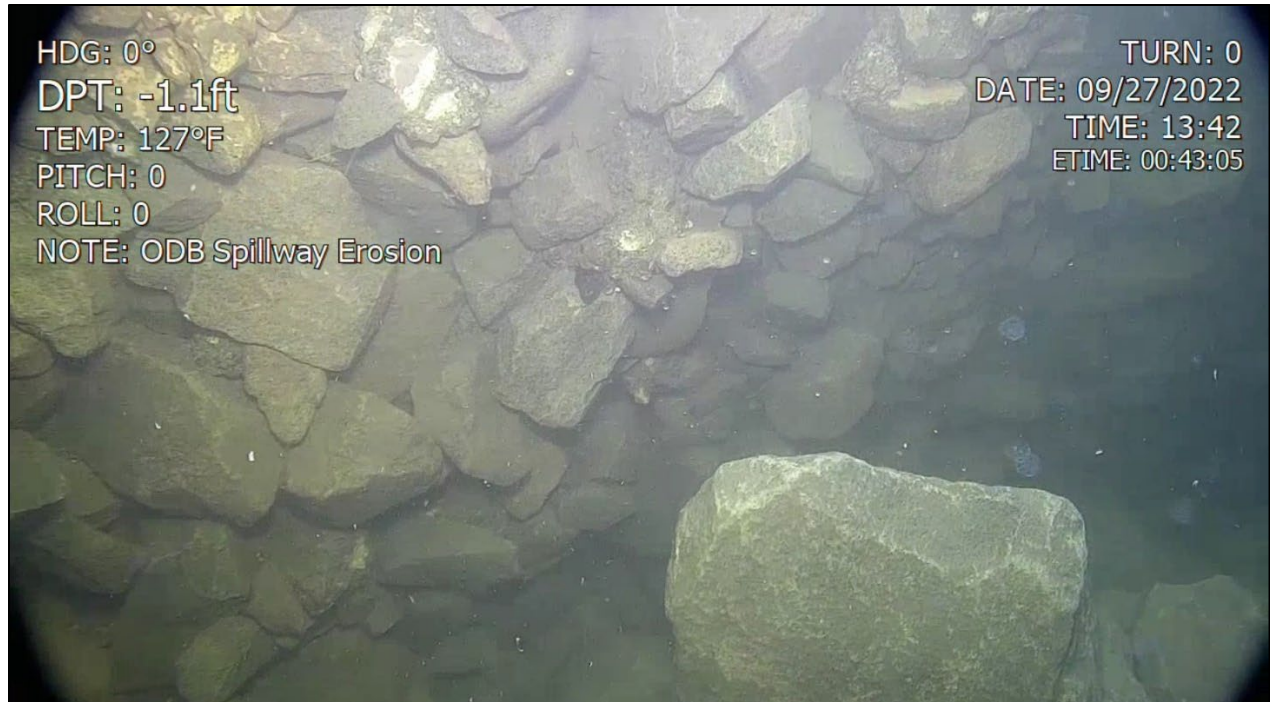
Figure 3 Image of undercut area in the southeast corner of the scour area.

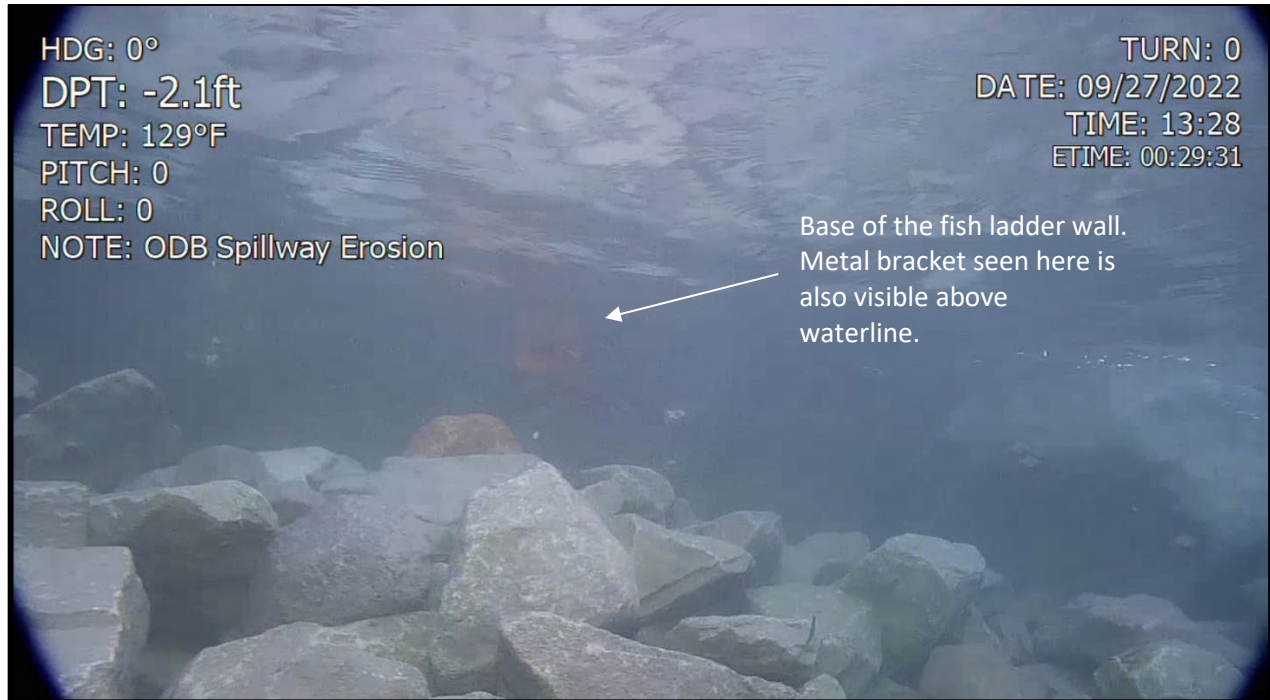
Figure 5 Image showing rock & rip rap up against the north wall of the fish ladder. No undercutting noted in this area.

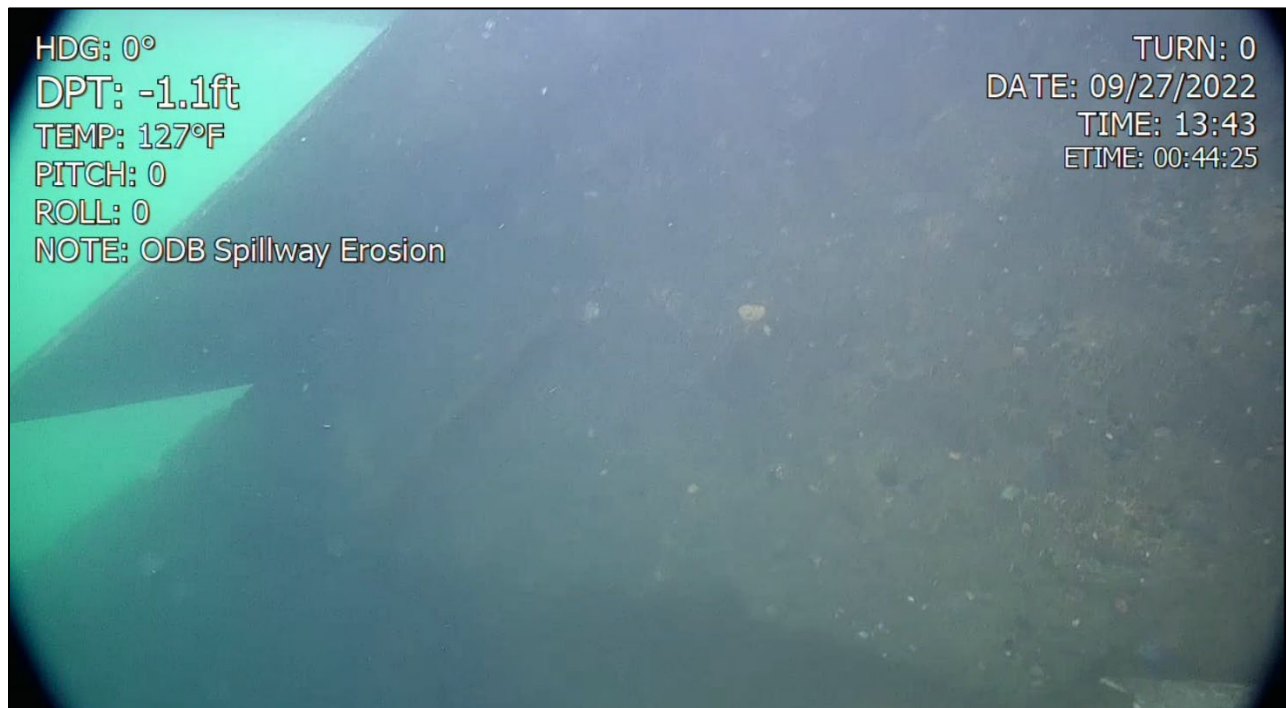
Figure 6 Image showing missing rip rap along western edge of concrete structure.

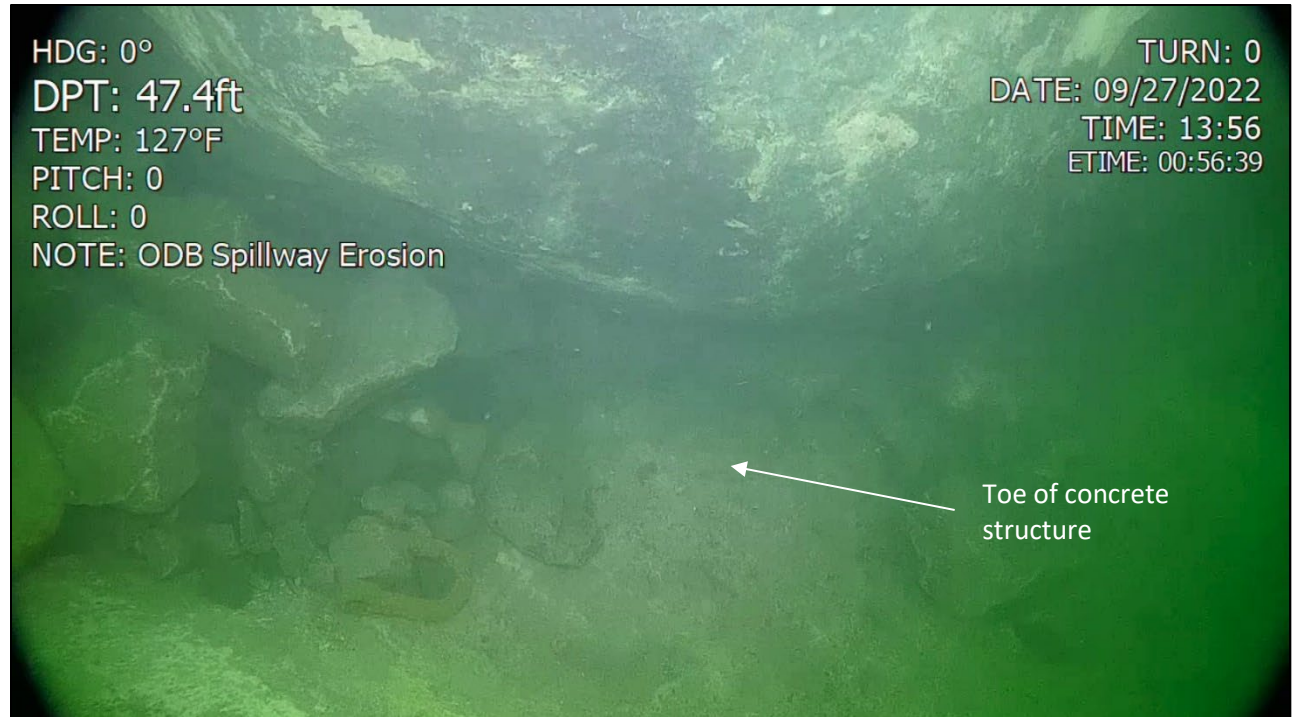
Figure 7 Image showing missing rip rap along the northern edge of the concrete structure.

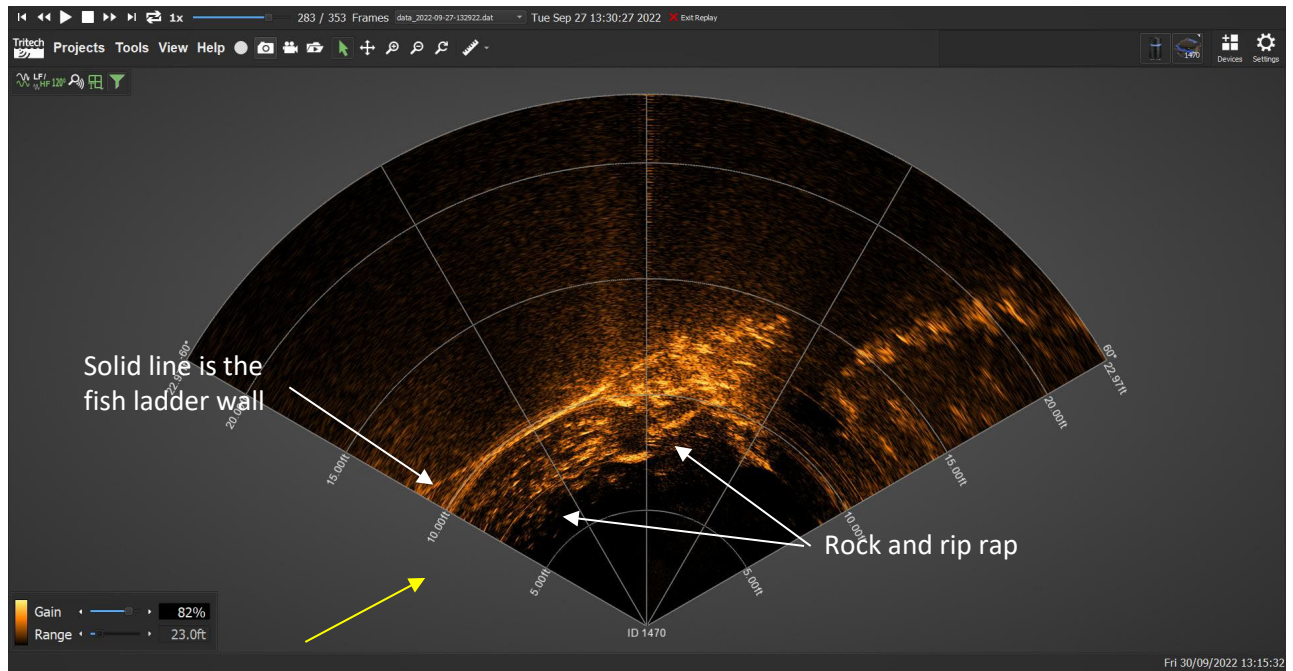
Figure 8 Sonar imagery showing rock & rip rap distributed up against fish ladder wall.

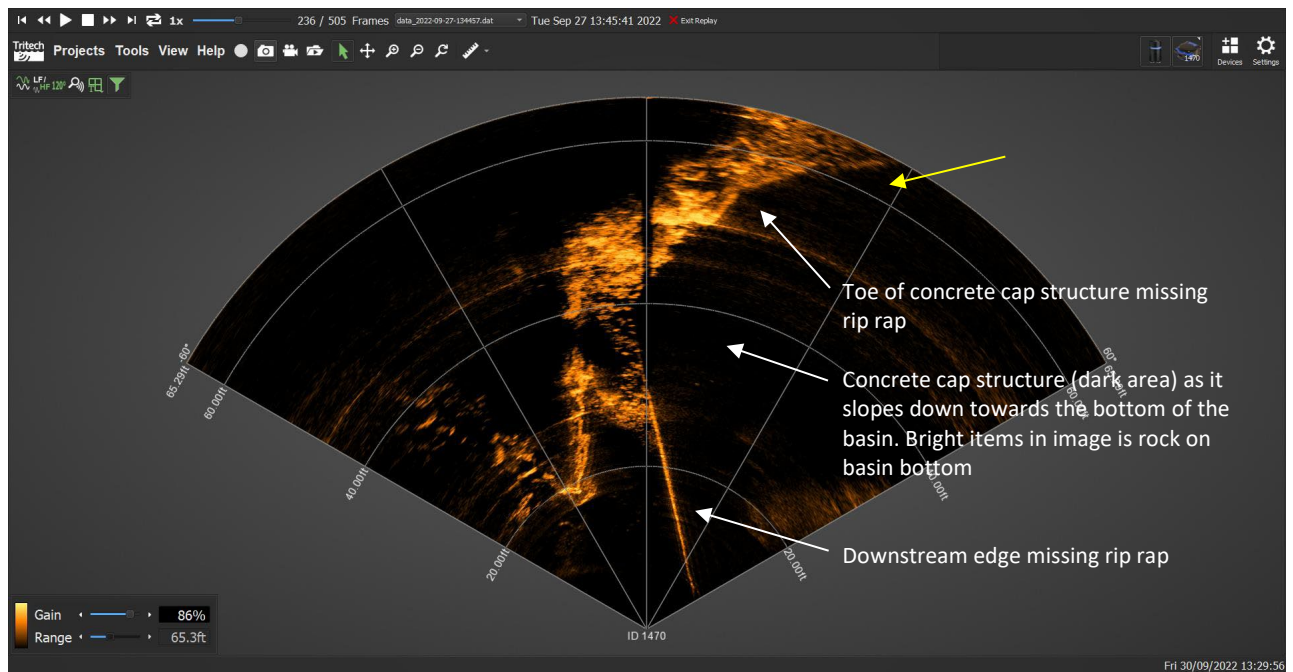
Figure 10 Sonar imagery showing missing rip rap along the toe and downstream edge of the concrete cap structure.
