MEMORANDUM FOR THE RECORD: 22 MCN 02 Delay in Early Start**SUBJECT: Delay in early start up.**

Location: McNary JFF

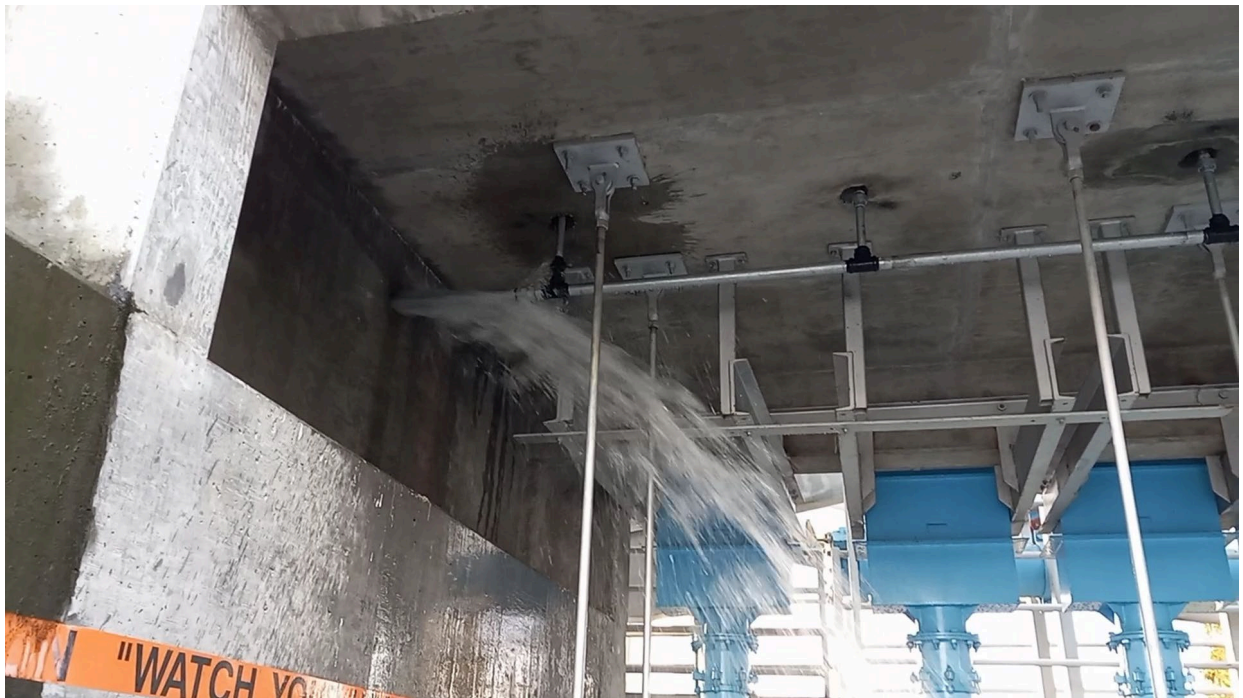
Narrative: In October and November of last year, the separator frost drain was replaced by the fisheries mechanics. The winterization pipe empties into the chamber below the porosity unit. The crew doing the work looked at the current water level instead of considering the future water level and did not replace the grout around the pipe where it enters the chamber. When we switched to secondary bypass on March 1 at 0700 hours, with flow over the porosity unit, water exited around the drainpipe due to the lack of grout around the pipe. After examining the issue, the system was switched back to primary bypass at 0720 hours and collection for the initial sample was not conducted. After the biologist initiated and accepted a safe clearance, air drying and grouting by powerhouse mechanics began at 1200 hours. The work was completed by 1500 hours. The grout will require 24 hours to dry. We are hoping to rewater the separator at 0600 hours and begin sampling at 0700 hours on March 3.

Photo 2: Leak

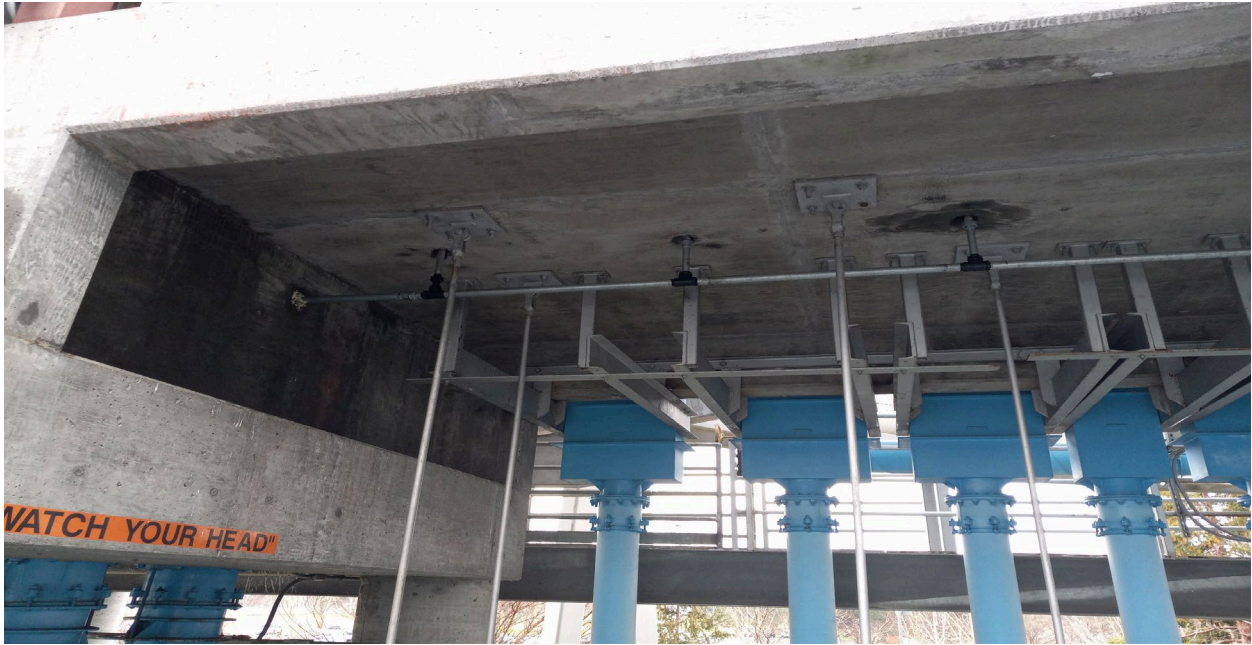
Photo 3: Repair

Method: The area was dewatered, and grout was applied around the drainpipe on March 1. The area will be rewatered on March 3. Photo 1 below shows the general area. Photo 2 is the leak. Photos 3 and 4 show the repair.

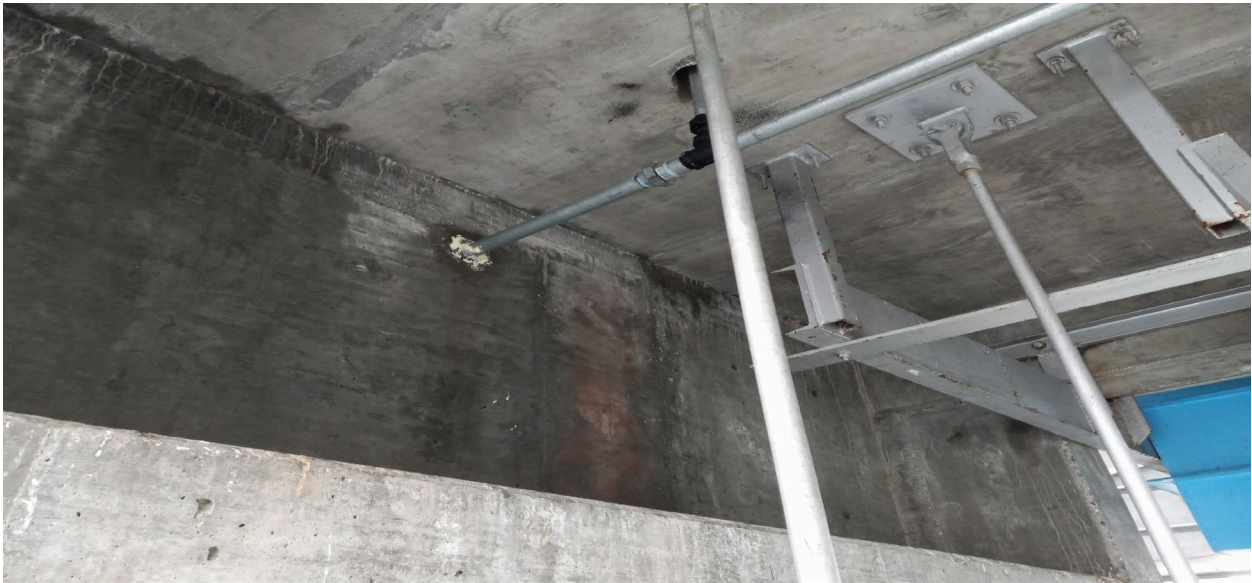
Photo 4: Close up of repair
