**MEMORANDUM FOR THE RECORD**

**SUBJECT: 22BON014 MFR Emergency WA Shore LPS Outage**

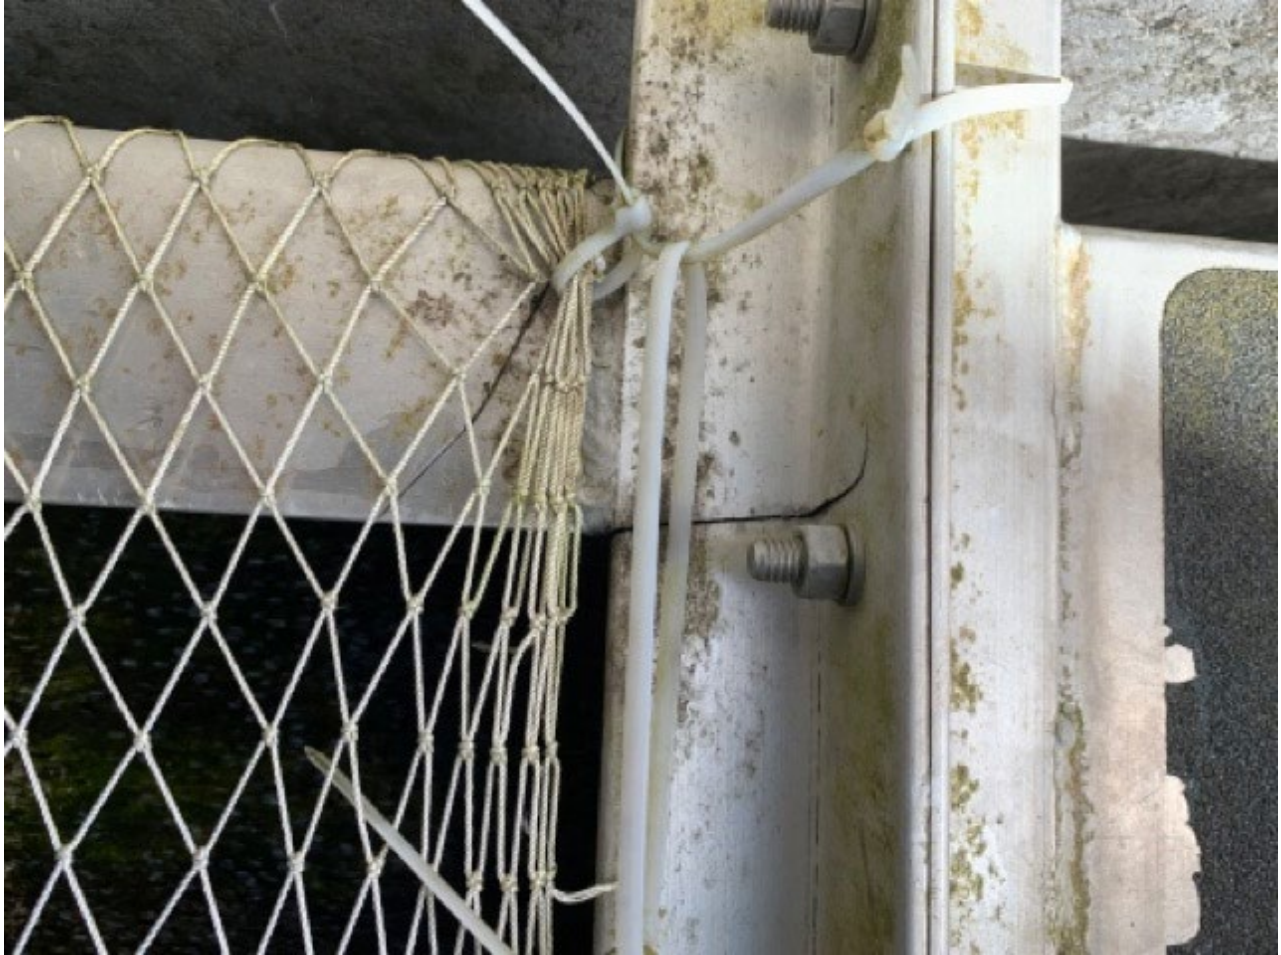
This has caused further damage in the form of cracked welds on the north ramp and rest box junction. As a result, BON fisheries decided FV6-9 should be operated within the non-shad passage season criteria to reduce the amount of force against the LPS ramps and reduce further damage until repairs can be made. Additional bolts were added on 05/31/22 to help secure the ramp until the clearance can be placed for repairs.

Crack on north ramp

The WA shore LPS will be dewatered on 6/2/2022 and the fish ladder water level will need to be reduced to facilitate the removal of the damaged ramp. Once the emergency ramp removal is completed, the system will be returned to service. There will still be the south entrance ramp in the AWS channel and two additional entrance ramps near the Upstream Migrant Tunnel Junction (UMTJ) to provide lamprey access to the WA shore LPS. This work needs to be completed as soon as possible to prevent further damage to the entire WA shore LPS.

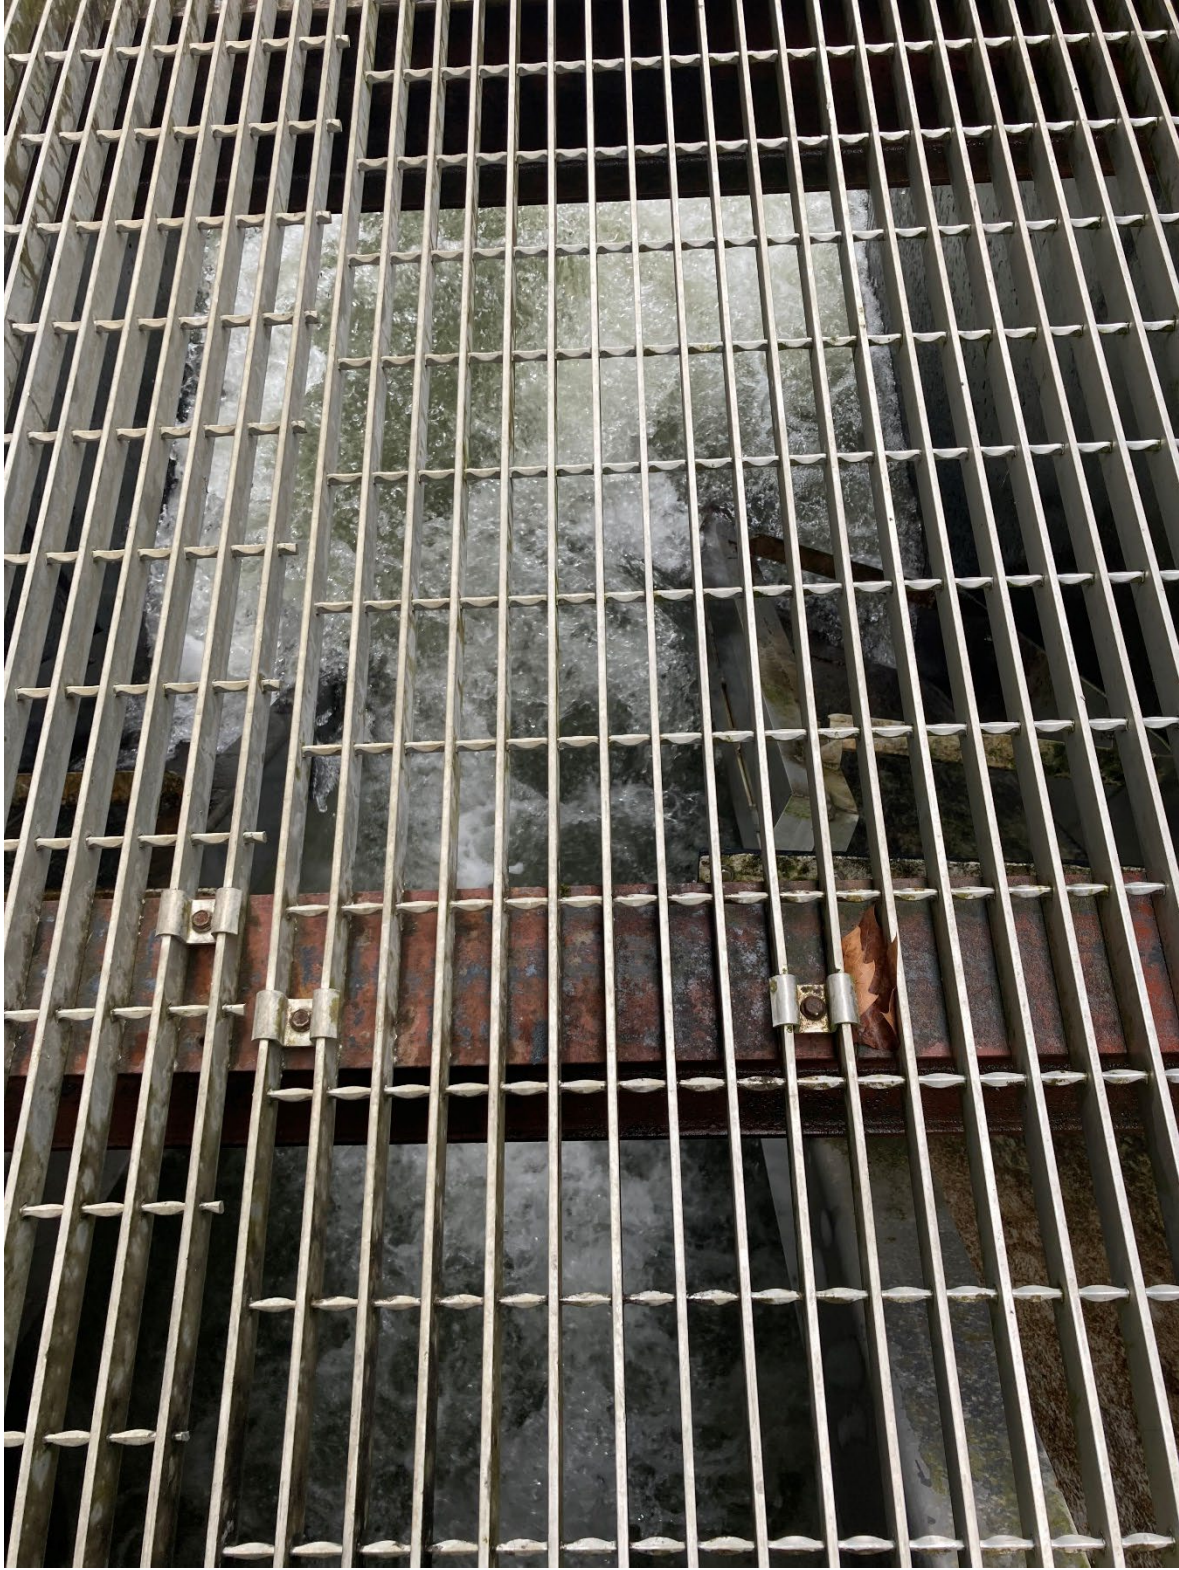
Photo looking downstream in AWS channel South ramp (left) and broken north ramp (right)

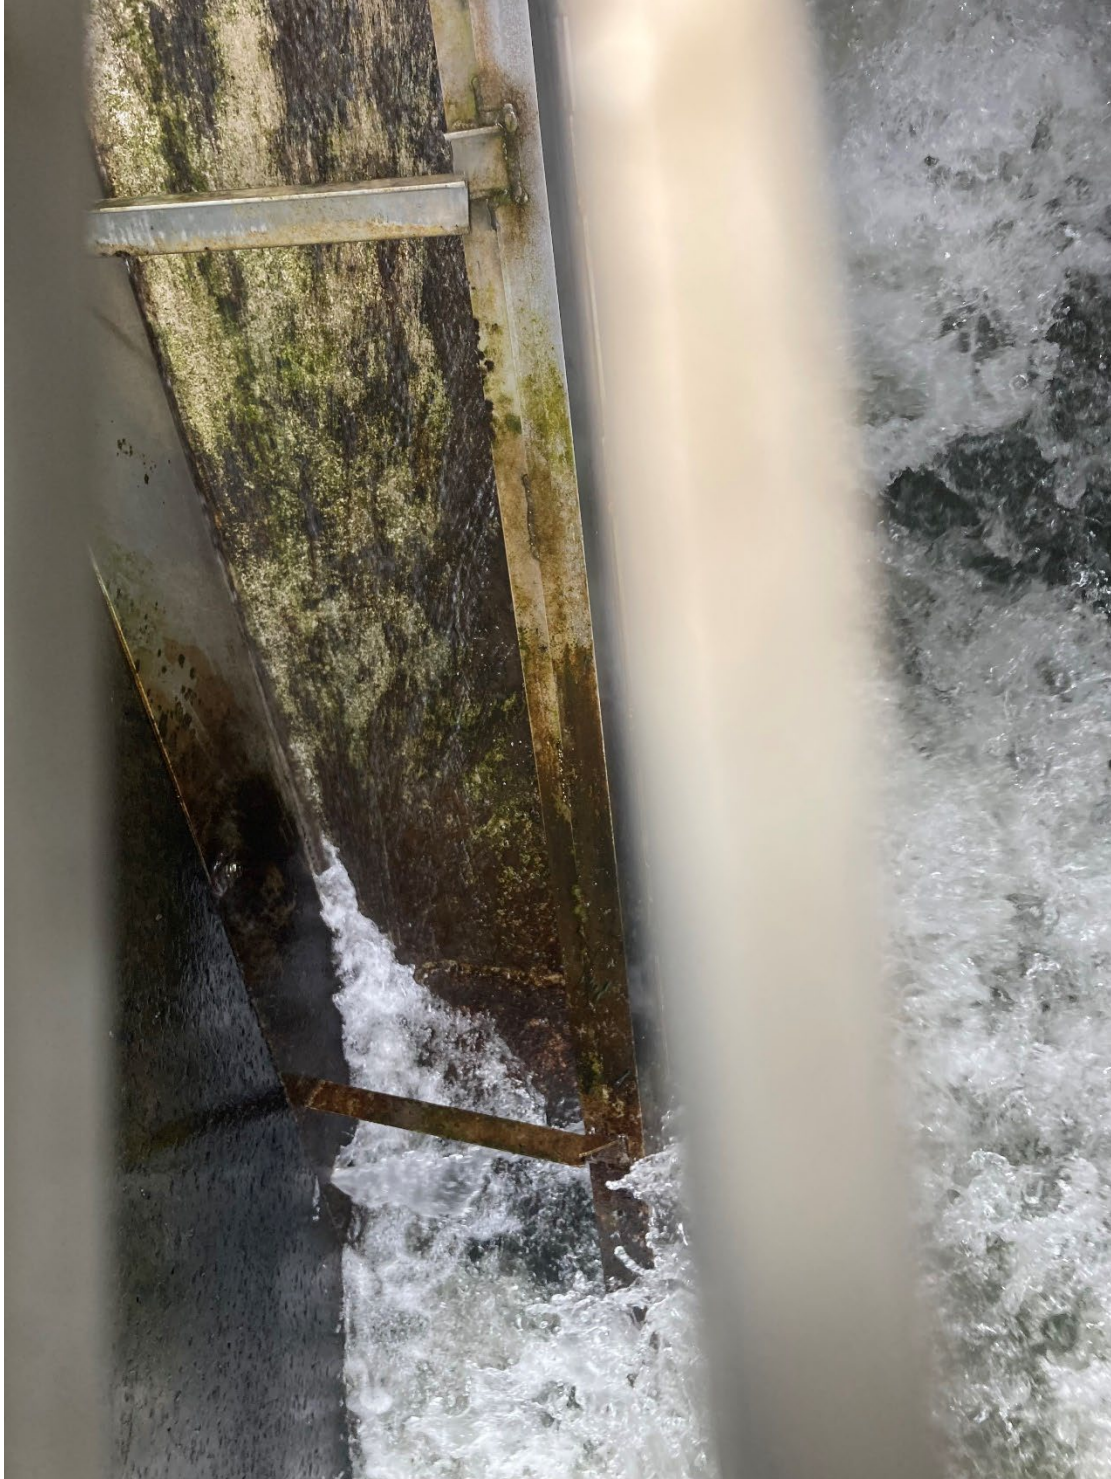
On Saturday, 28 May, BON fisheries discovered the north entrance ramp of the Washington Shore Auxiliary Water Supply Lamprey Passage Structure (WA-AWS LPS) angle irons and bolts were breaking/shearing off the concrete wall of the AWS channel. The force of the water from Fish Valve 6-9 (FV6-9), in combination with the breached structural integrity of the north ramp, is causing excessive stress on the remainder of the LPS.

Broken angle iron on north entrance ramp of LPS with AWS flow surrounding ramp.

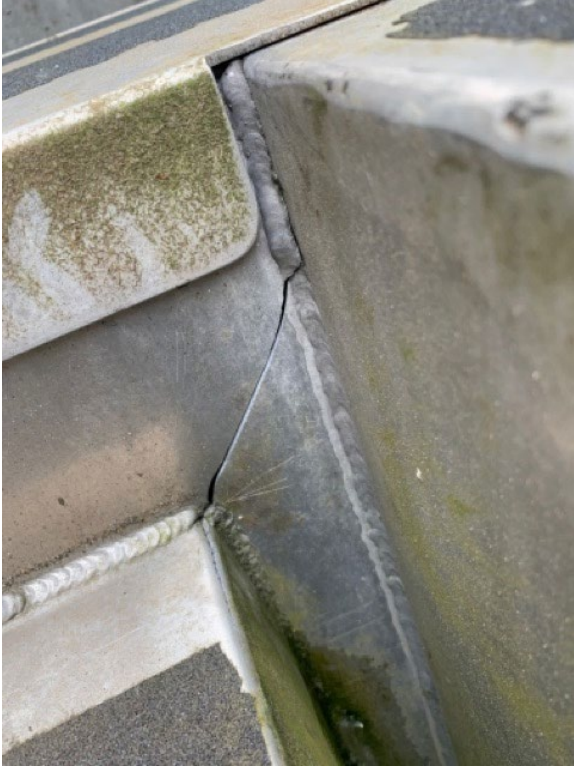
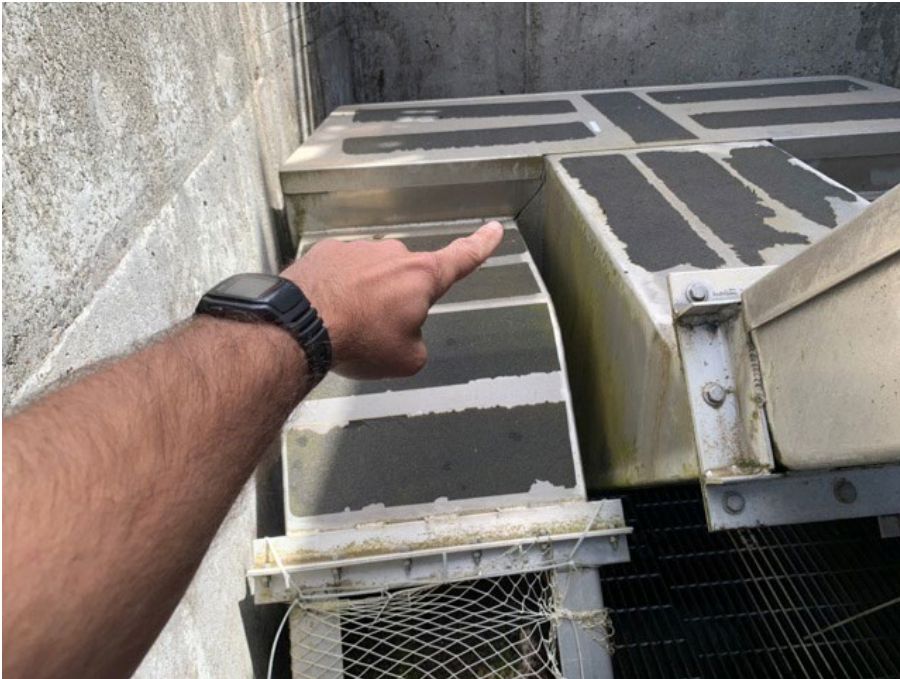
Crack at junction of rest box and north ramp.

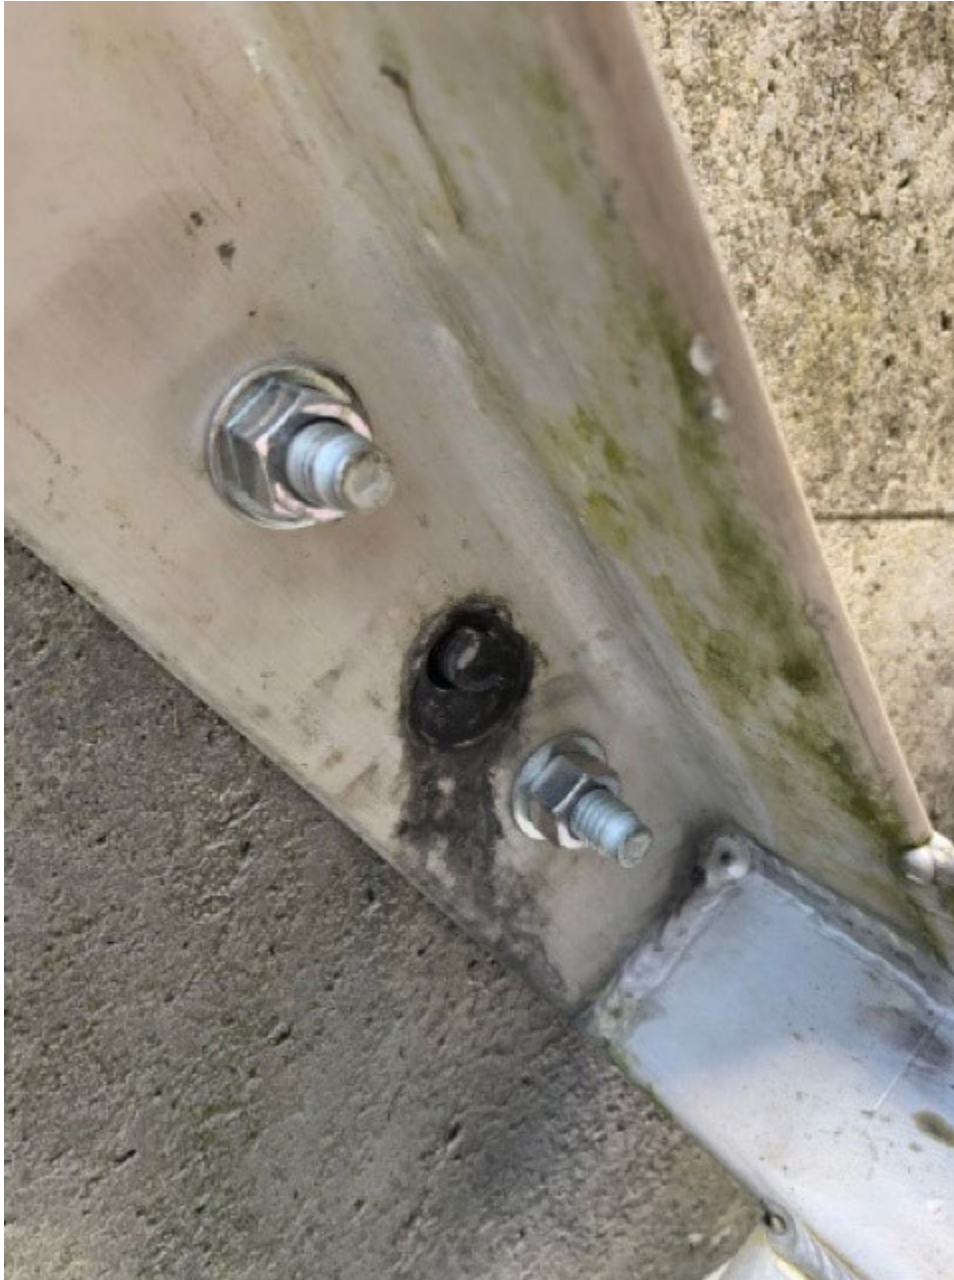
Sheared off bolt (middle) with two new bolts installed on 5/31 to help ramp stay in place until LPS dewatering
