MEMORANDUM FOR THE RECORD: 22 MCN 02 Delay in Early Start**SUBJECT: Delay in early start up.**

Location: McNary JFF

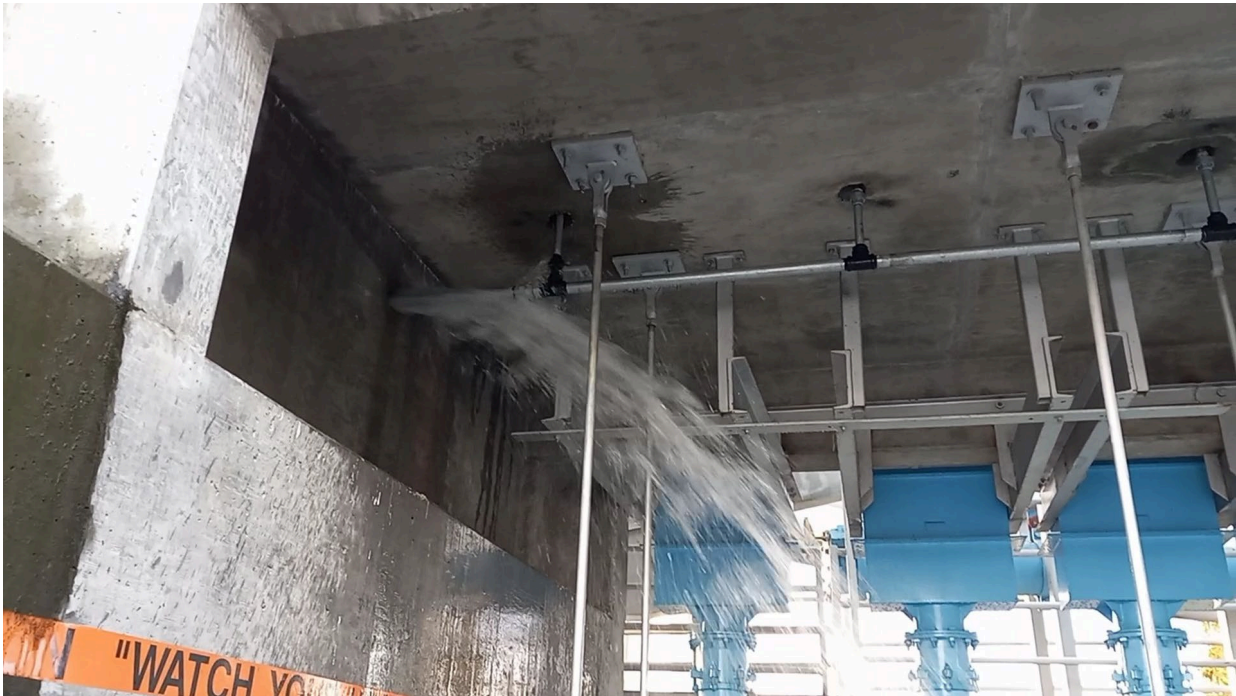
Narrative: In October and November of last year, the separator frost drain was replaced by the fisheries mechanics. The winterization pipe empties into the chamber below the porosity unit. The crew doing the work looked at the current water level instead of considering the future water level and did not replace the grout around the pipe where it enters the chamber. When we switched to secondary bypass on March 1 at 0700 hours, with flow over the porosity unit, water exited around the drainpipe due to the lack of grout around the pipe. After examining the issue, the system was switched back to primary bypass at 0720 hours and collection for the initial sample was not conducted. After the biologist initiated and accepted a safe clearance, air drying and grouting by powerhouse mechanics began at 1200 hours. The work was completed by 1500 hours. The grout will require 24 hours to dry. We are hoping to rewater the separator at 0600 hours and begin sampling at 0700 hours on March 3.

Photo 2: Leak

Method: The area was dewatered, and grout was applied around the drainpipe on March 1. The area will be rewatered on March 3. Photo 1 below shows the general area. Photo 2 is the leak. Photos 3 and 4 show the repair.

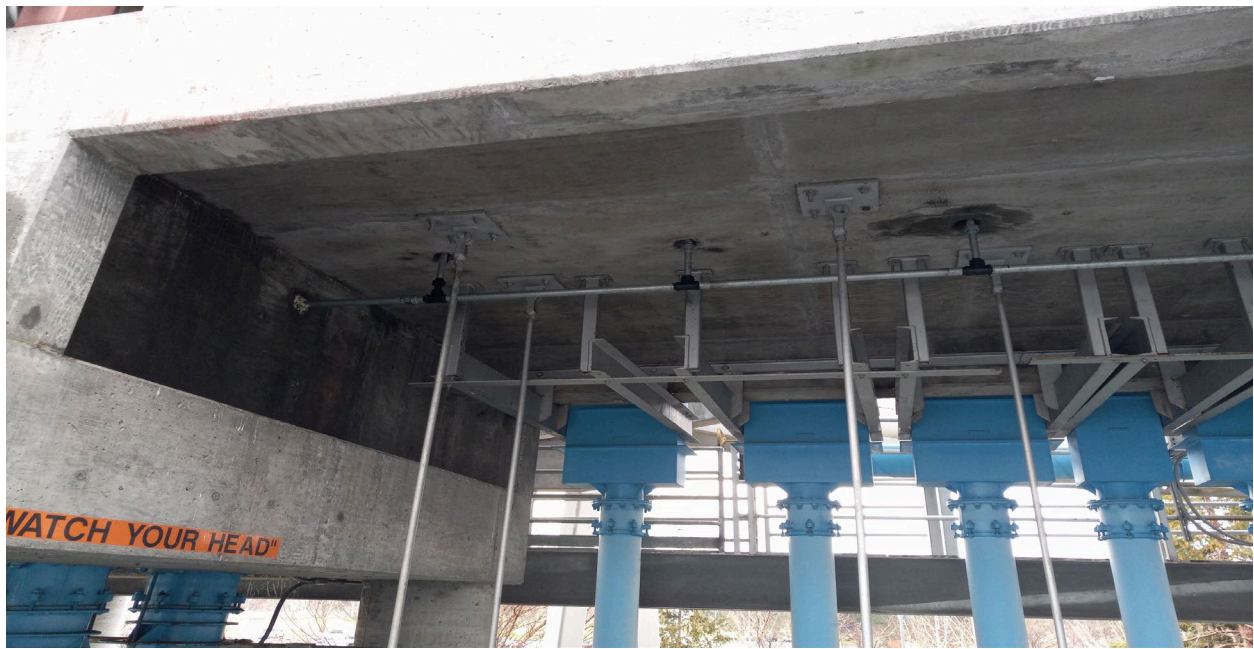
Photo 3: Repair

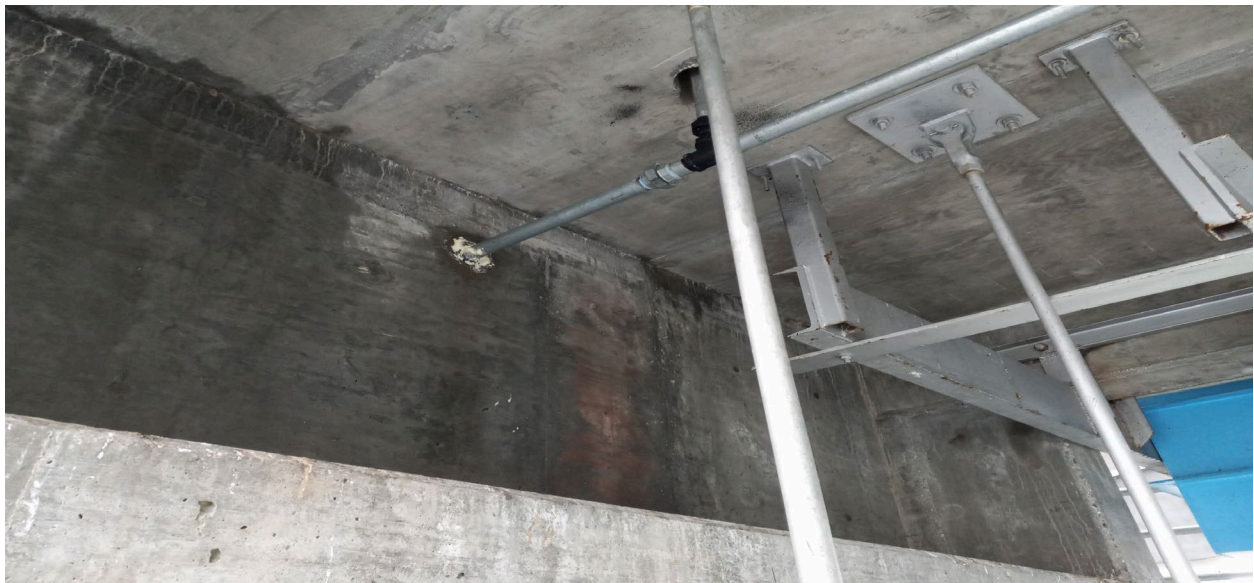
Photo 4: Close up of repair
