MEMORANDUM FOR THE RECORD (22TDA02 MFR Wasco PUD mortality)

SUBJECT: *fry and lamprey mortality in Northern Wasco County PUD dewatering structure on the north shore of The Dalles Dam.*

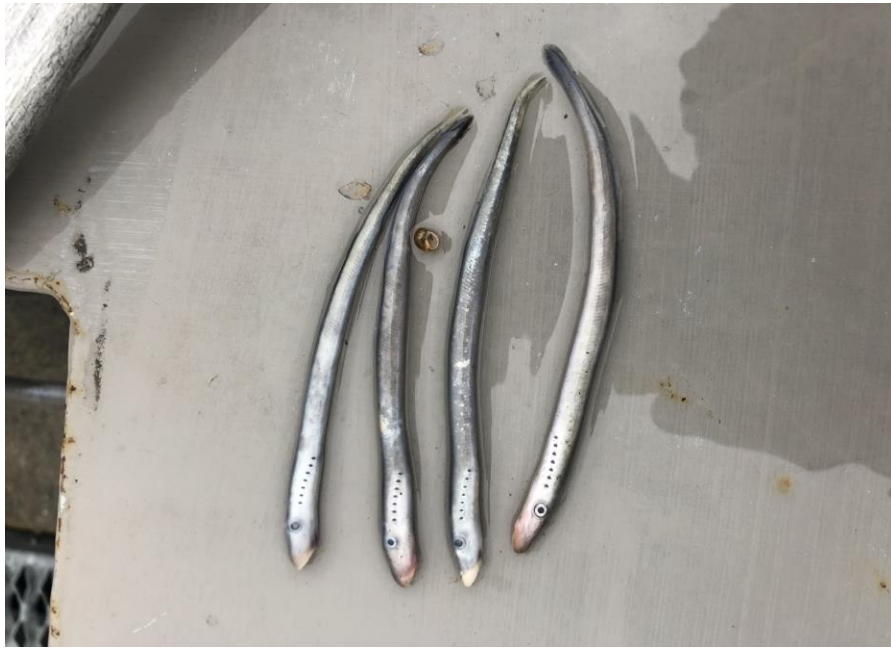
It would be difficult and time consuming to get an accurate count of the number of fish impacted but it appears there are hundreds of fry and an unknown number of lamprey. A more accurate count would require dewatering, clearances, turbine and ladder outages, separation of morts from debris and considerable PUD staff at a time when it is desperately needed to reconnect the bypass system. Brushing the screens is pointless because there is no exit for the debris. PUD staff will do what they can to minimize future impacts, see section G below.

Lamprey morris

The PUD contract biologist, Rick Martinson, PSMFC, will work with PUD staff to investigate a complete dewatering and better assessment of the situation. A full dewatering may be needed prior to water up to clean the unbrushed sections of the screens at the downstream end of the dewatering structure.

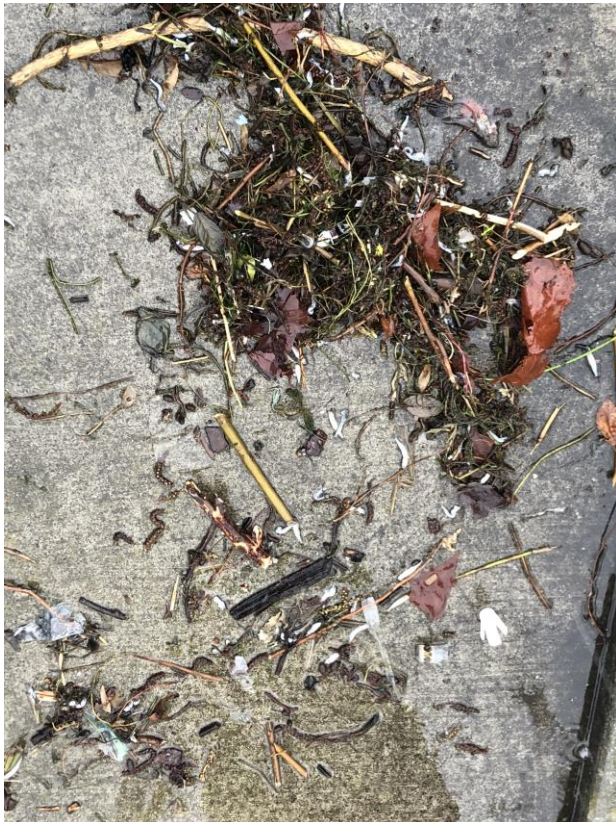
Fry mixed with debris

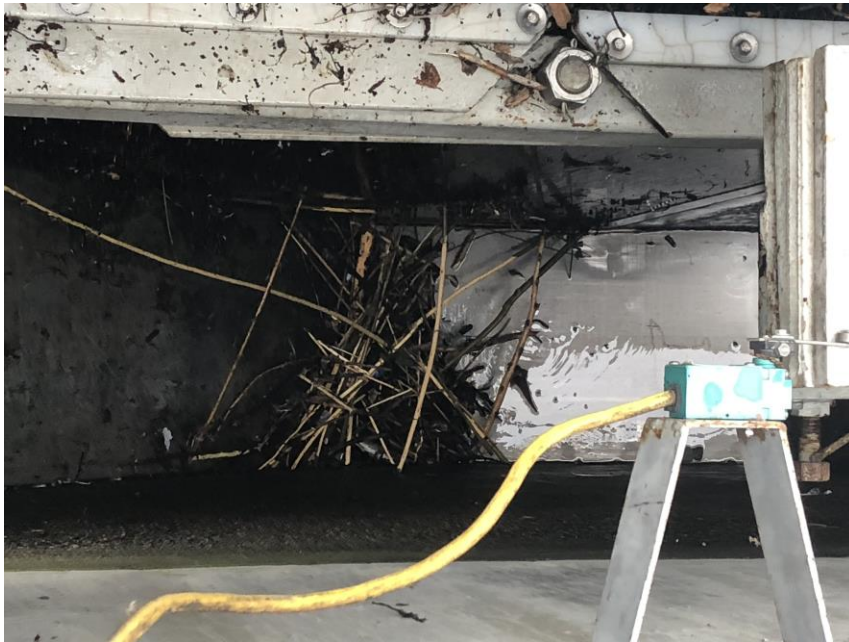
The PUD conducted a back flushing operation in the dewatering structure on Tuesday, March 8, 2022. The process worked well to evacuate most of the debris present in the structure but overall the amount of debris was far less than suspected. There was an accumulation of stuck sticks in one spot that is the biggest concern (see picture below). The PUD will attempt removal of the sticks next week using a “grappling” hook device to break it loose.

No fry were observed swimming in the clear slack water at the downstream end of the structure. There were some fry impinged in the screen at the furthest downstream point, but other than that no other impinged/dead fry or lamprey were observed.

All of the debris accumulation and mortality was concentrated at the downstream end making the situation appear worse than it was. All of the wall screens were free of debris.

The PUD will continue to monitor the situation until the bypass returns to service.
