MEMORANDUM FOR THE RECORD 22TDA06**SUBJECT: *East fishladder exit weir 155 failure***

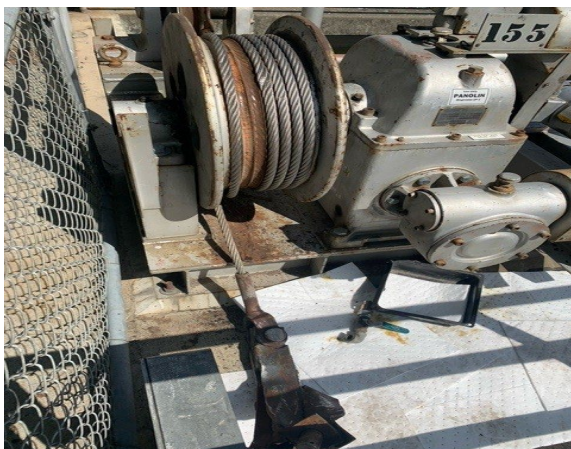
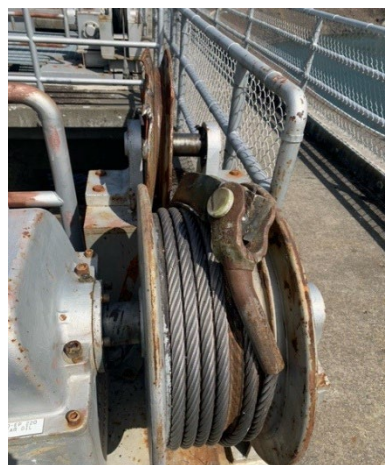
East ladder exit weir 155 failed. This is 1 of 4 weirs that are used for adjusting flow through the range of forebay elevations. The cause of failure is being investigated. The weir raised through its upper limits, pulling the weir attachment onto the drum. The hoist cables broke causing the weir to fall to the seated position. Its gearbox also failed resulting in approximately 1/2 gallon of gear oil to enter the fishway which was not recoverable. The weir is now stuck in the seated position. Criteria operation per Fish Passage Plan cannot be maintained at forebay less than 157.5'. A forebay restriction has been requested. A plan for repair will be made, but it is likely 155 will remain in this position through the remainder of the passage season.

- A. Species –All salmonids passage
- B. Origin –NA
- C. Length –NA
- D. Marks and tags –NA
- E. Marks and Injuries found on carcass –NA
- F. Cause and Time of Death –NA
- G. Future and Preventative Measures –Determine cause of failure and repair when possible.
This will take priority over other planned fish improvements.
