**MEMORANDUM FOR THE RECORD: 22 LWG 10 Change in Ladder Cooling Pump Operation****SUBJECT: Change in Ladder Cooling Pump Operation**

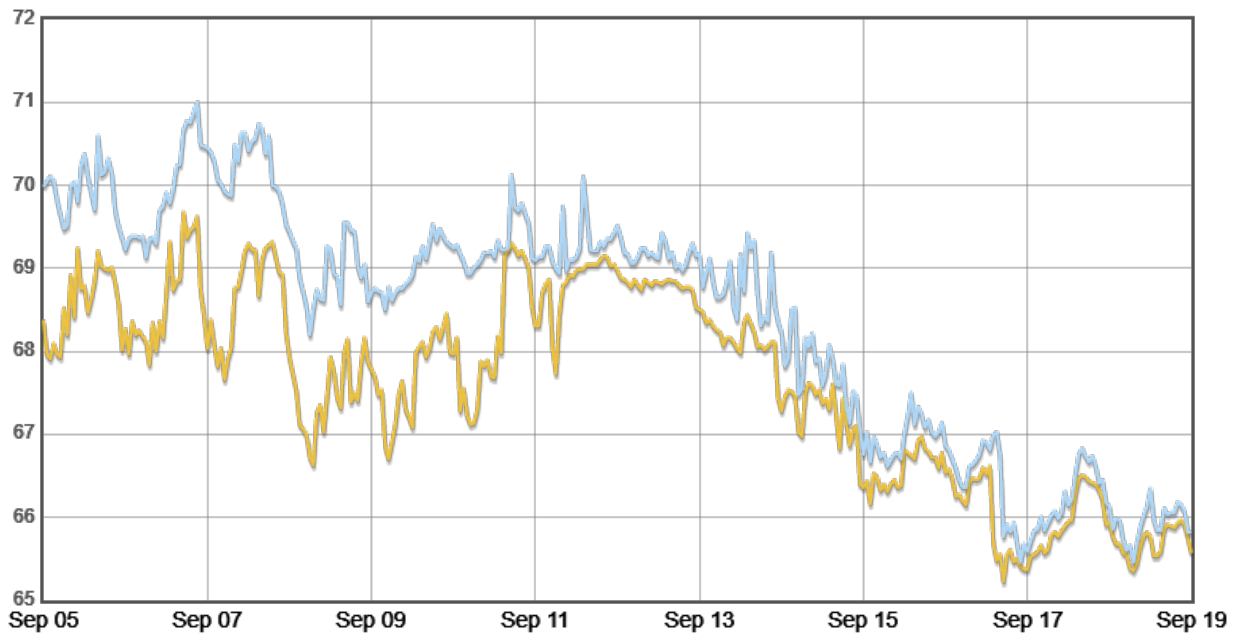
Figure 1. Lower Granite fish ladder exit pool (blue) and forebay (yellow) temperatures September 5-19.
