MEMORANDUM FOR THE RECORD 23 MCN 02**SUBJECT: Spillbay 16 closer due to failed dogging mechanisms.**

Location: McNary spillway.

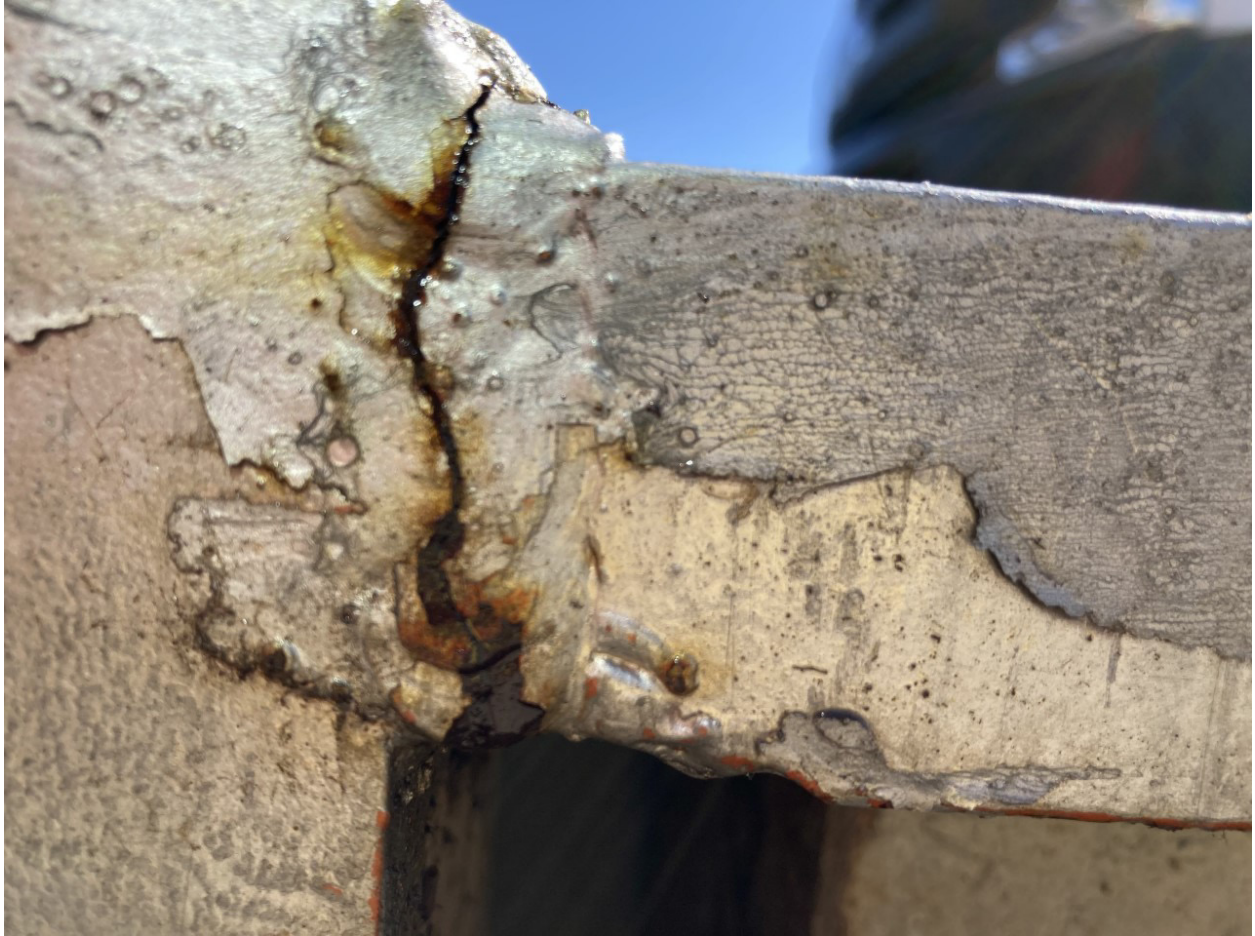
Narrative: As maintenance and preparations for the spill season have evolved, project engineers had had observed what appeared to be weld cracks in the spillgate dogging mechanisms in bay 16. Closer inspection required removing paint so underlying metal and welds could be seen (see photo below). Due to the heavy workload on the spillway, the mechanisms were not examined until April 4. During the inspection, the engineers found cracks on both dogging structures in bay 16. The gate cannot be opened or operated until project staff repairs the mechanisms. While repairs are being made, the bay must remain closed. Repairs are estimated to take one month.

F. Future and Preventative Measures: This fall, McNary staff will perform a thorough inspection all of the dogging structures post spill season and make repairs as necessary.
