MEMORANDUM FOR THE RECORD: 23 LWG 01 Failed Spillway Bird Wires

SUBJECT: Failed Spillway Bird Wires

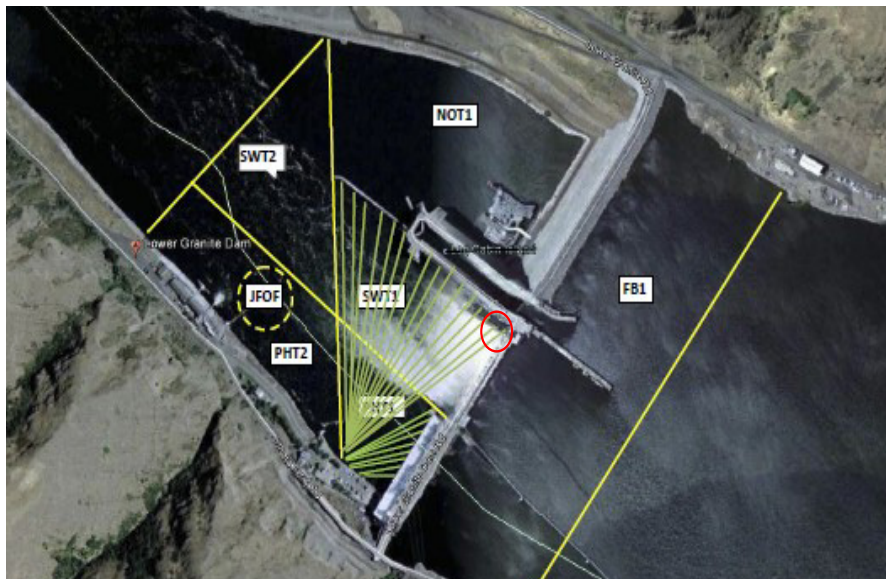
Two spillway bird wires were found down across the tailrace during the fish ladder inspection December 22. There is a third wire that is sagging and needs repair. At the time of inspection LWG was spilling to support T1 transformer gasket replacement work and ambient temperatures were below freezing, which resulted in ice buildup on the wires causing them to fail. The general location of the attachment points for the missing bird wires are circled in Photo 1.

Photo 1. Representation of LWG bird wire array.

- A. Species – N/A
- B. Origin – N/A
- C. Length – N/A
- D. Marks and tags – N/A
- E. Marks and Injuries found on carcass – N/A
- F. Cause and Time of Death – N/A
- G. Future and Preventative Measures – The contract and funding process to replace the wires has been initiated. LWG is currently working with USDA who will be provide a quote and work plan.
