10 Post-2020 Survey Summary and Analysis

15 Appendix B – Post-2020 Stilling Basin Conditions

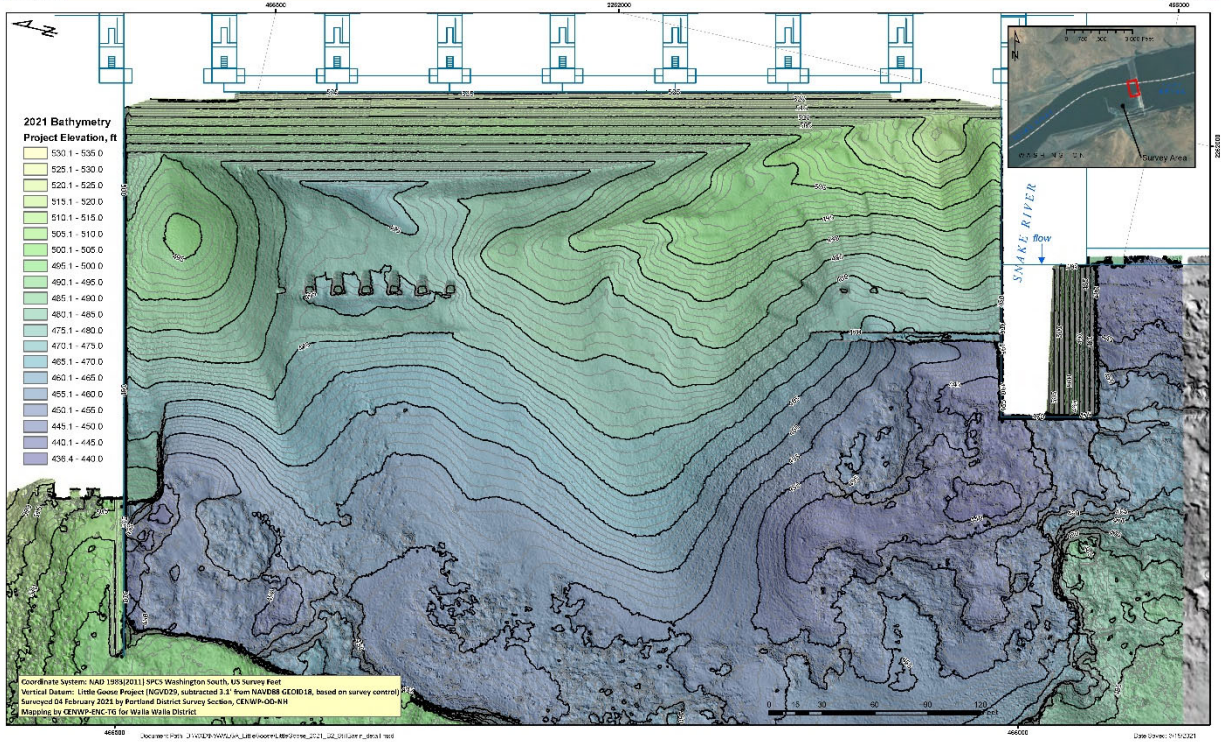
US Army Corps of Engineers **Little Goose Dam - 2021 Bathymetry, Map B-2: Stilling Basin detail**

The Little Goose survey shows a significant increase in rock accumulated within the stilling basin with preliminary estimates about 30 thousand cubic yards (see Appendix B). There is little to no stilling basin floor visible in the 2021 survey and the condition of the concrete beneath the rock is unknown. Significant undermining of the jetty retaining wall downstream of the right side of the spillway exists as well as undermining of the powerhouse/spillway training wall. The undermining of these walls was seen in previous surveys. The high level assessment in 2018 was done in a memorandum for operations (USACE, 2018). This memo assessed undermining of the left and right training walls as high risk at that time but indicated more study was needed. There is likely some additional undermining of these walls since the 2017 survey, but the multi-beam surveys done in 2021 is not the correct type of survey to assess undermining.

Rock and debris in the stilling basin increases the likelihood of ball milling erosion; the rock should be removed to minimize the potential for erosion and to fully assess the erosion that has occurred. The rock accumulated within the stilling basin was estimated for each of the dams and is summarized in Table 10-1. Prior to the 2021 survey Lower Granite had the most rock accumulated in the stilling basin, but Little Goose now has significantly higher rock accumulated than any other stilling basin.

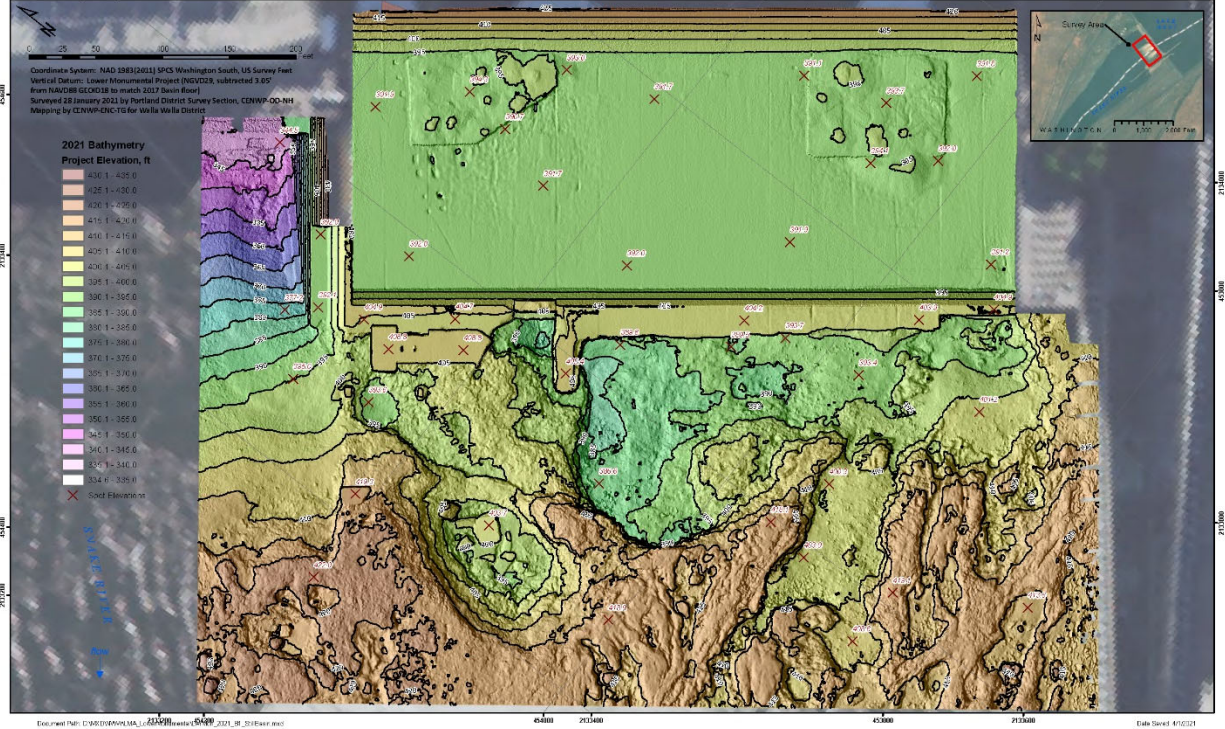
US Army Corps of Engineers **Lower Monumental Dam - 2021 Bathymetry, Map B: Stilling Basin**

The 2021 Lower Monumental survey shows some accumulation of rock within the stilling basin. There is no noticeable difference in erosion of the stilling basin from the 2017 survey, movement of material has occurred downstream of the end sill within the immediate tailrace.

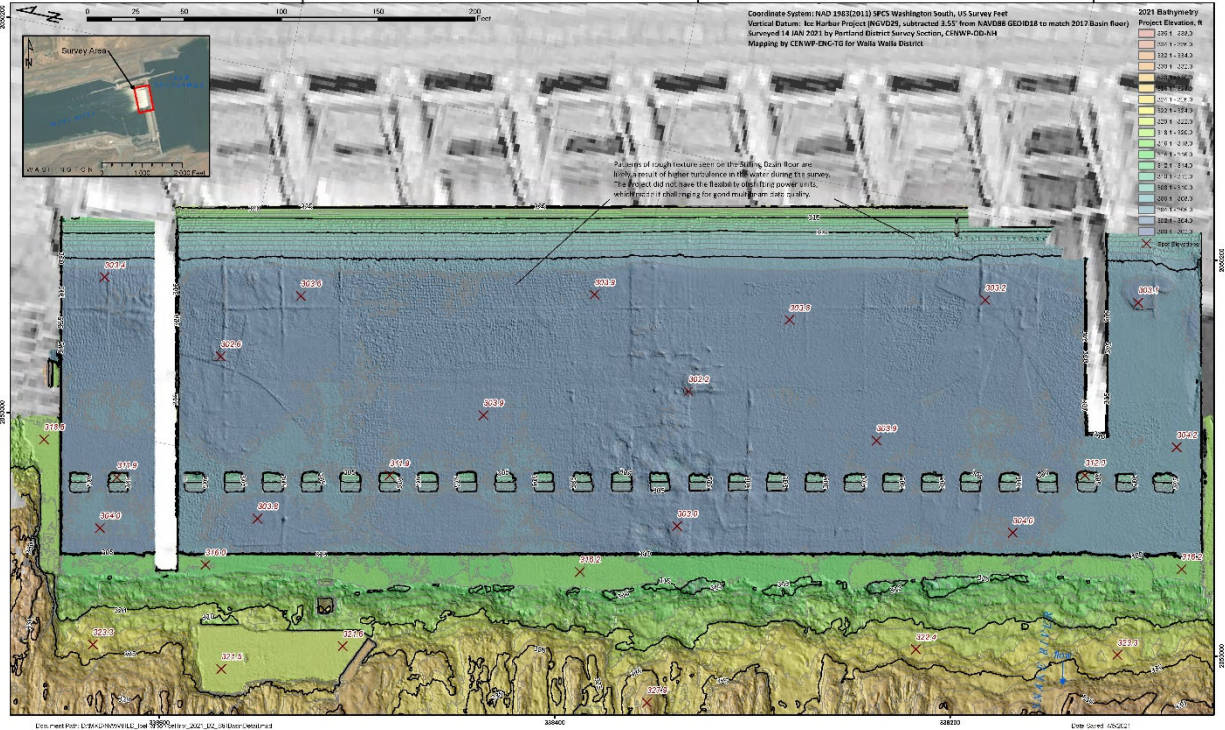
Ice Harbor Dam - 2021 Bathymetry, Map B-2: Stilling Basin detail

The 2021 Ice Harbor survey shows very little rock accumulation within the stilling basin, and the comparison with the 2017 survey show some minor erosion of up to 0.4 ft. at the toe of the spillway below spill bays 2 and 8. The hydraulics of the end bays during 125% gas cap spill were more unstable fluctuating between plunging and skimming flow more often than the interior bays. Erosion downstream of the stilling basin does not seem extensive which is likely due to the high erosion resistance of the rock

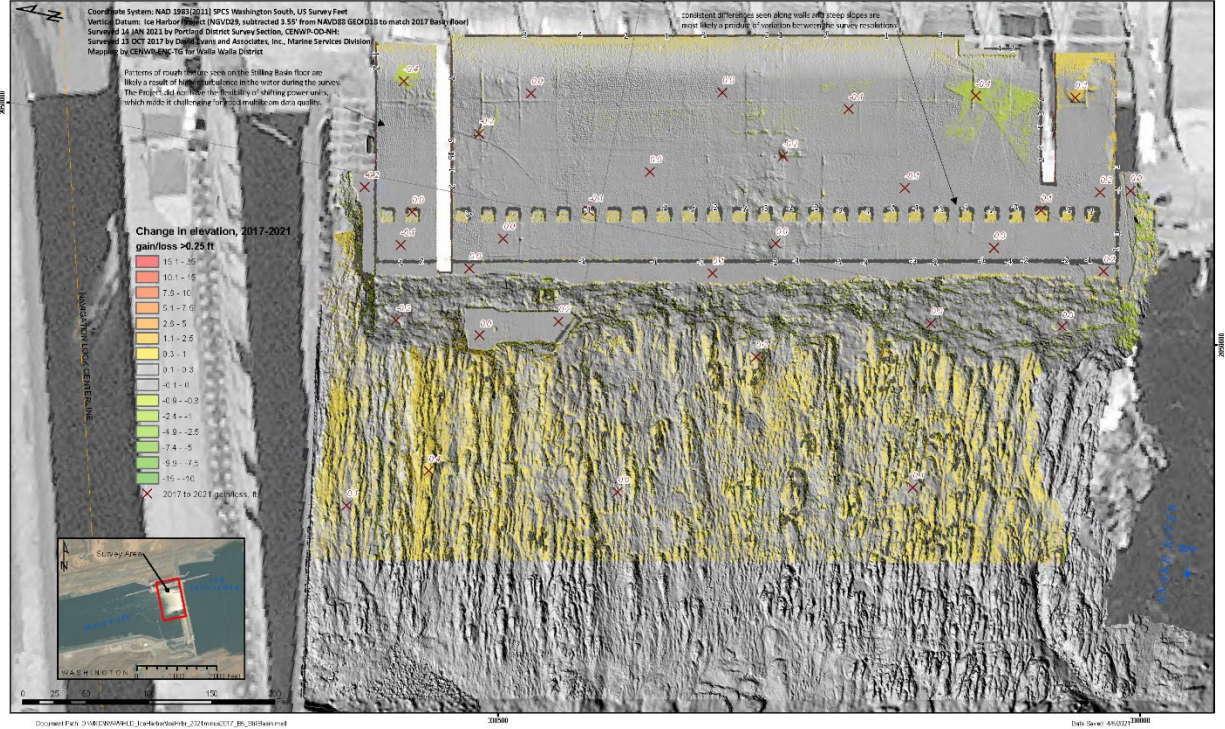
Ice Harbor Dam - 2021 Bathymetry, Map B-5: Stilling Basin change

downstream of the stilling basin. However, erosion of the coffer cells is still a concern. The 2021 survey indicates minor changes at the coffer cells since the 2017 surveys.

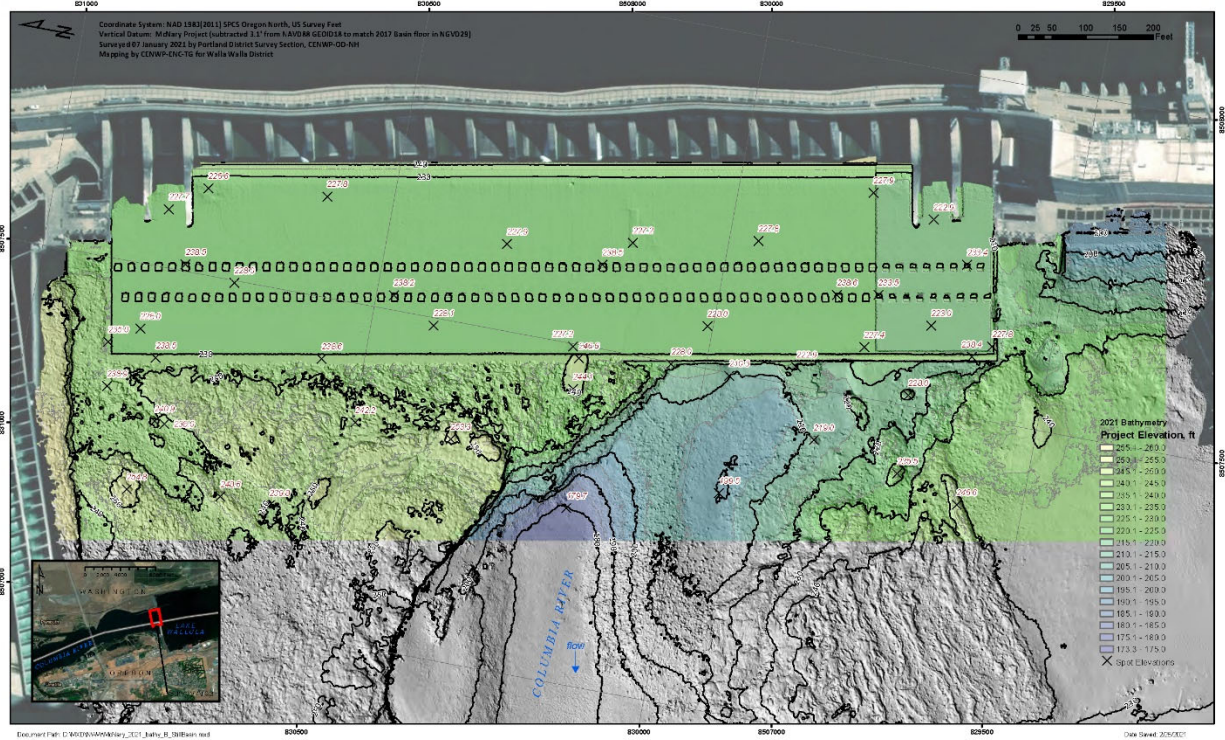
US Army Corps of Engineers **McNary Dam - 2021 Bathymetry, Map B: Stilling Basin**

The 2021 McNary survey shows little rock in the stilling basin. The survey did not show much erosion from 2017 to 2021 however there is a one foot deep hole at the base of spillbay 3. This area was covered by a debris pile in 2017 so it is unclear if the erosion occurred recently or over time. There is significant undermining of the endsill which has occurred over time, with little to no indication of significant scour or deposition occurring over the past three years.
