# MCNARY SPILLWAY STATUS

FPOM  
5 October 2023

# MCNARY SPILLWAY

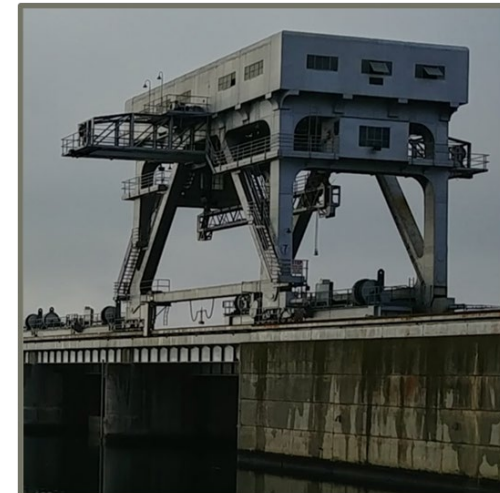
- Overloaded by estimated 20% according to BDI tests in 2003/05- not counting for lifting beam or frictional losses. – Violation of American Society of Mechanical Engineers (ASME) and Engineer Manual (EM) 385.

- Gantry crane frames do not comply with current American Institute of Steel Construction (AISC) codes - Under breakdown torque simulations, the downstream legs fail.

- The electrical system is outdated. Asbestos. DC hoist controls at risk of failure. Obsolete component replacement is becoming more challenging.
- Frequently down for weeks or months at a time – most recently a gantry drive gearbox failure required bearings that are no longer readily available.

- Recently had a main hoist gearbox replacement to address severe vibration issues, with mixed results.
- January 2023, Cranes 6 & 7 were limited to two engineered lifts (250 tons) per year.

- Replace spillway gantry cranes with updated (350 ton) cranes (**PRIORITY**)
- Replace spillway gate lifting beams with updated lifting beams

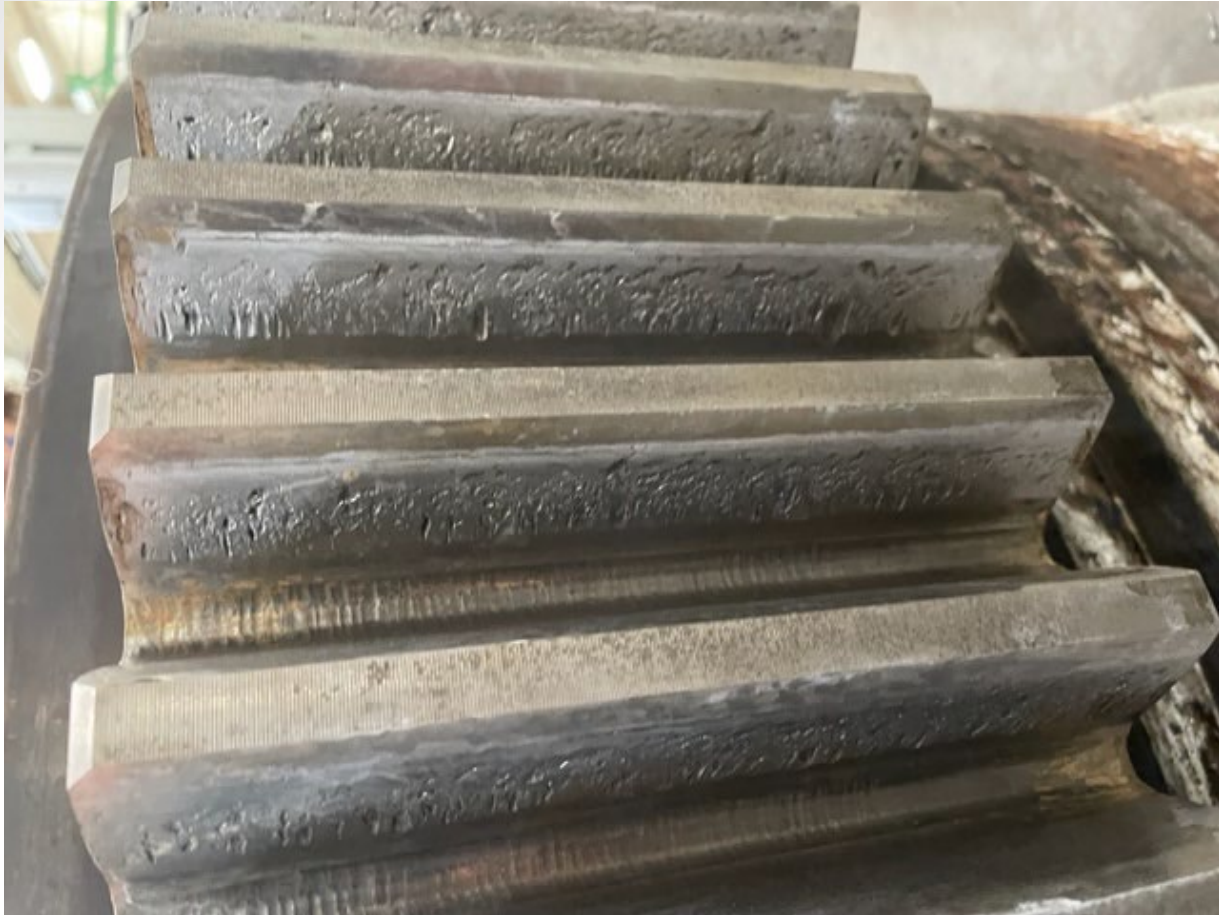
- 2022, Hoist #6 failed, gears showed severe pitting due to material fatigue from high contact stresses, replaced with hoist from bay #16. Bay #16 RTS after about three month outage.  
Hoist #15 OOS for one week for repairs  
Hoist #20 taken OOS for repairs  
Hoist #21 gearbox coupler failed and brakes failed during closure causing gate to fall on sill

Pitted north drum gear

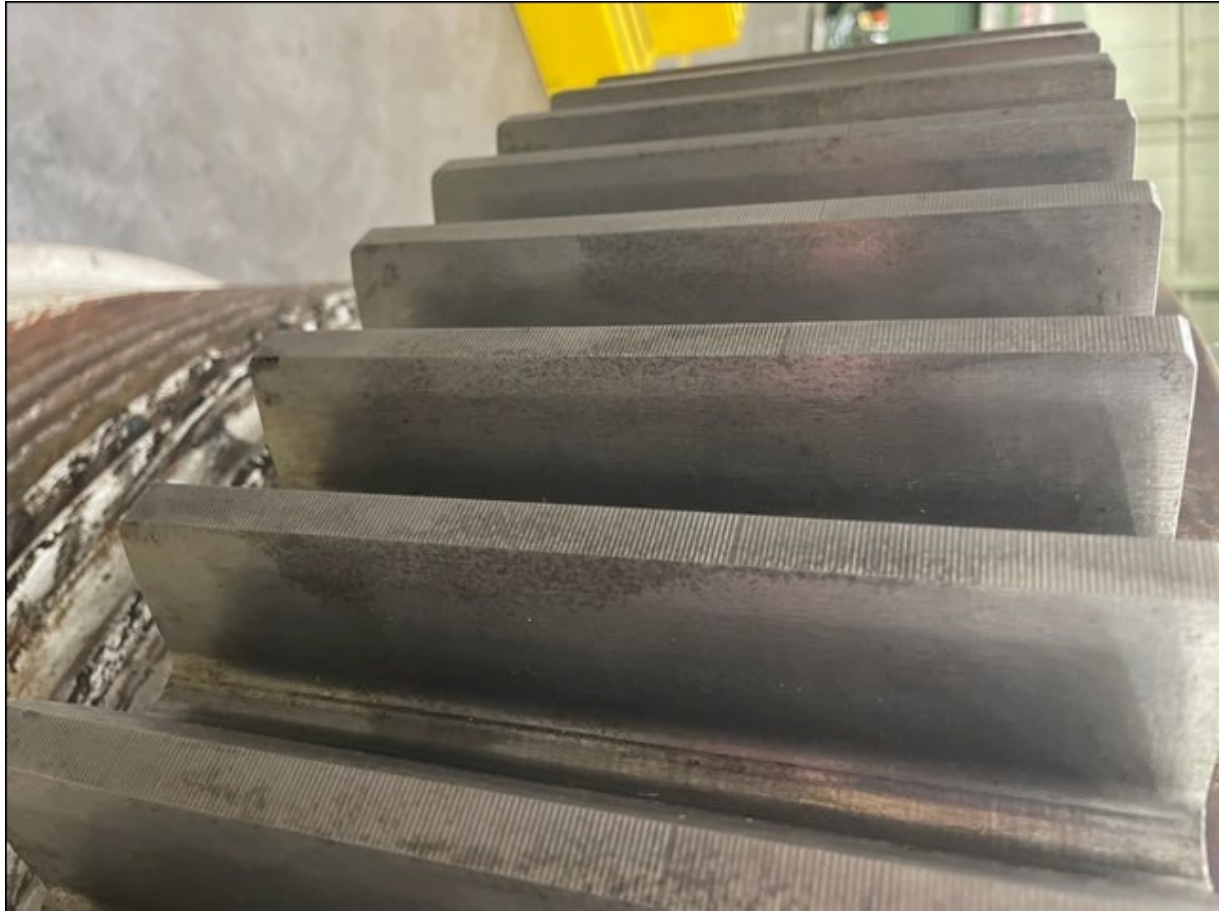
Unworn gear

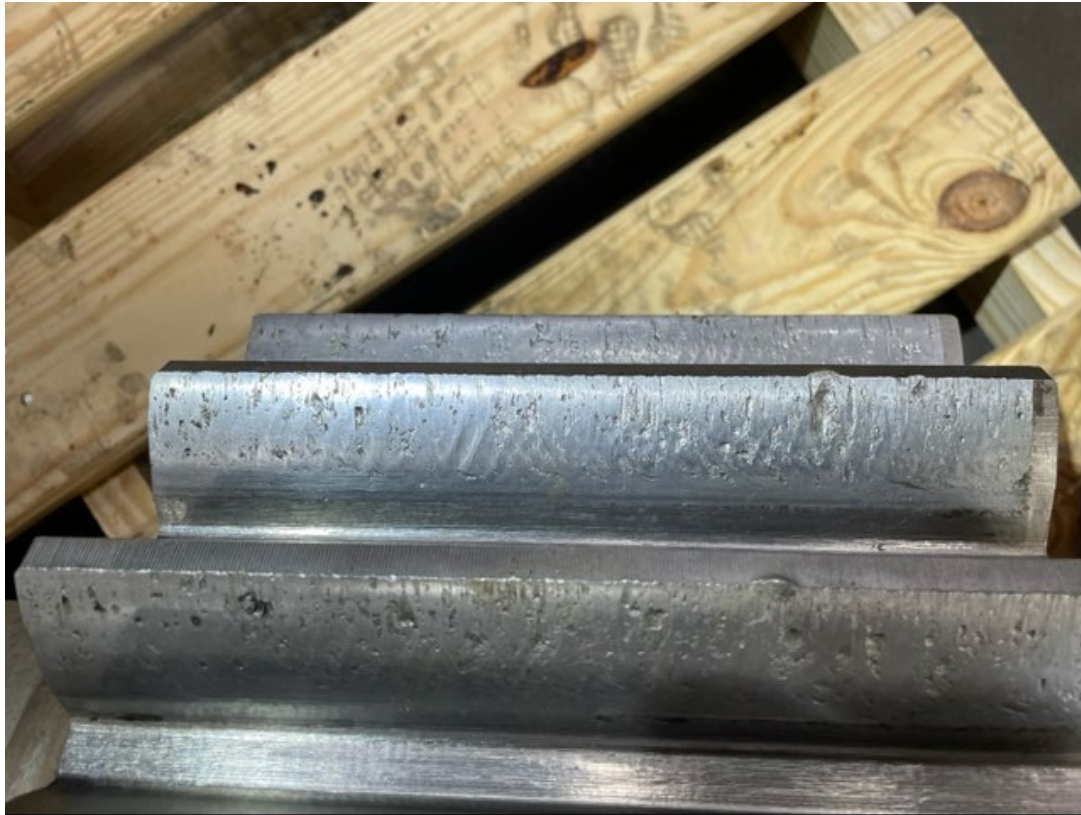
Pitting on south pinion gear

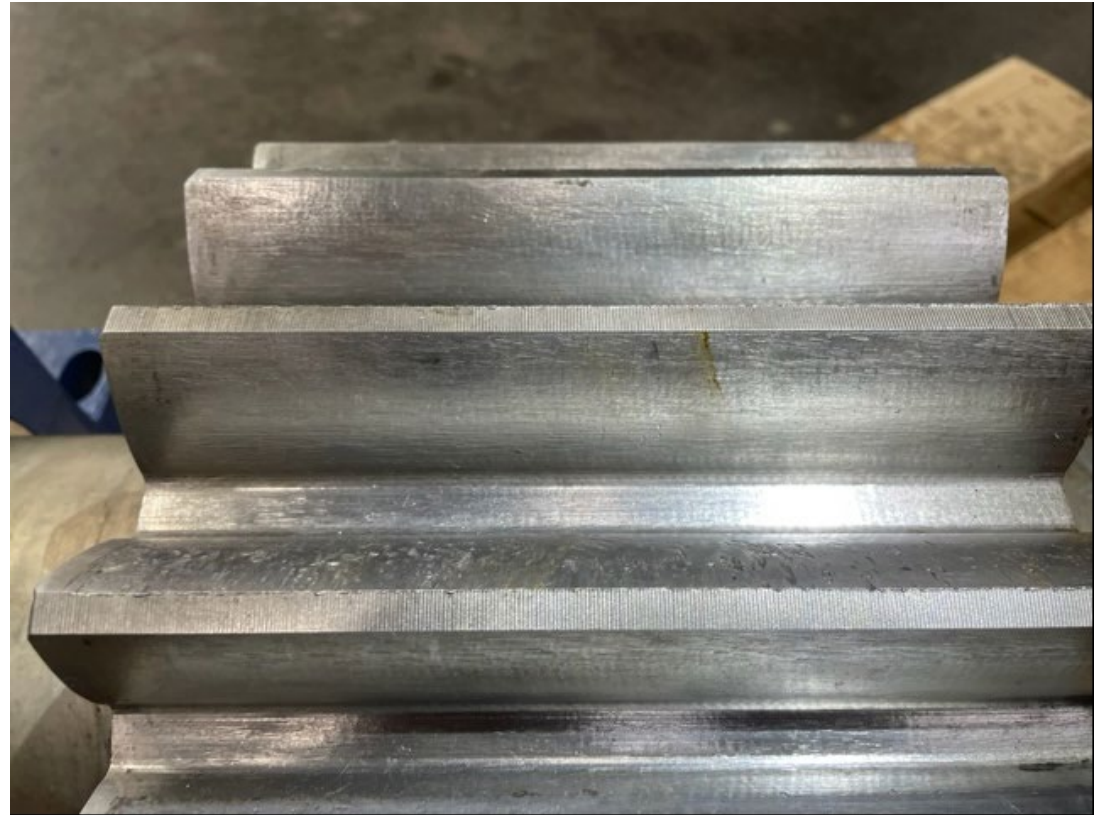
Unworn pinion gear

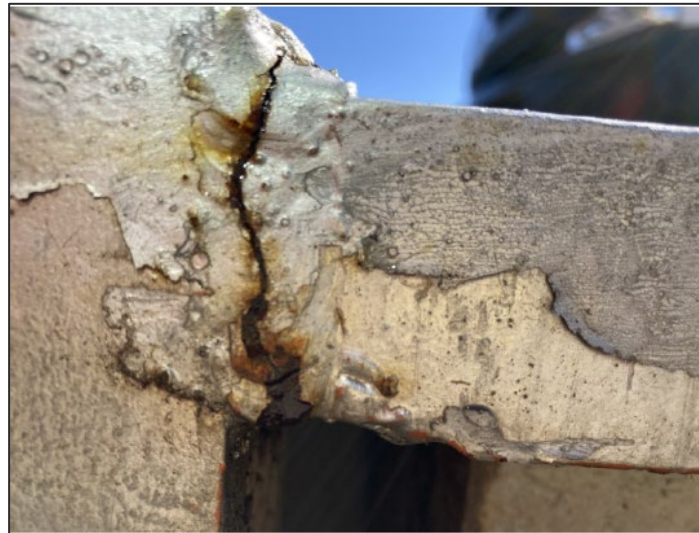
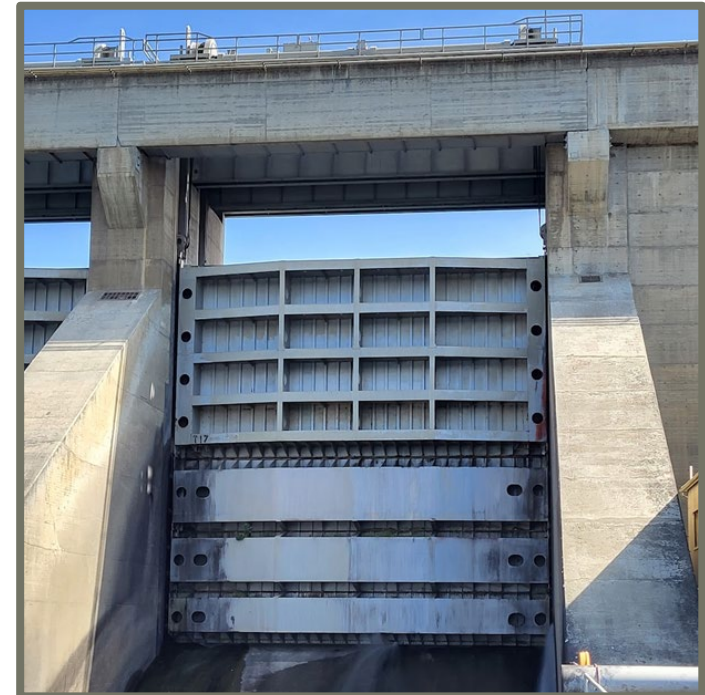
- 2022, Testing of lifting eyes showed deterioration and overload of design capacity  
Gate girders; several were close to failure for normal operations, and many did not meet criteria for emergency operation
- 2023, Spillbay #16 closed to repair cracks in dogs and dog mounting points  
Bays #1, #3, #21 taken OOS to repairs dogs. Other bays to follow over the next year
- Result of structural analysis is that all 22 (+2 spares) spill gates should be replaced

- Based on 2023 structural analysis, we must replace all spillway gates with updated capacity for hydraulic down-pull forces.
