MEMORANDUM FOR THE RECORD**SUBJECT: 23JDA33 Chinook Morts in Gatewell 1C**

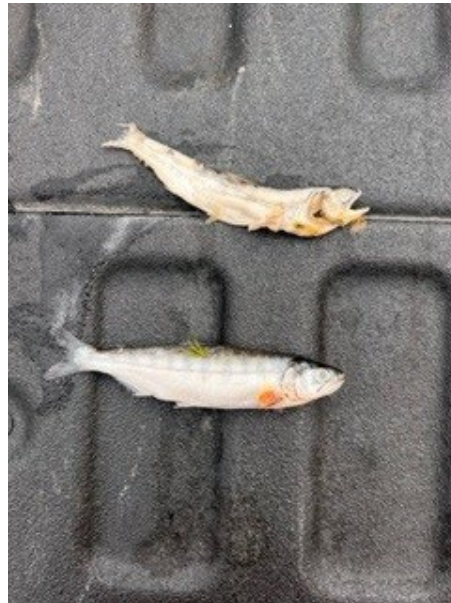
On Monday 21 August 2023, at approximately 0800, JDA fisheries personnel found 2 Chinook subyearling morts in gatewell 1C. They were removed from the gatewell, scanned for PIT tags (no tags), and returned to the river. The morts were older, and both descaled. Personnel will continue to perform daily gatewell inspections to ensure no other mortalities appear.

- A. Species – Chinook subyearling
- B. Origin – Clipped
- C. Length – Subyearling ~12cm
- D. Marks and tags – None
- E. Marks and Injuries found on carcass – Descaled
- F. Cause and Time of Death – Unknown
- G. Future and Preventative Measures – JDA discovered that MU1 gatewell C was not in auto cycle mode and there was a problem with the air lines. Upon that discovery the bios cycled the orifice. If more morts float up, they will install bulkheads and manually inspect the orifice. Maintenance will repair the air system as quickly as possible.

We took some extra precautions and rov'd the gatewell slot and fish orifice. Front side was free of debris and we're closing the tainter gate to backflush the orifice just to be safe.
