MEMORANDUM FOR THE RECORD: 24 LGS 06: Transformer-1 MOD Failure**SUBJECT: Priority unit, spill pattern, potential MOP, potential TGD deviations due to catastrophic transformer connection failure and damage**Background

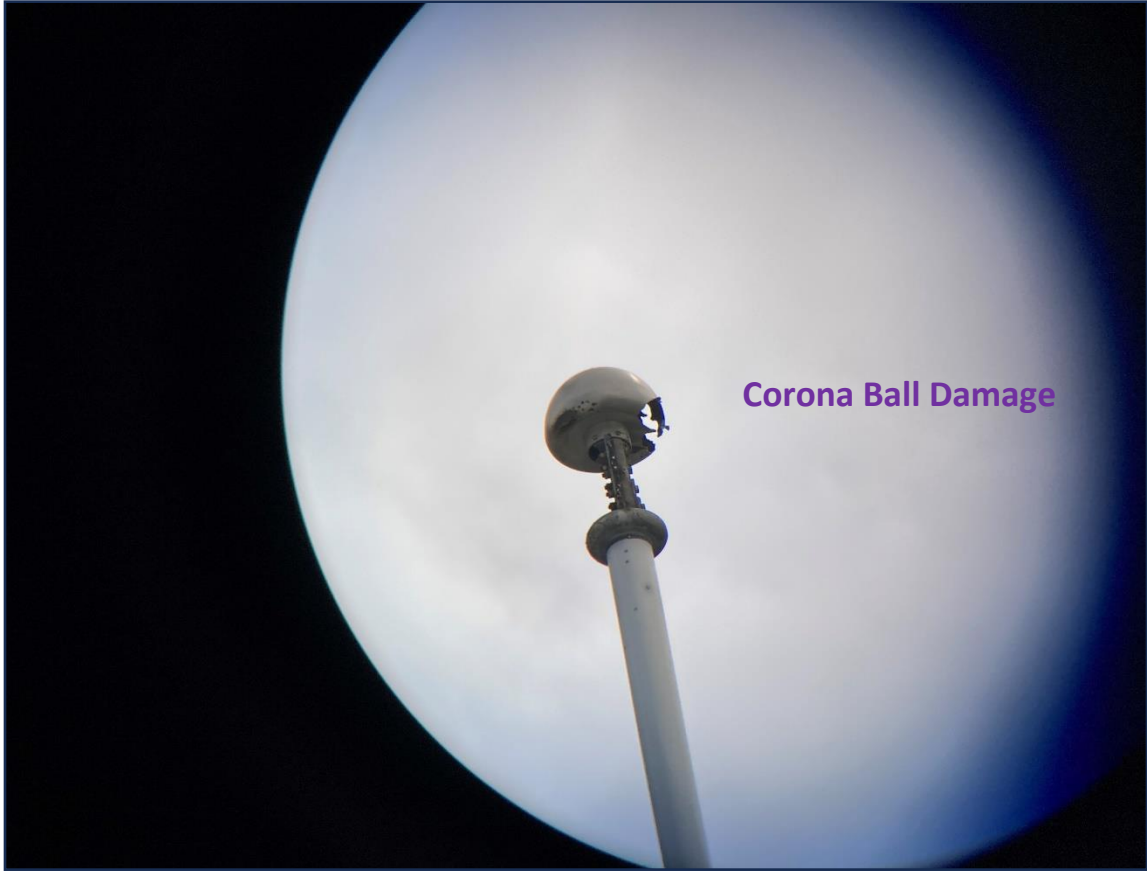
Corona Ball Damage

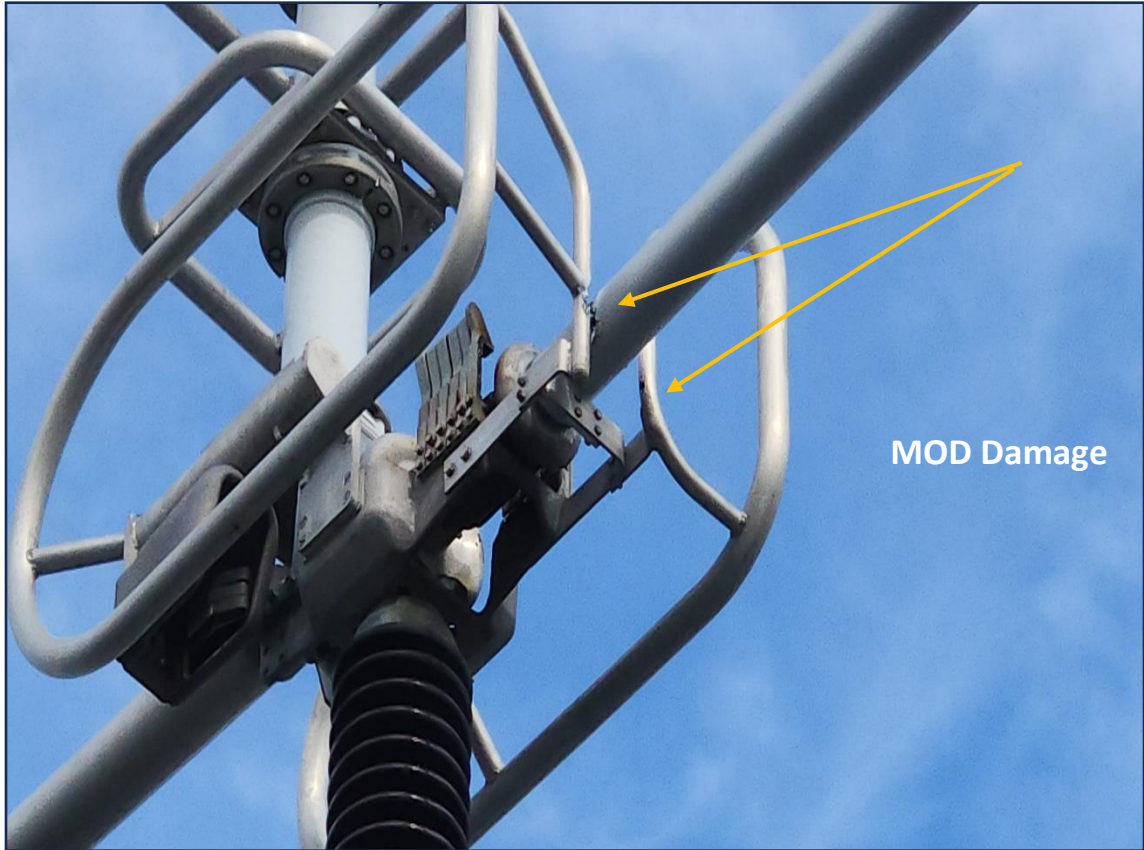
Intermittent arc flash events occurred to the Motor Operated Disconnect (MOD) switch to Transformer 1, infrastructure supported by units 1- 4. Eyewitness and film footage accounts documented arc flash and spark showers beginning the 0400 hour of June 14 and manifesting again during the 0700 hour. Another 6 short bursts occurred during the 0800 hour of June 15. BPA switchyard, LGS relay data, and infra-red camera inspections took place in between events without any findings. However, visual camera inspections revealed deformities materializing on the MOD corona ball and blades. During the June 15 inspection at 1930 hours, LGS operations determined repetitive arcing continued to degrade the MOD unit with potential to cause larger events at increasing damage levels. This led to enacting emergency procedures with BPA.

MOD Damage

- B. Origin – Hatchery, Wild
- C. Length – N/A
- D. Marks and tags – N/A
- E. Marks and Injuries found on carcass – N/A
- F. Cause and Time of Death – N/A
- G. Future and Preventative Measures – Short term strategies entail assembly of a jumper configuration consisting of jumper cable, pad connectors, and collars to connect the line to the transformer side of the MOD, effectively bypassing the MOD switch and bus work. Jumper completion target is the evening of June 19, pending either manufacture or availability of jumper collars. Intermediate strategies include removal of the burnt and eroded MOD switch corona ball, blade contacts, contact plate, and arm. Demolition of the MOD switch will require 2 cranes, man basket lift, future line outage coordination, and manufacture on site.
