MEMORANDUM FOR THE RECORD

SUBJECT: Sampling cancelled due to channel water elevation fluctuations.

Location: McNary juvenile fish facilities.

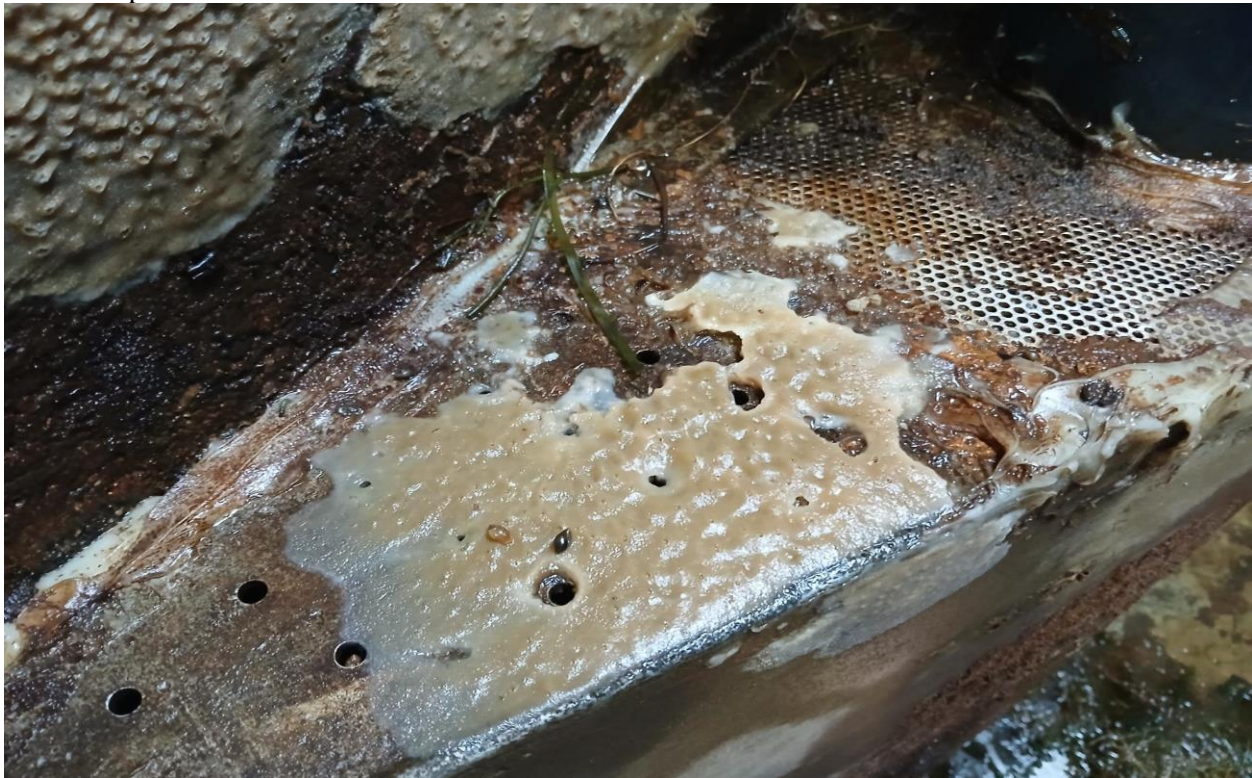
G. Photos Taken:
Shroud Top

F. Future and Preventative Measures: The still well and shroud are cleaned every winter. It appears freshwater sponge is becoming an increasing issue in our systems and more frequent cleaning will be required.
