2018 The Dalles Dam Spillway Stilling Basin ROV Inspection Report

Inspection date: 12/11/2018;

Inspection conducted for: Dam Safety;

Desired inspection targets: Verification of structural condition and debris loading;

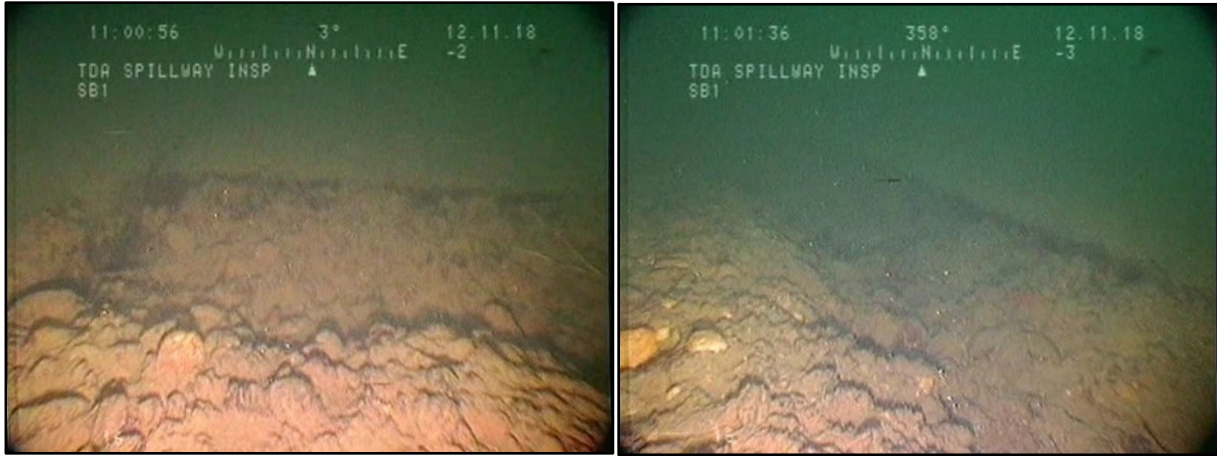
Spillbay 1- Two areas of significant construction joint erosion was found. Both are perpendicular to the water flow. One is approx. 20 ft. long and varies in width from 1-4 ft. with approx. 6 inches of scour depth. The second is smaller at 9 ft. long by 1.5 ft. in width with approx. 6 inches of scour depth.

Figure 3 Scoured construction joint found on the ogee of Spillbay 1.

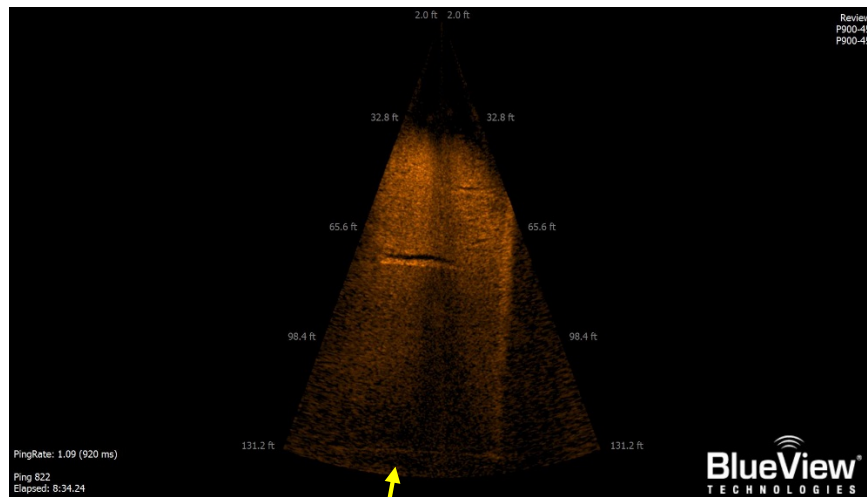
Figure 4 Sonar image of scour in Spillbay 1. The larger scour is approx. 20ft long by 2ft wide (width varies). The smaller scour is approx. 9ft long by 1-1.5ft in width.

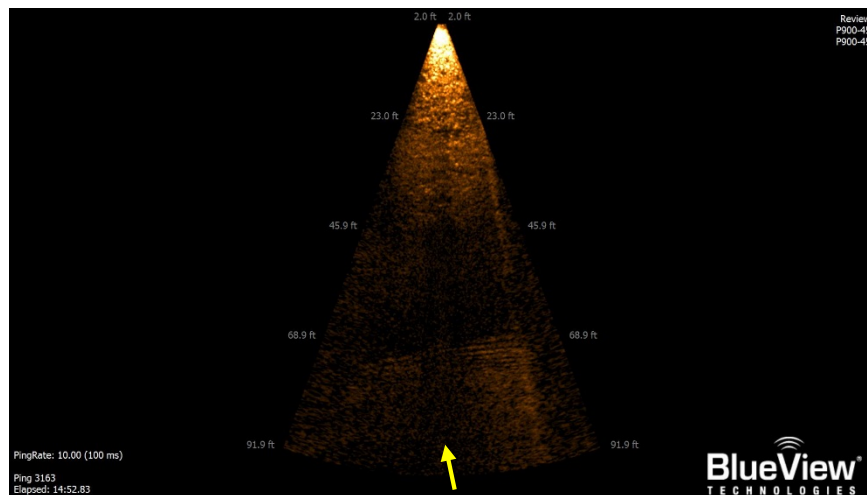
Spillbay 2- Minor concrete surface erosion of various depths (2-3 inches) was found across the majority of the SB2 ogee.

Figure 5 Sonar imagery showing rough surface conditions of ogee concrete in Spillbay 2.

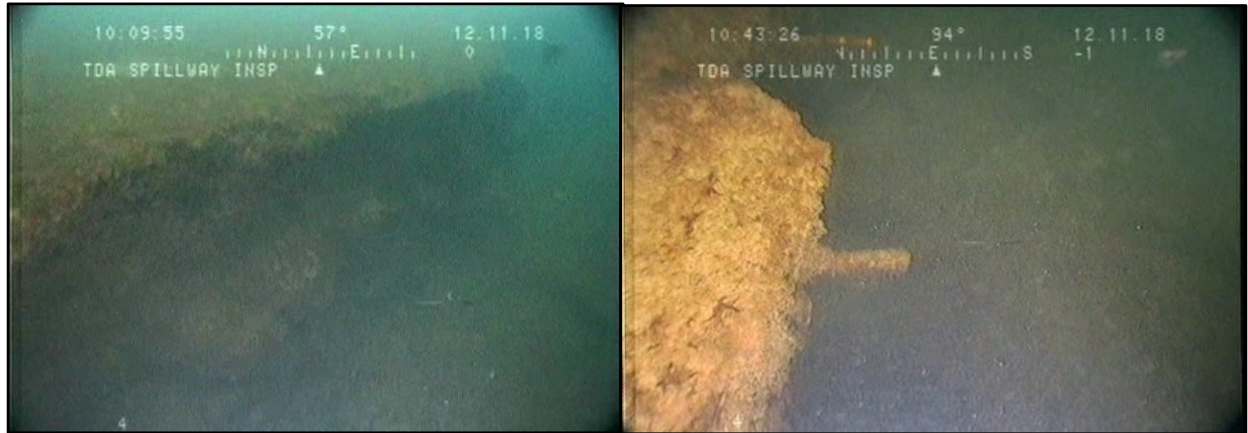
Spillbays 3 thru 5- No significant discrepancies found on the spillbay ogees or baffle blocks. The downstream apron surface shows moderate surface erosion and along its edge. Undercutting was found in this area and varies in range from 4 to 8 ft. deep. To capture these undercut images, the BlueView sonar was rotated 90* on its horizontal axis and positioned perpendicular to the downstream apron end sill. The resultant imagery indicates the undercut depth by showing how far back the sonar beams must travel to reflect off of solid structure.

Figure 6 Images showing typical downstream apron end sill erosion along the entire apron downstream of Spillbays 1-8.

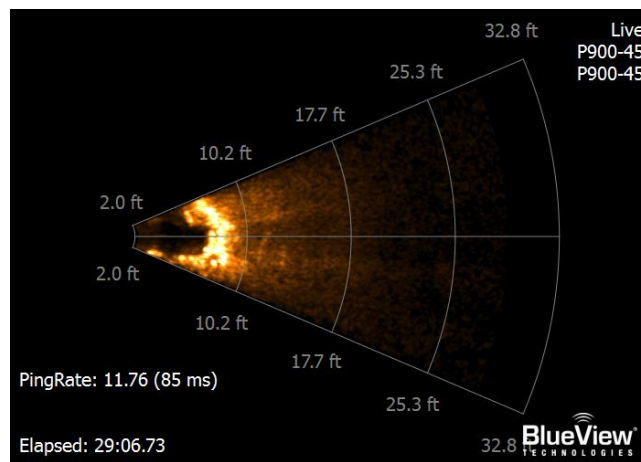
Figure 7 BlueView sonar image showing the approx. 5-6ft undercut of the apron downstream of Spillbay 3.

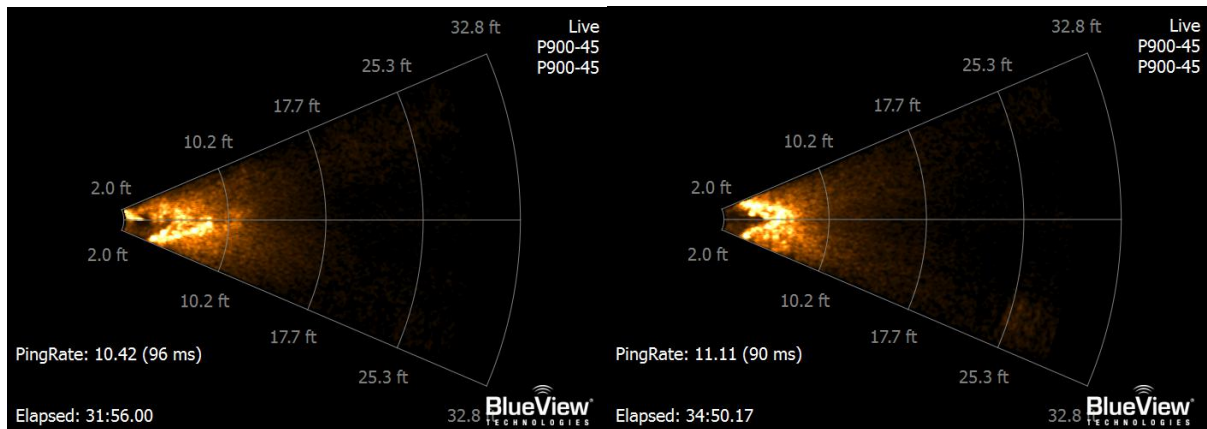
Figure 8 BlueView sonar images showing the approx. 6-7ft undercut of the apron downstream of Spillbay 4 (left) and 5-6ft of undercut at Spillbay 5 (right).

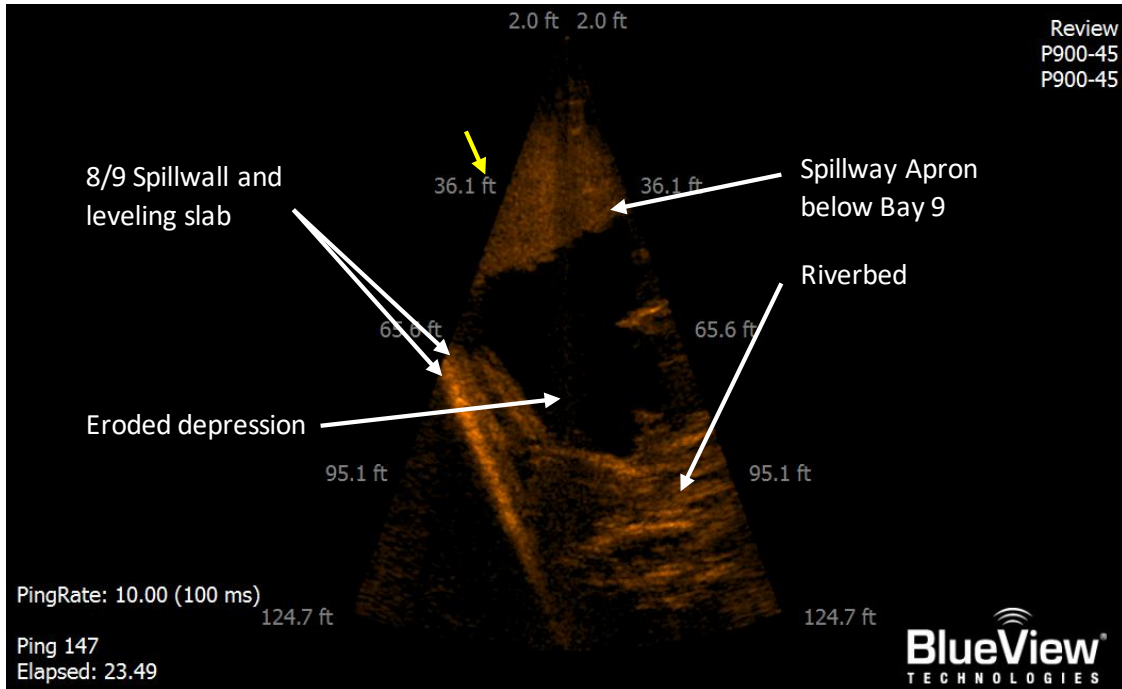
Spillbay 9- The known scour on the Oregon side of the Spillwall where Bay 9 apron meets the wall and riverbed was inspected and does not appear to have changed much in size or condition since the last ROV inspection. There is a small area of undercutting under the apron located approx. 8- 10 ft. south of the wall. The undercut area is approx. 2-4 ft. in length.

Figure 9 Sonar image showing the eroded area where the apron, 8/9 Spillwall and riverbed intersect. This area does not appear to have expanded since the last ROV inspection conducted here.

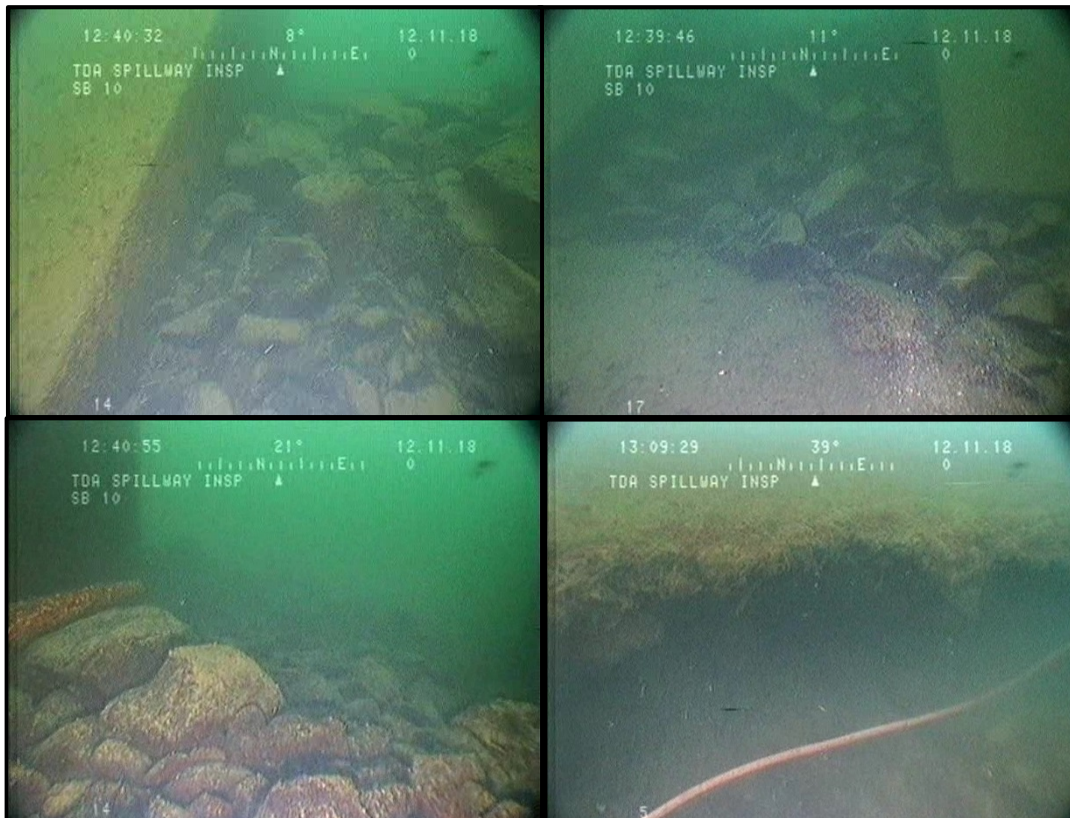
Spillbay 10- A large pile of rock was located between the baffle blocks in SB10. This rock appears to be fractured basalt of various sizes. It appears to have collected in this location but does not appear to have caused any structural damage due to "ball milling" at this point.

Figure 10 Images showing rocks found between baffle blocks in Spillbay 10 as well as the typical condition of the downstream apron end sill to riverbed interface showing minor undercutting.

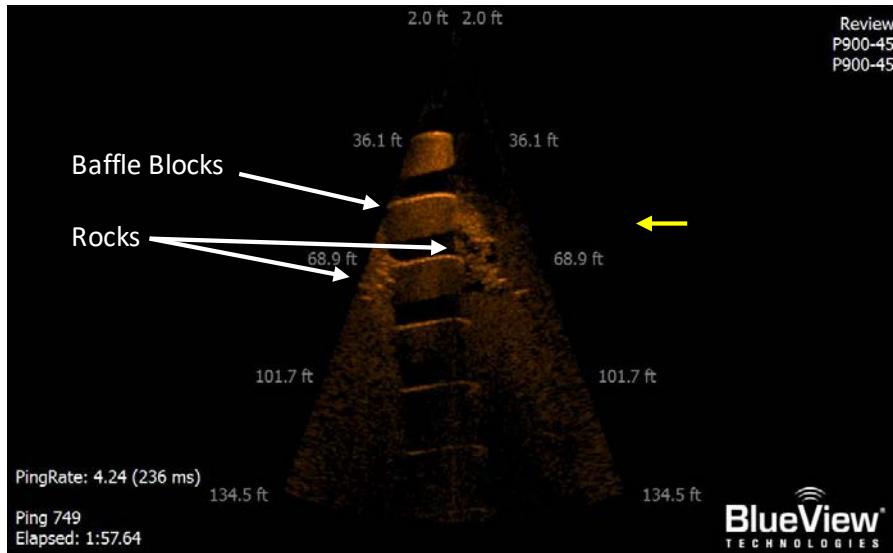
Figure 11 Sonar image showing the rocks found in Spillbay 10. Rocks are piled upstream, between and scattered downstream of baffle blocks. Rock pile is approx. 3 ft high between the baffle blocks.

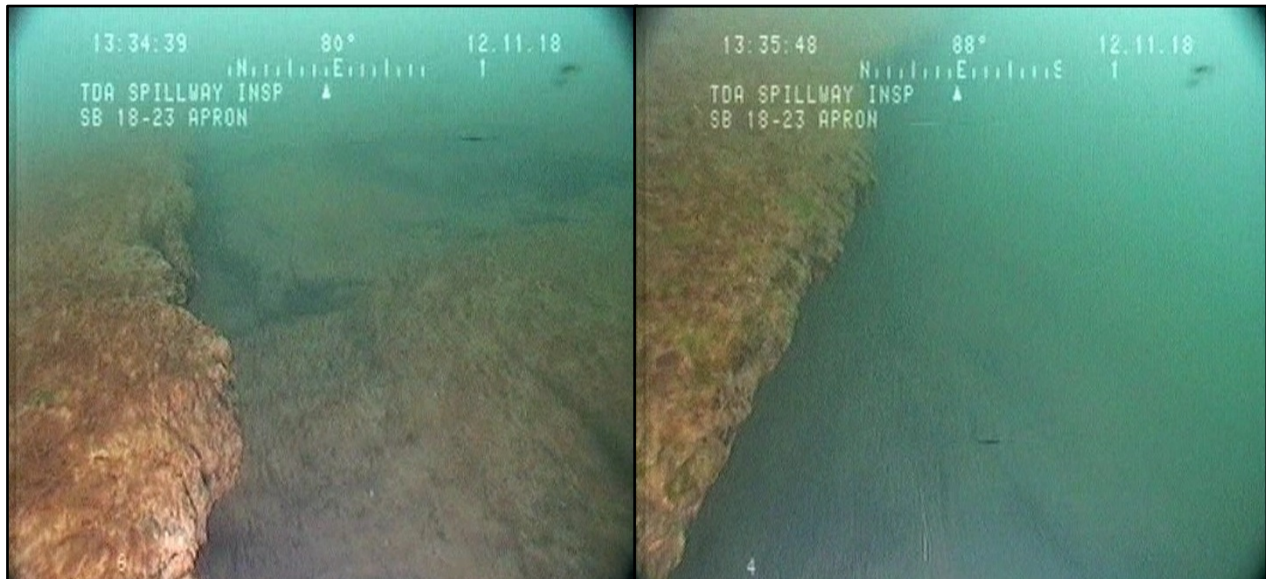
Spillbays 11-23- The stilling basin just below the ogee to the upstream apron wall was covered in approx. 2-3 inches of silt across this entire area. Minor surface erosion of the downstream apron joints and the moderate to significant erosion of the downstream apron edge was noted in this area. The undercutting of the apron in the area of bay 23 was found to be anywhere from 15-20 ft. deep in places. Maneuvering the ROV to thoroughly inspect this end of the apron is difficult at best due to powerhouse flow coming around the bend in the river.

Figure 12 Image on the left is the apron to riverbed interface in the area of Spillbay 18. The image on the right is in the area of Spillbay 23. The distance from the apron edge to the river bottom increases in this area as does the noted undercut. This area is very difficult to inspect by ROV due to the powerhouse generation and ice & trash sluiceway flow.

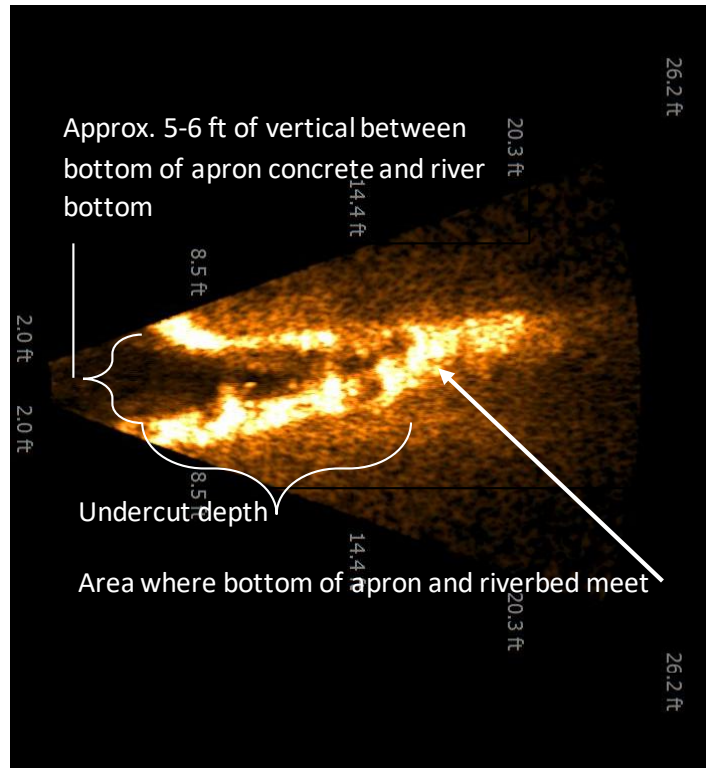
Figure 7 This rotated sonar image shows the approx. 15 ft of undercut in the area downstream of Spillbay 22. This also shows the vertical distance from the river bottom to the underside of the apron concrete.

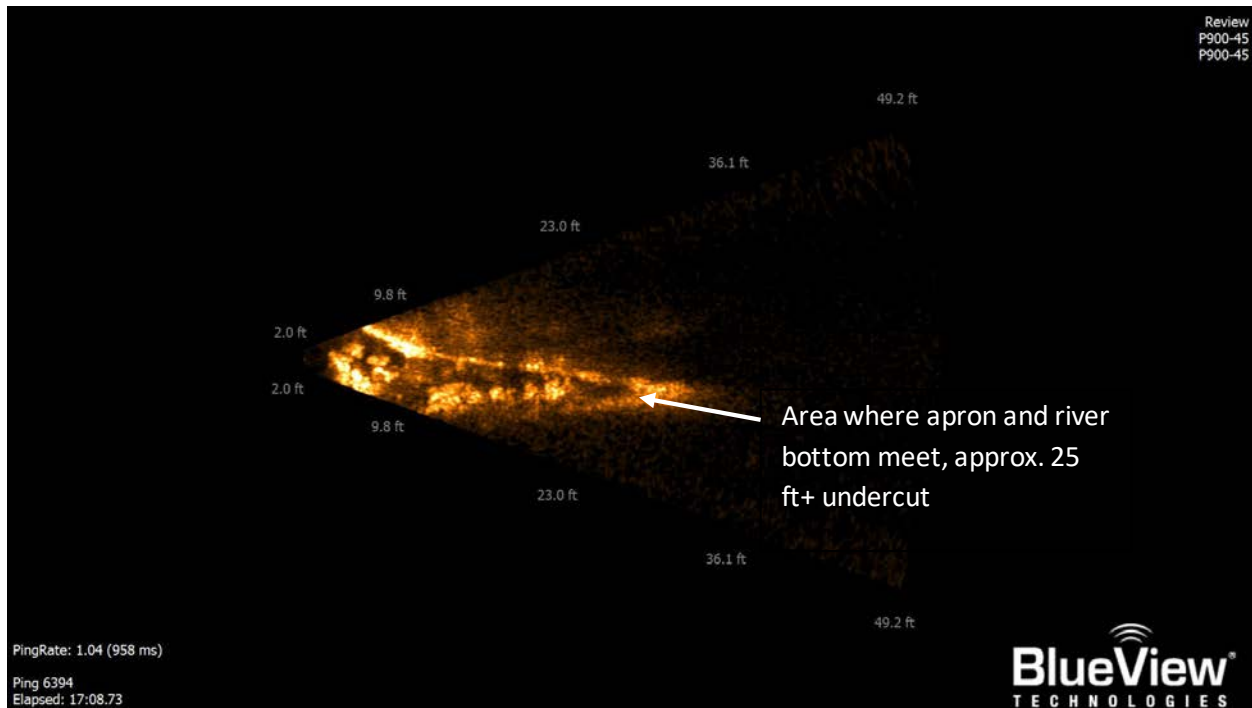
Figure 6 This sonar image shows the approx. 23-25 ft. undercut in the area of Spillbay 23. Due to the difficulty in inspecting this area, it is suggested to re-inspect during the lowest flow.
