Refurbishing The Dalles Fish Water Turbine-Generators, Phase 1A Final Report

The Dalles Fish Water Units 1 and 2

Final Report – REVIEW DRAFT

May 2019

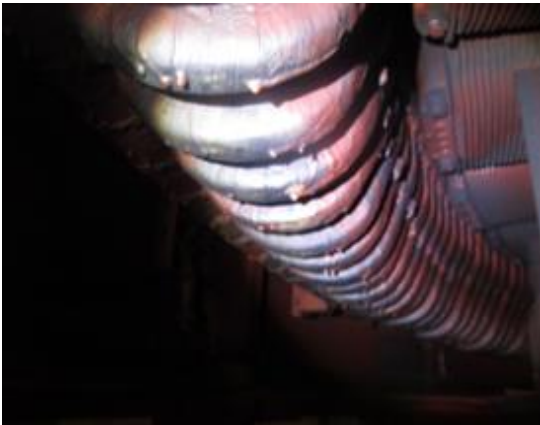
The rotors of both units are still in place. Visual inspections of the stator end-windings were therefore limited. According the Project team at TDA, the windings have never been inspected or cleaned since they were rewound in 1997. Findings apply only to the areas visibly observed during the rotor inspection. Unit 1 end-windings have oil deposit and are covered with brake dust. Unit 2 end-windings were clean and dry. No signs of partial discharge activity or discoloration were evidence on both units. No cracking and bulging of the insulation was found. The blocking, lashing and ties appeared to be tight with no sights of movement. Wedges also appeared tight and there were no signs of migration. Overall the windings in both units appear in fair condition for their age. The rotor poles were inspected from above. There were no signs of movement. Inter-pole connections were examined. They appeared to be in good condition. The main and neutral leads were also inspected. No signs of insulation deterioration were observed.

Figure 6. Unit 1 Lower End-Windings

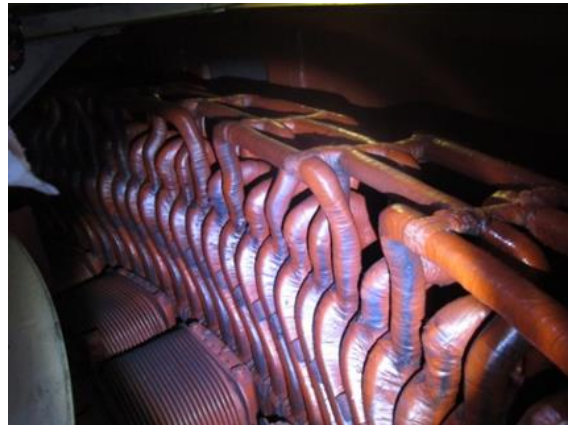
Figure 7. Unit 1 Upper End-Windings and Connection

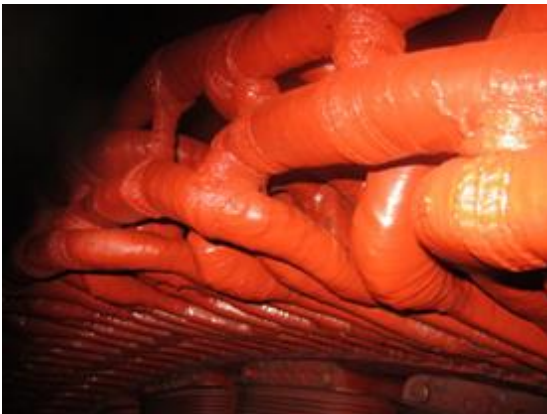
Figure 8. Unit 2 Upper End-Windings and Connection

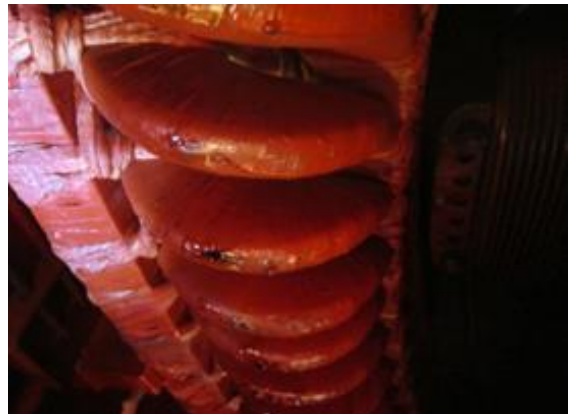
Figure 9. Unit 2 Lower End-Windings

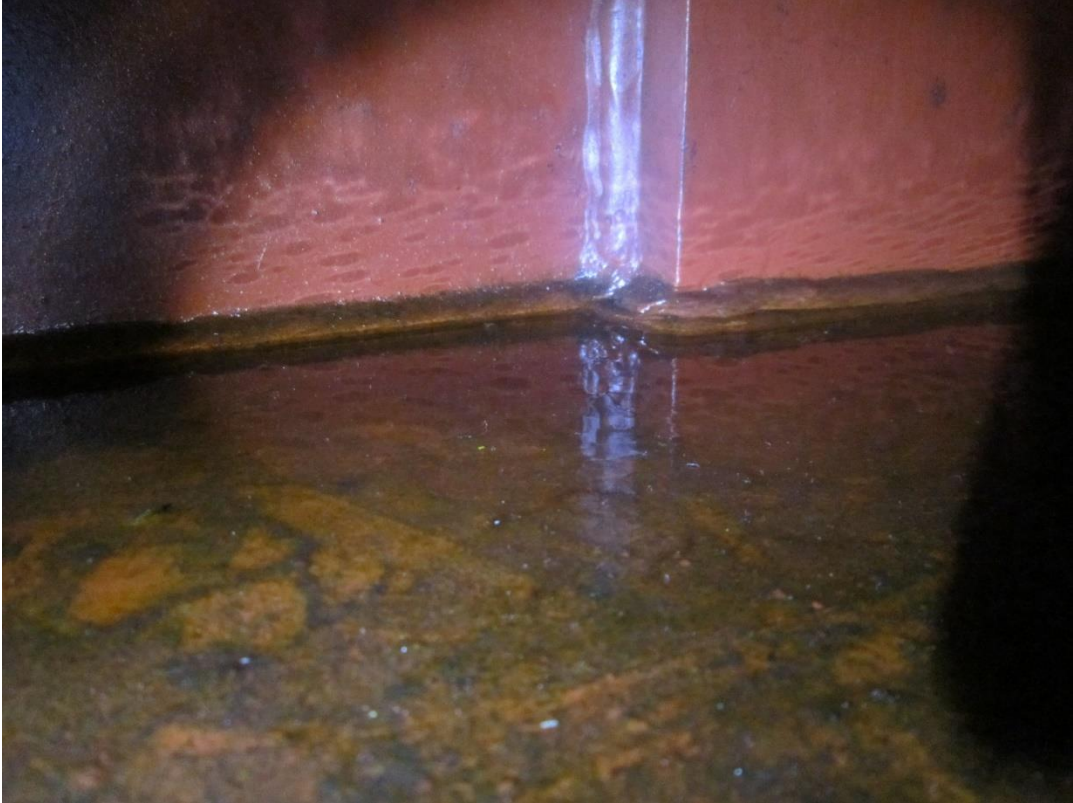
Figure 12. Oil Found on the Bottom of Unit 2 Generator Frame

Oil was seen on the bottom of the generator stator frame. It was not known where the oil came from or how it got deposited. However it did not appear that oil got on the winding or core. It is recommended that the oil be cleaned. Project has cleaned the oil since then.

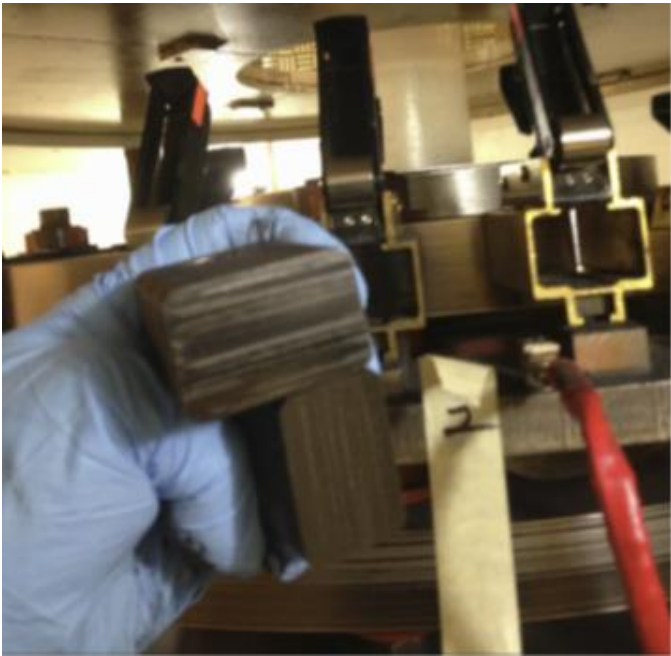
Figure 13. Brush Threading and Uneven Wear

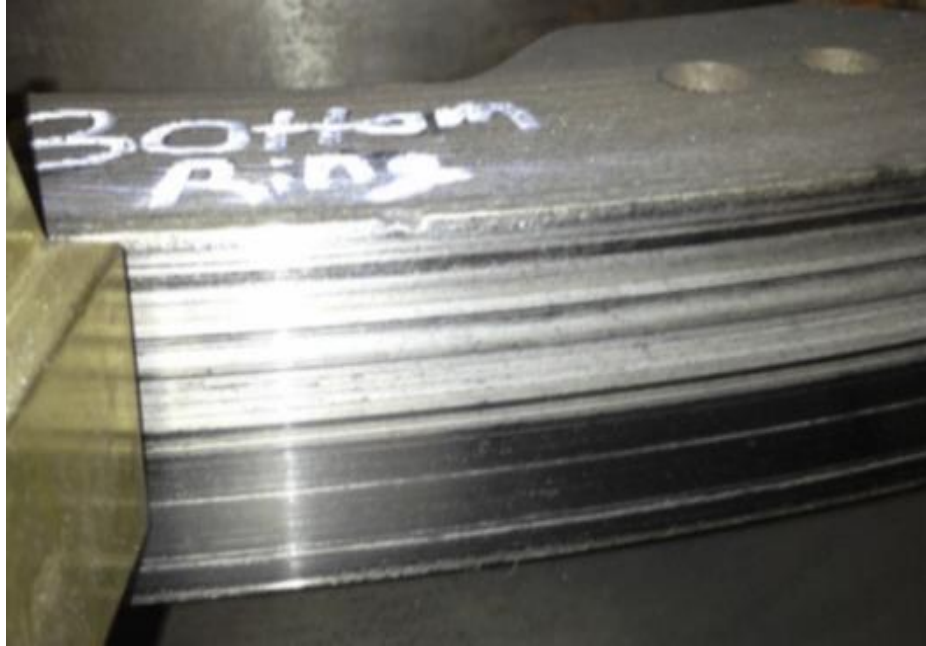
Figure 14. Typical Film and Streaking

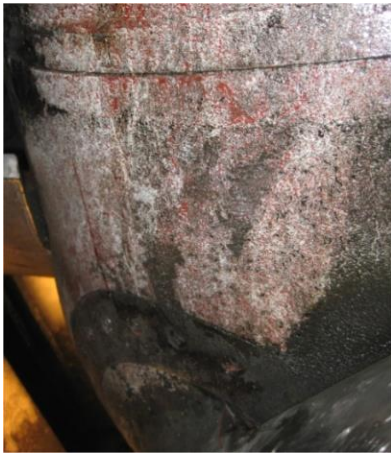
There is minimal cavitation damage on the runner surfaces, but cavitation has been addressed and looked in good repair at the time of the 2016 inspected. Cavitation is an ongoing issue that must be addressed during scheduled outages. At this point it looks like cavitation repair of the blades, hub and discharge ring liner is well in hand, although vigilant inspection will be a constant necessity in the future.

Figure 19. Stainless Steel Overlay on the Blades Suction Side (Underside, Leading Edge)

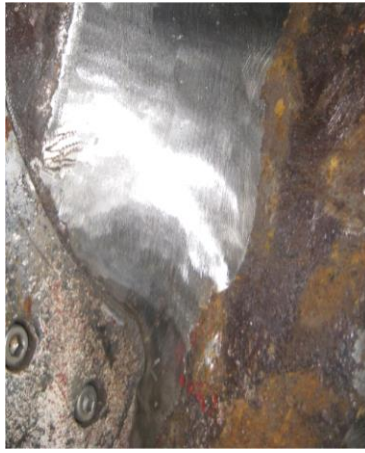
Figure 20. Paint Still Visible on the Runner Hub

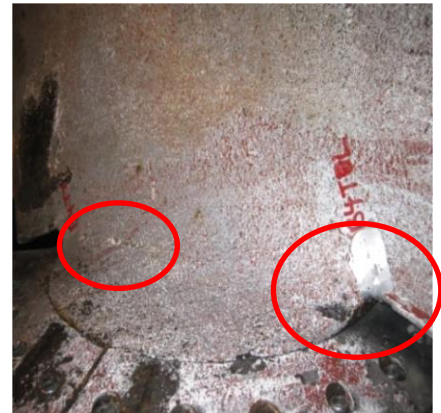
Figure 21. Blade Cracks That Have Been Repaired and Are Not Re-Cracking

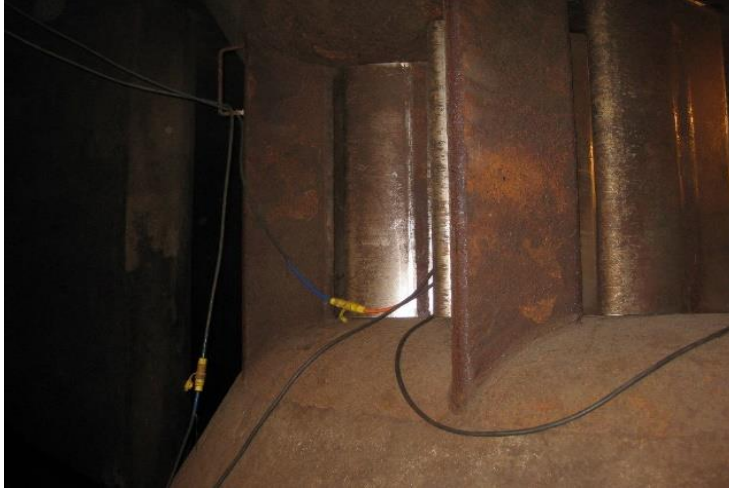
Figure 22. Wicket Gates and Stay Vane in Good Condition

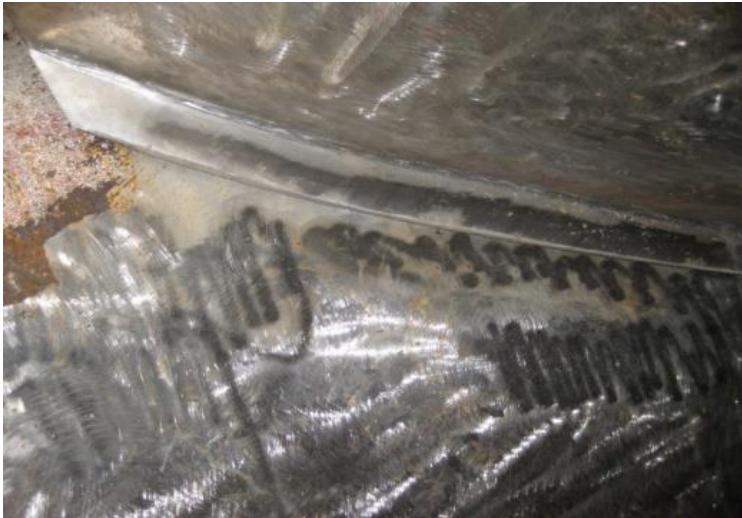
Figure 24. Additional Photo Showing Wicket Gates and Stay Vane with a Corrosion Patina

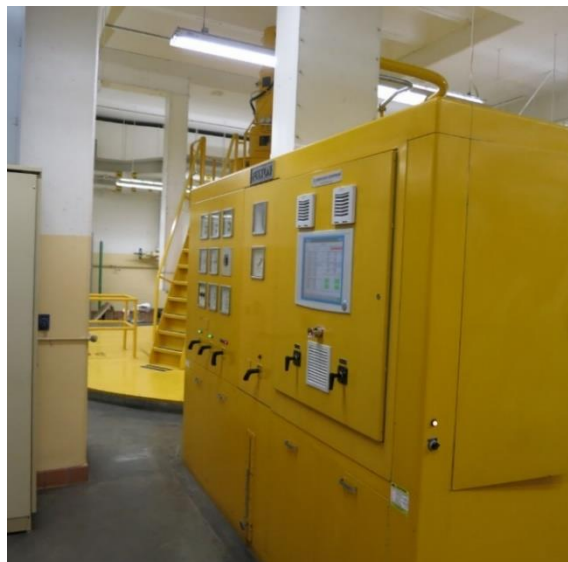
The governors were originally supplied by Pelton and converted from mechanical to digital control by American Governor. This work was completed in 2012. These governors are currently in good operating condition.

Figure 30. American Governor Digital Governors Installed Circa 2012

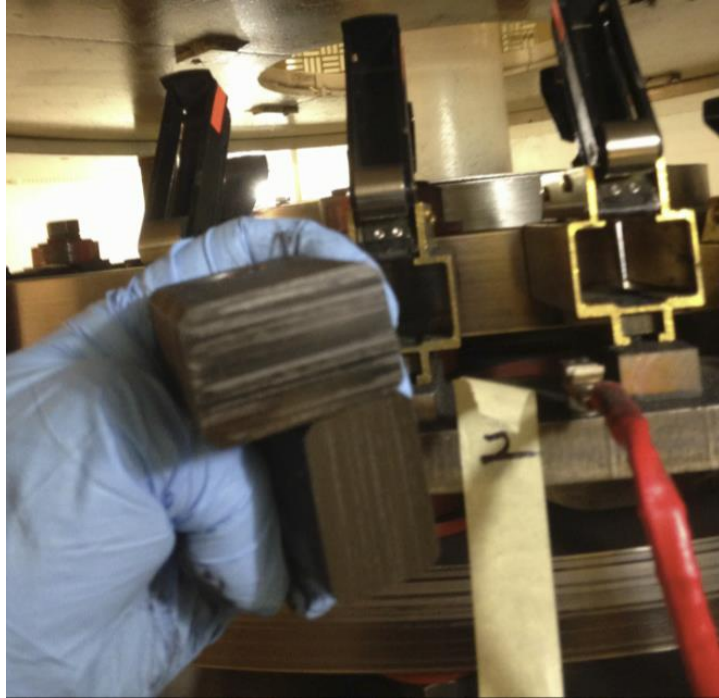
Figure H-1. Brush threading and uneven wear

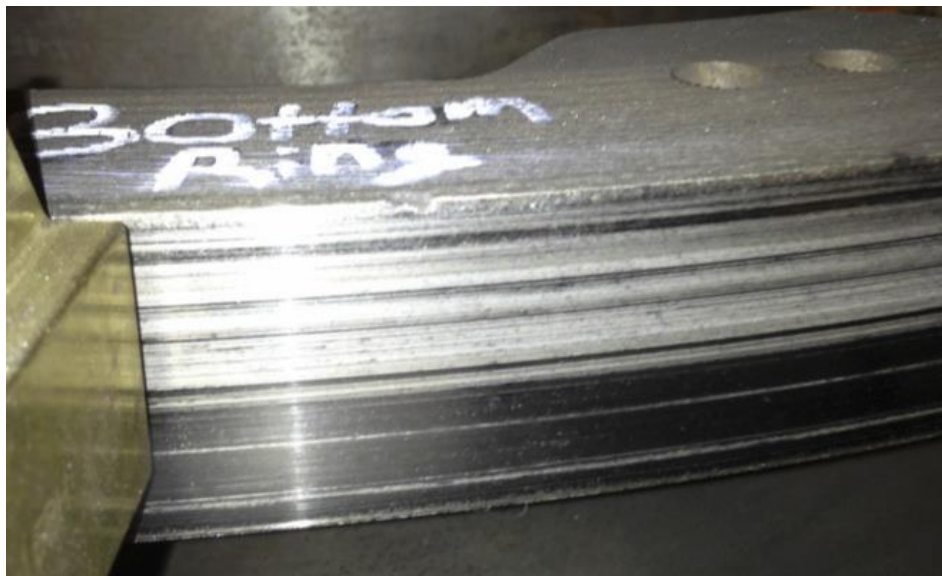
Figure H-2. Film and streaking

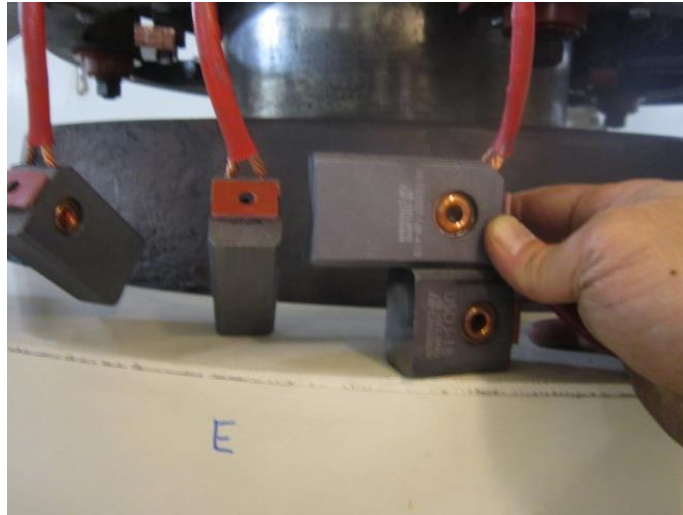
Figure H-3. Generator Brushes

Initial discussion focused on removing the second brush as originally proposed. Also considered was switching to a composite grade electrographite brush. During these discussions it was also proposed that the differential brush height with the removed brush position 6 could lead to a poor conductive film deposition for the corresponding height brush – brush 3 – relative to the remaining brushes as shown in photo 3.
