Appendix 1

December 1st ROV Footage Analysis

Video Analysis of AWSBS Trashrack

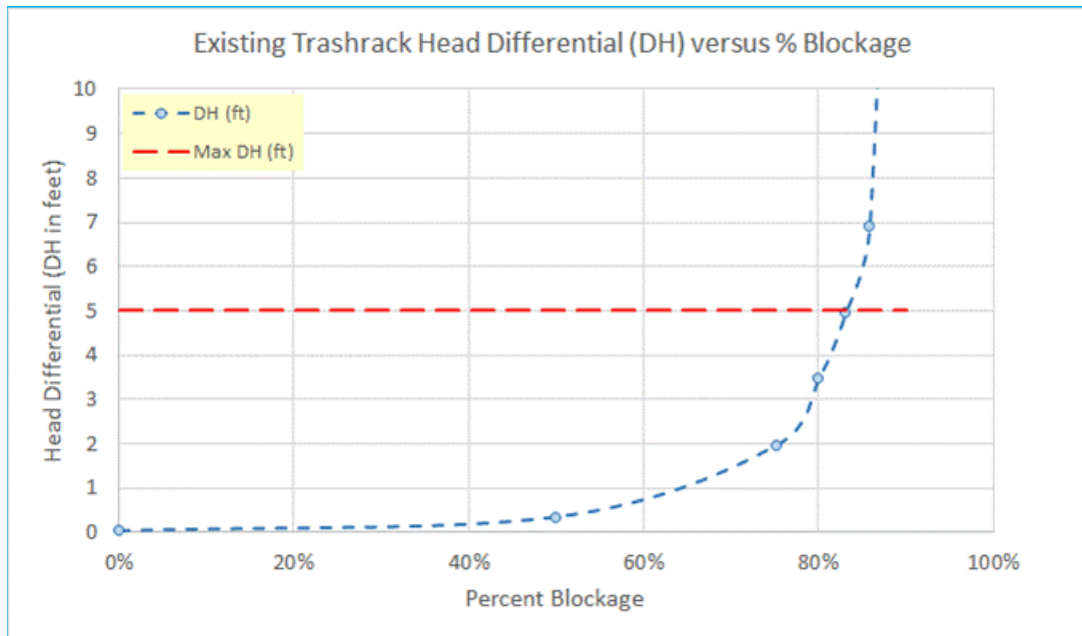
Figure 2-2 from section 2.4 Hydraulic Constraints

- Per the graph below and seen in Section 2.4.3, the percent blockage at the time of shutdown corresponding to a 0.6' differential is approximately 55%.

- The change in head differential from 0% blockage (perfectly clean) to 40% blockage (seen in the video) is essentially negligible, per the graph below.

- A 2' head differential, which has been chosen as a trigger for valve cycling, corresponds to an approximate blockage of 75%.
- Even though the head differential may be deemed safe, if debris accumulation rates stay constant and the baseline is 40% instead of 0% blockage, the time between valve cycling will decrease.

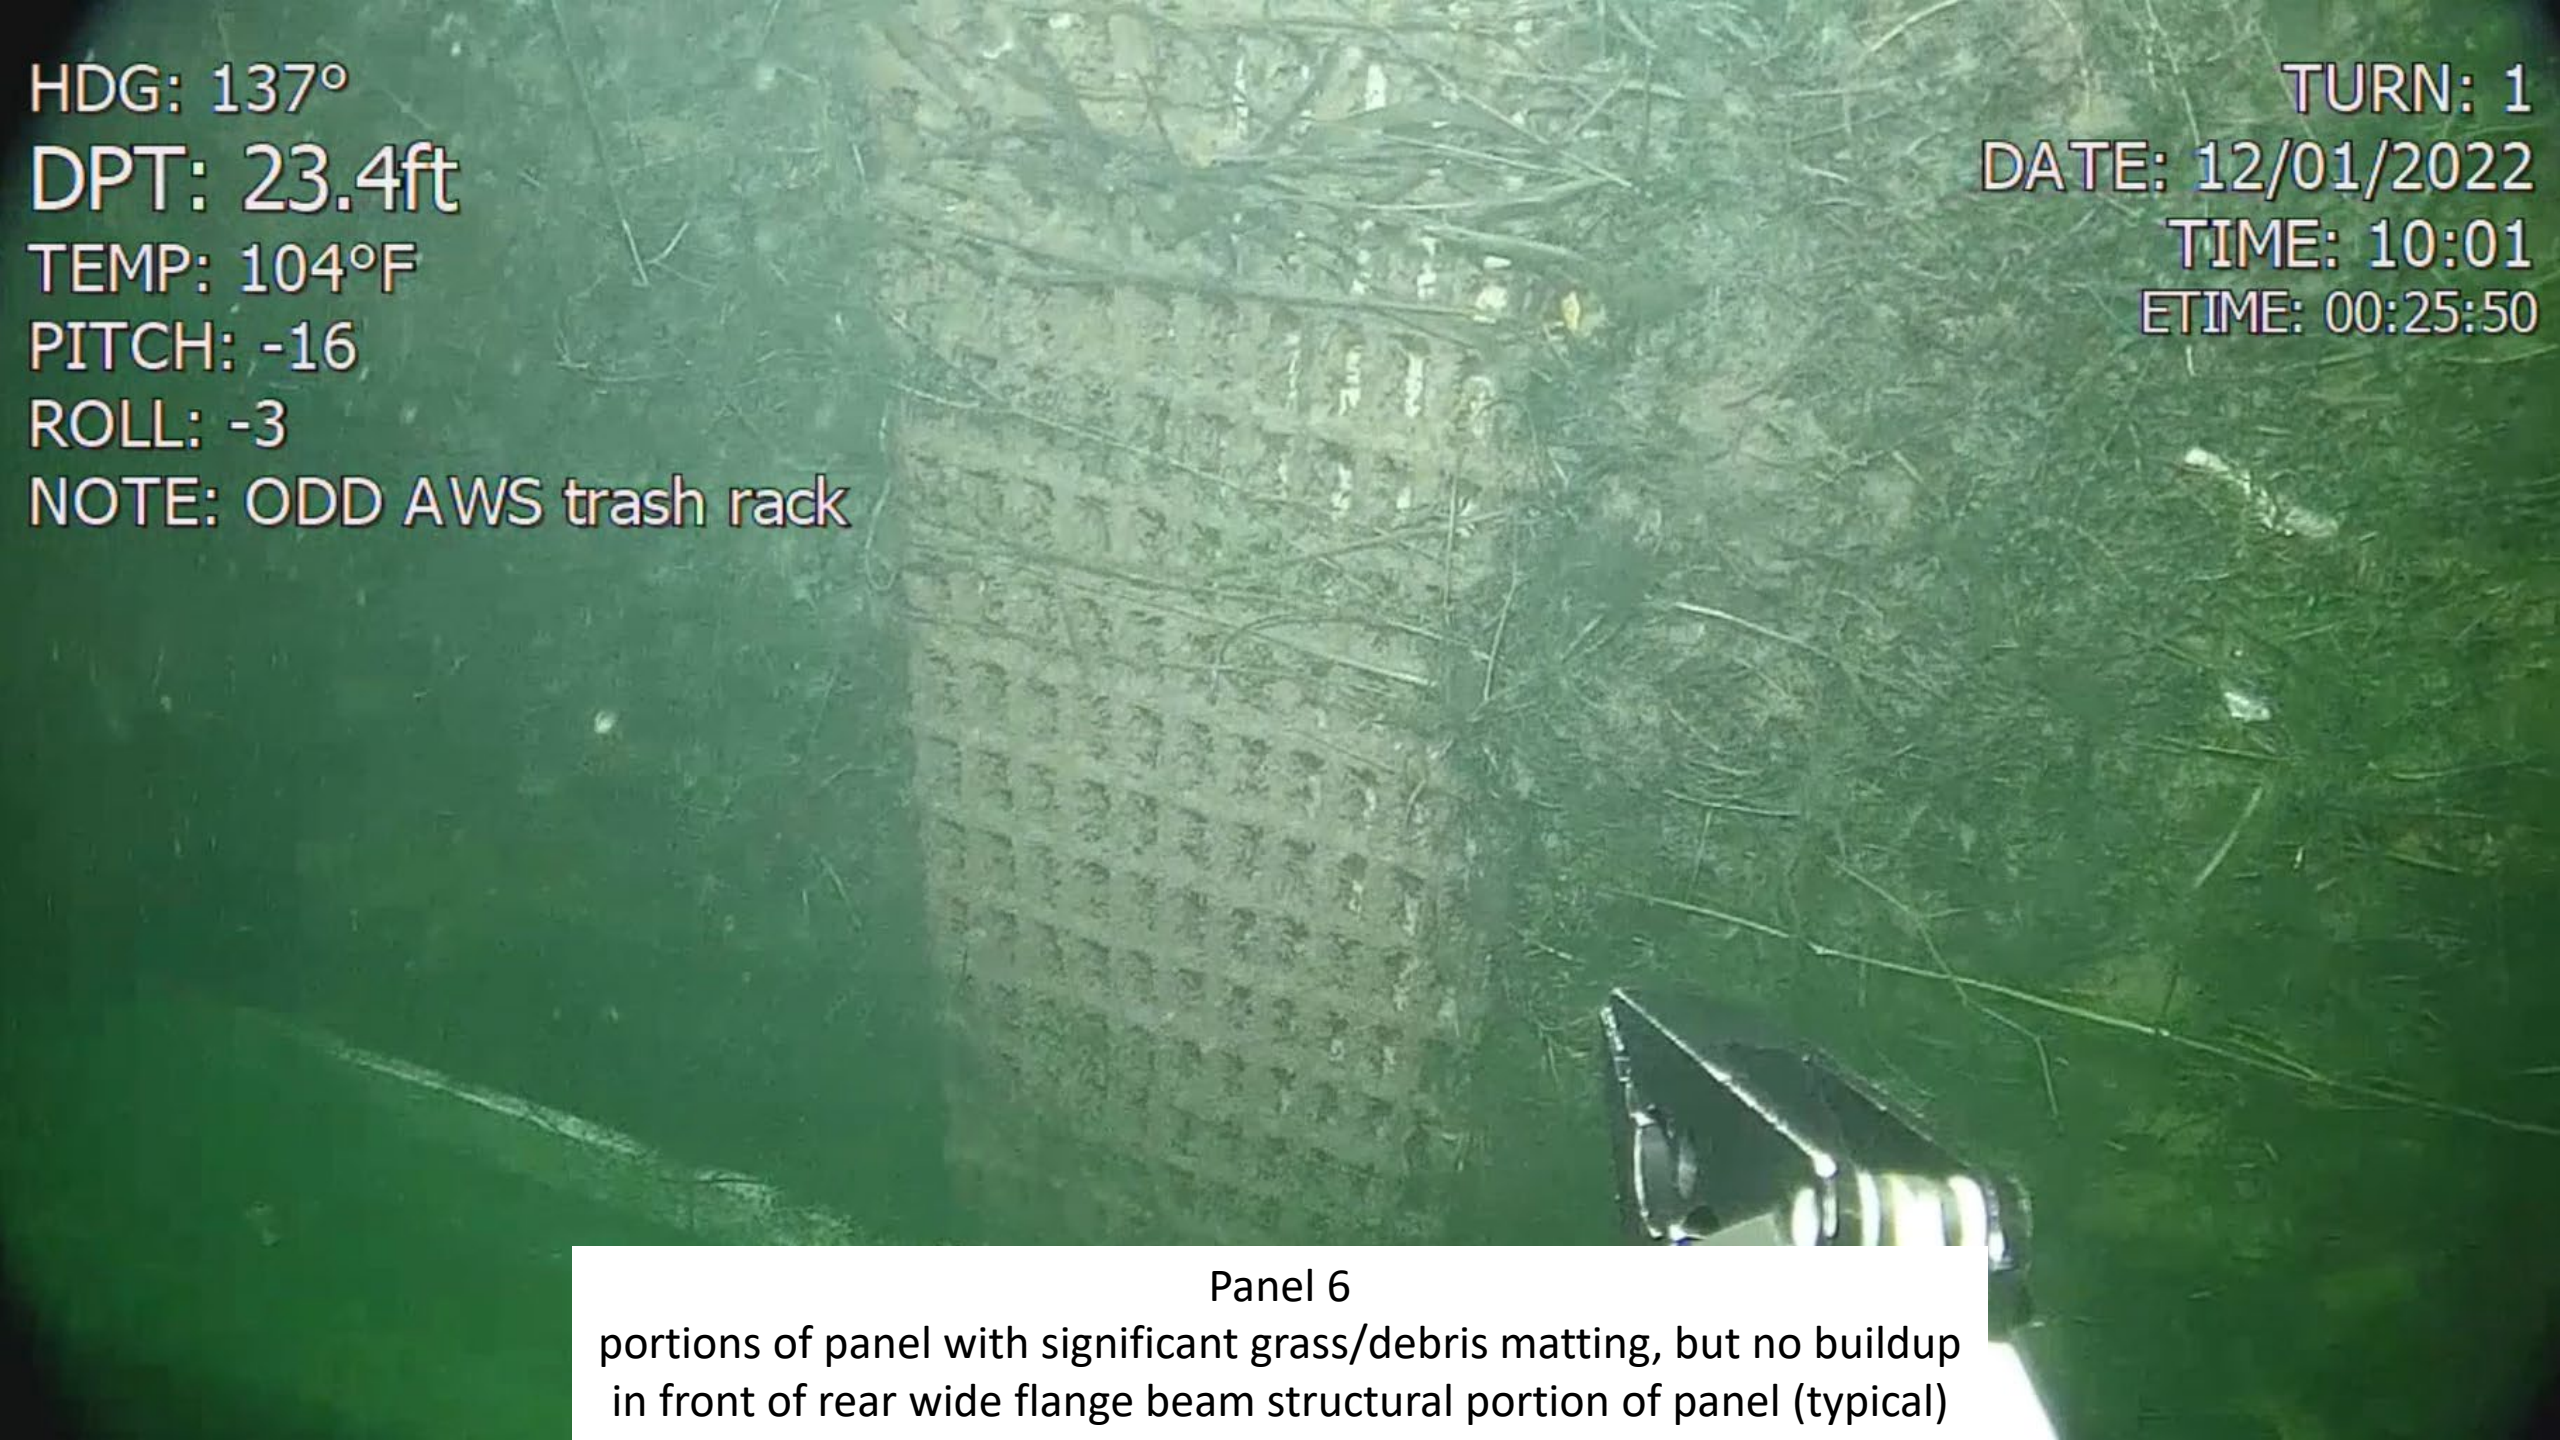
Panel 6
portions of panel with significant grass/debris matting, but no buildup
in front of rear wide flange beam structural portion of panel (typical)

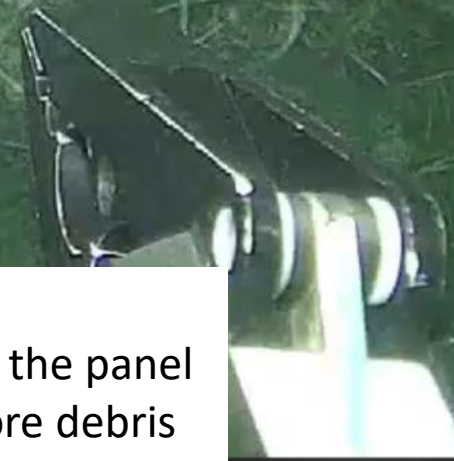
Panel 6

closeup of matted debris on right portion of the panel
right portion of panels typically showed more debris

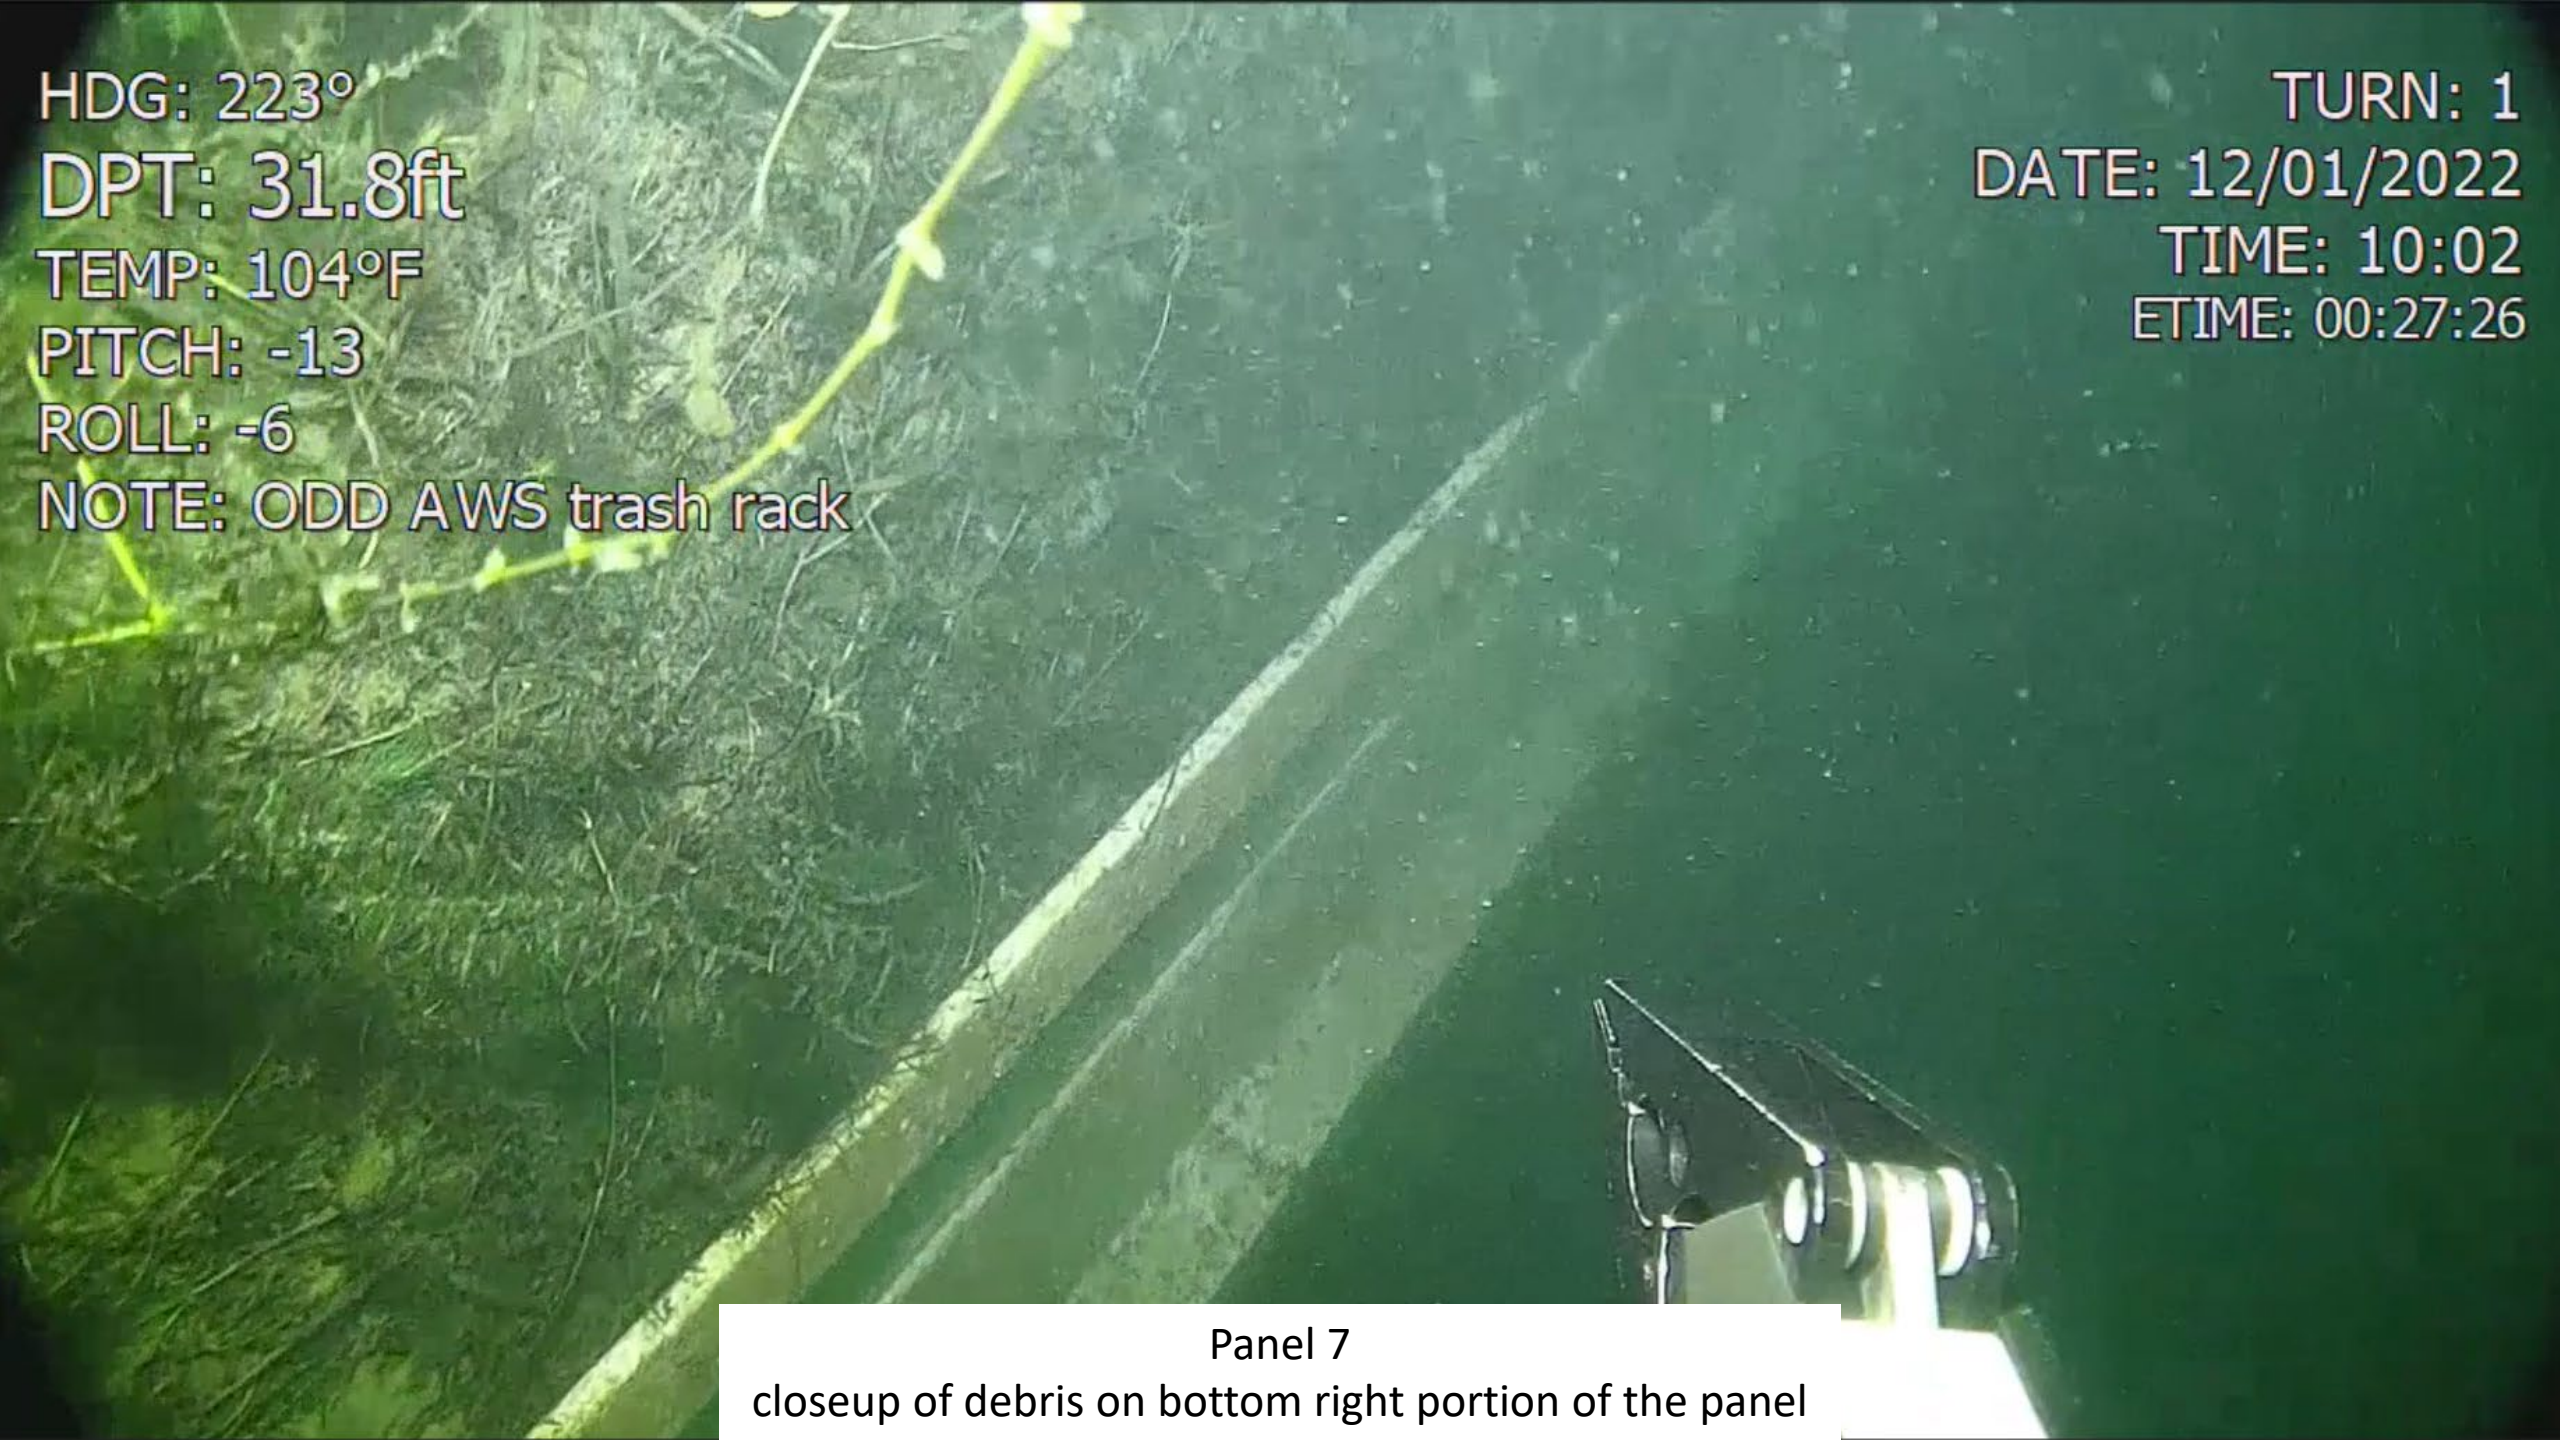
Panel 7

closeup of debris on bottom right portion of the panel

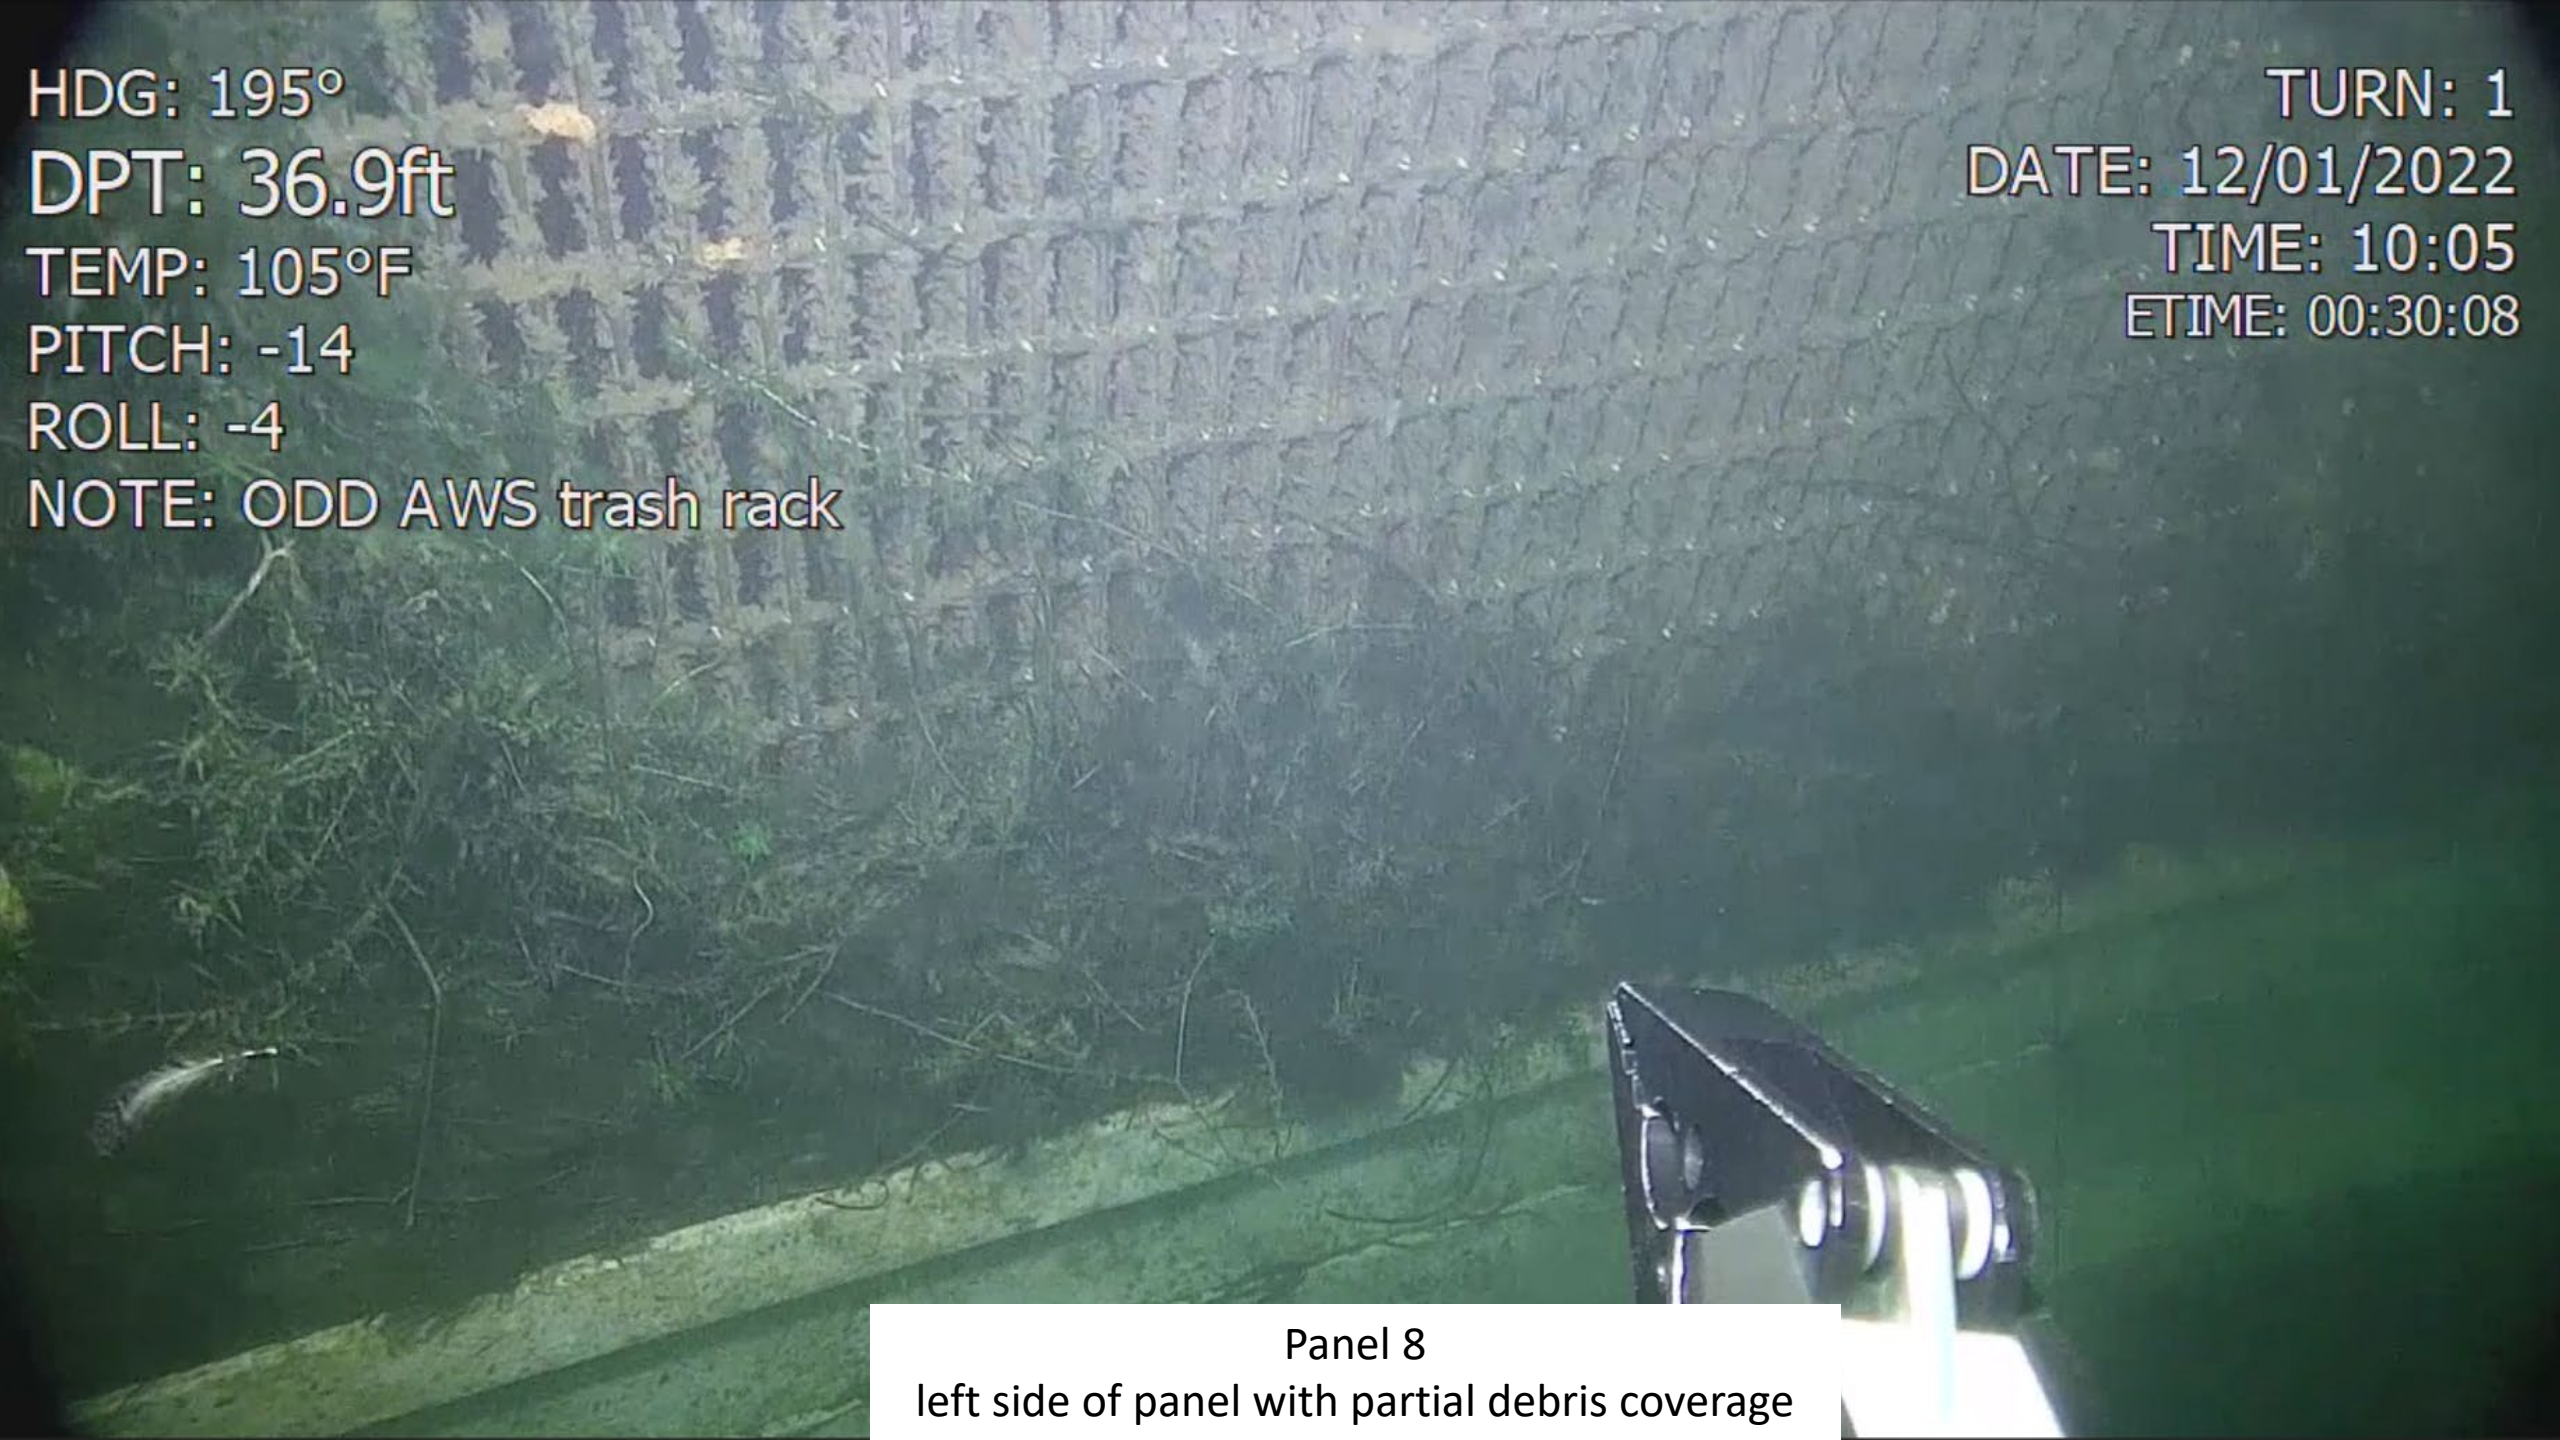
Panel 8
left side of panel with partial debris coverage

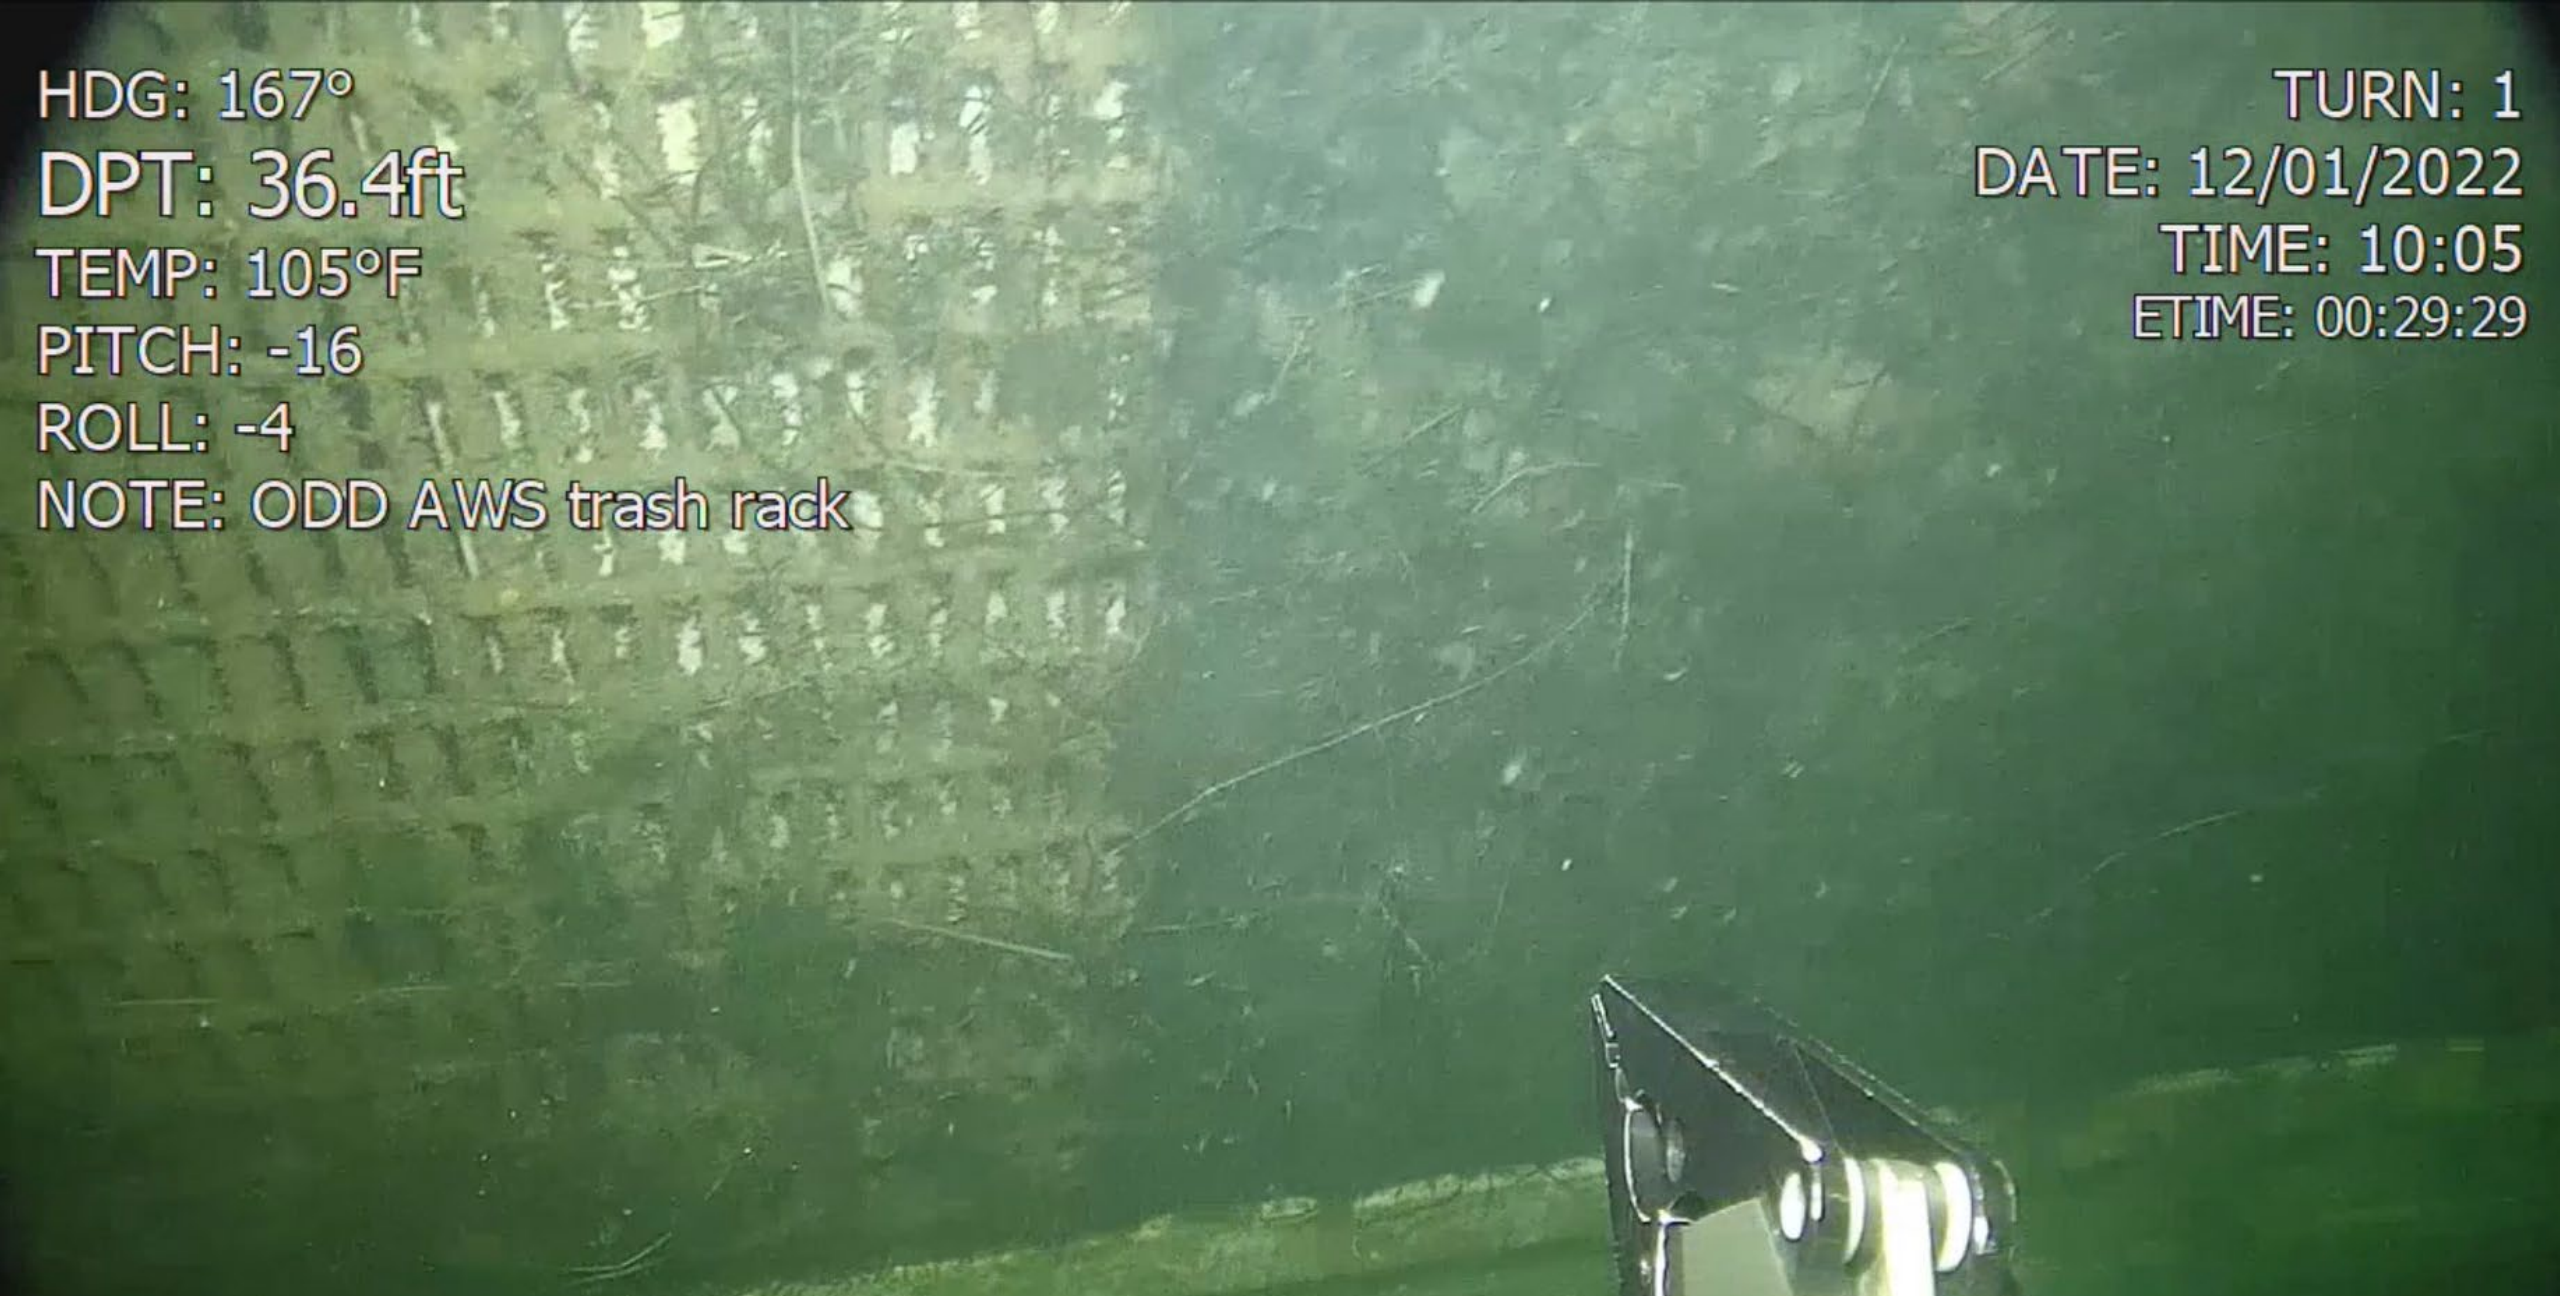
Panel 8

middle portion of panel with defined transition from no debris to full debris matting

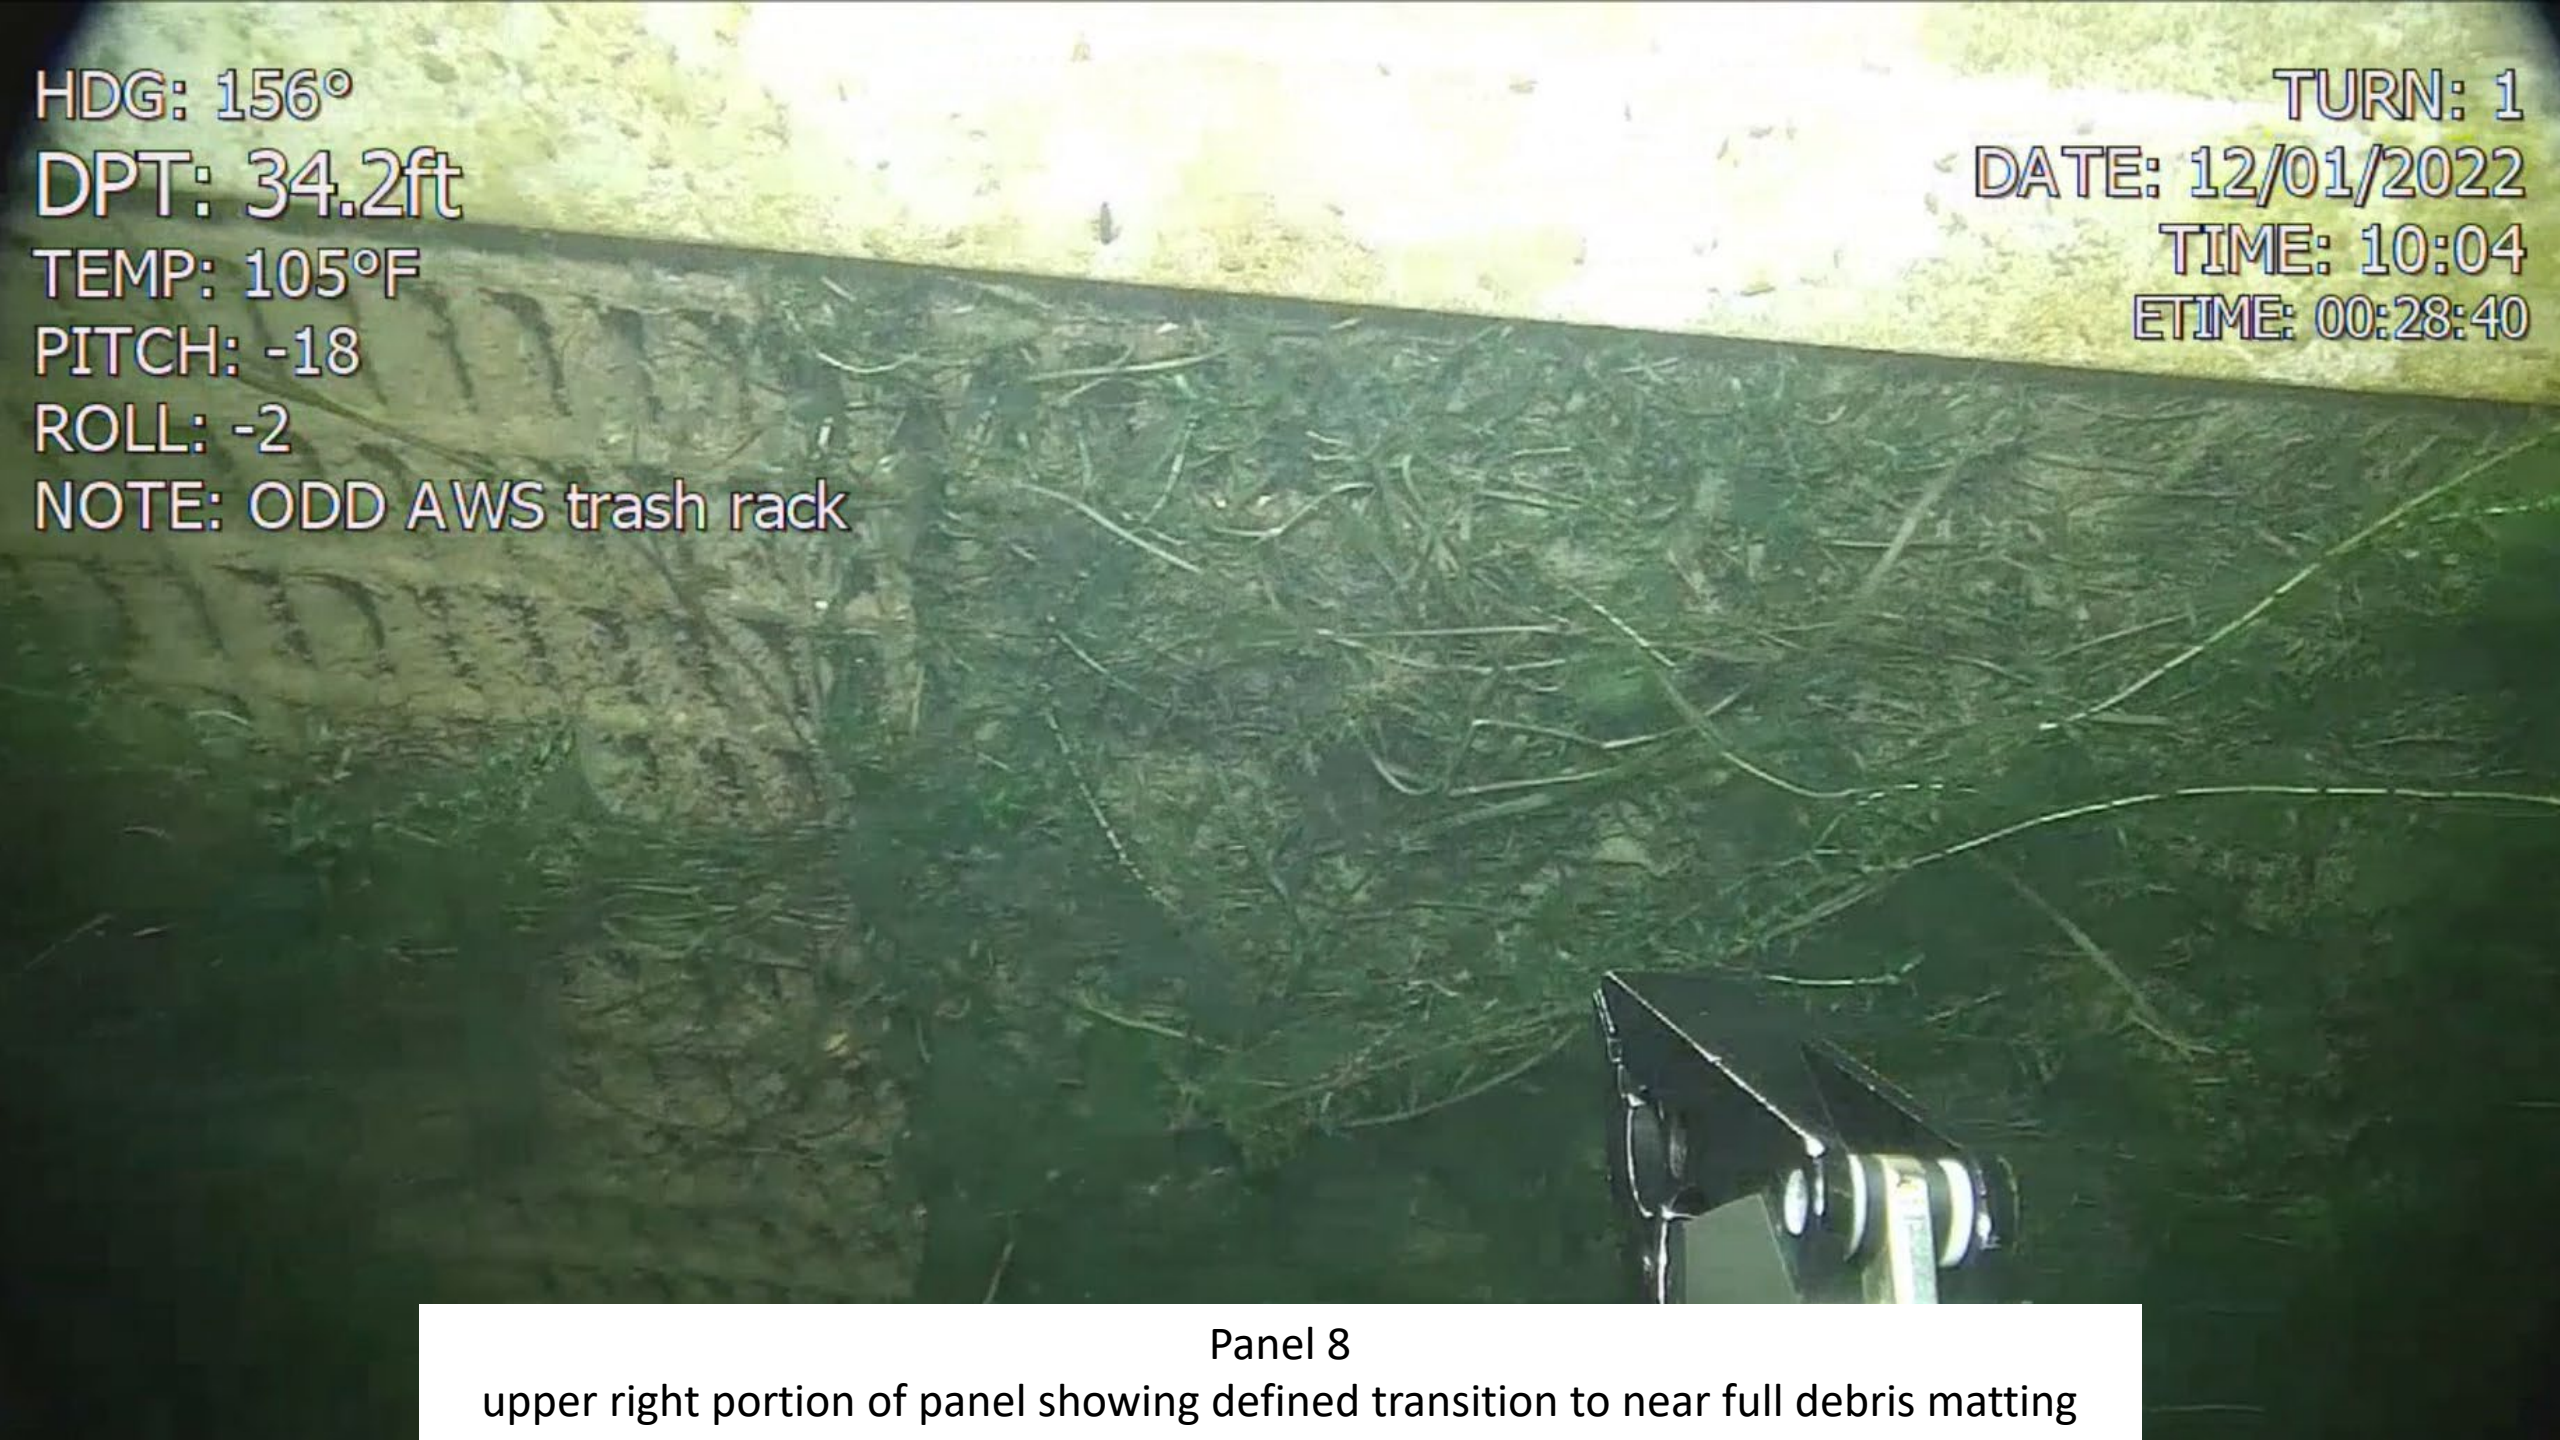
Panel 8

upper right portion of panel showing defined transition to near full debris matting

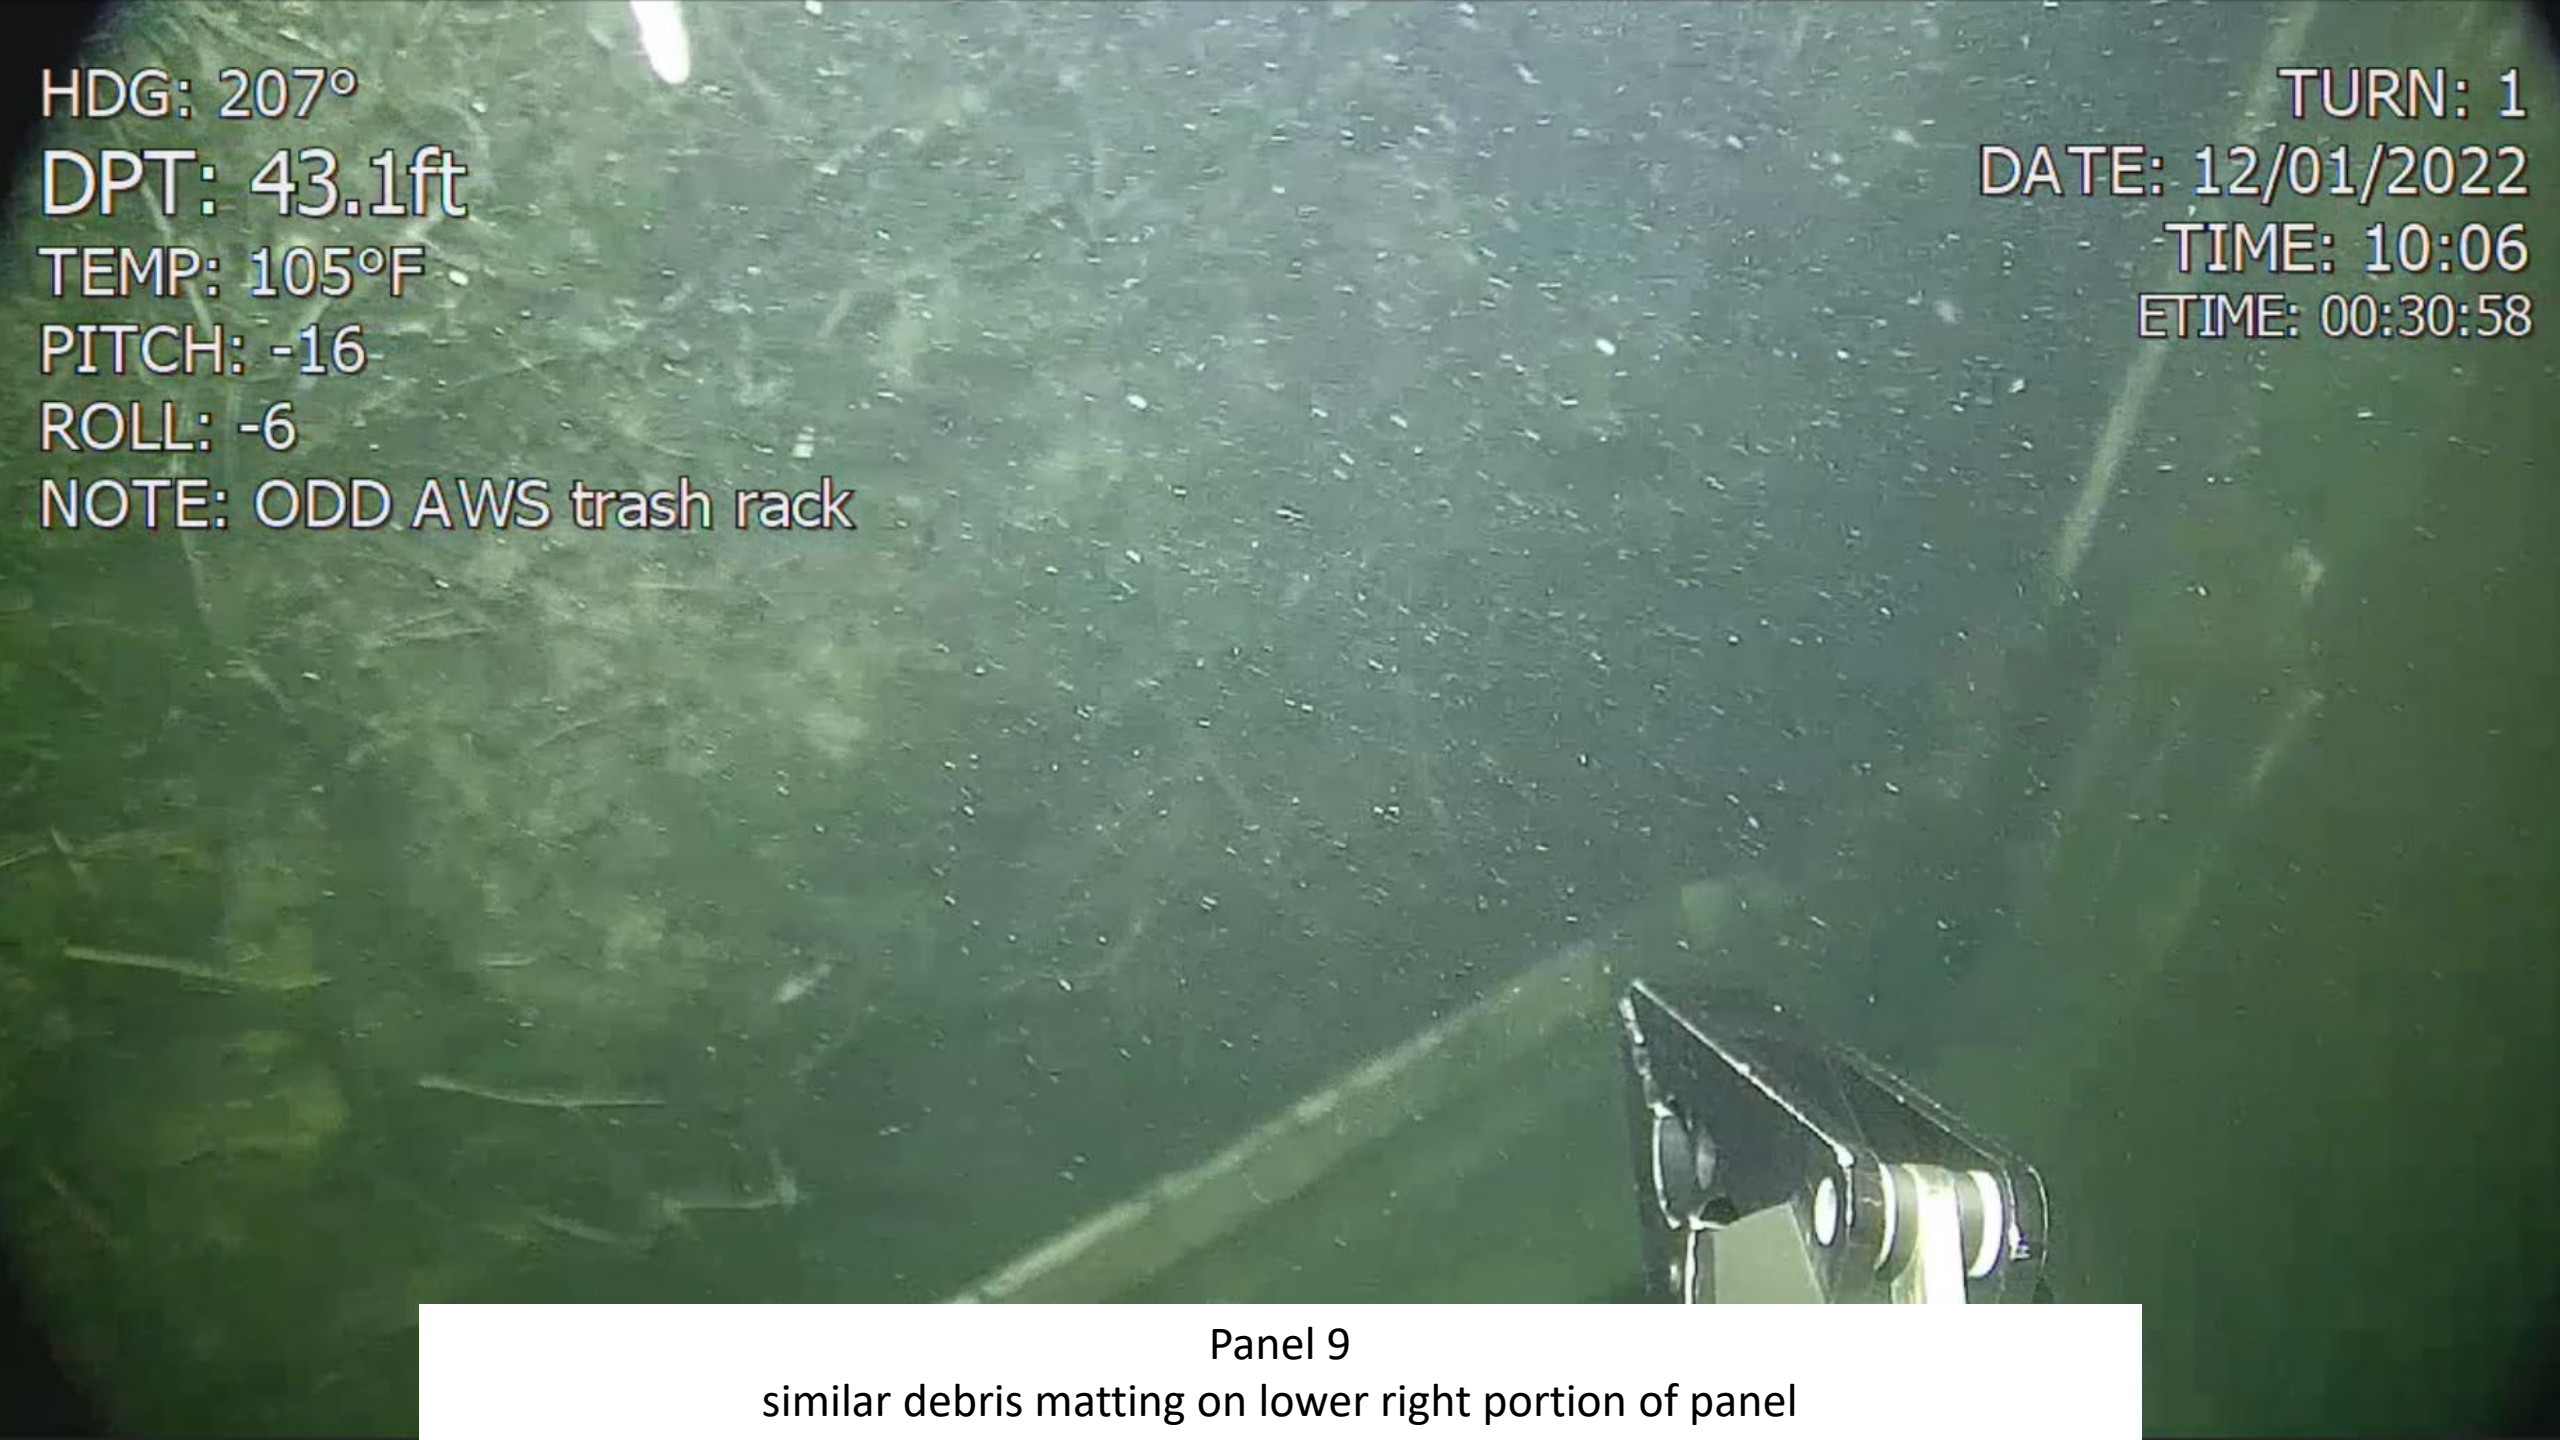
Panel 9

similar debris matting on lower right portion of panel
