Appendix 1

December 1st ROV Footage Analysis

Video Analysis of AWSBS Trashrack

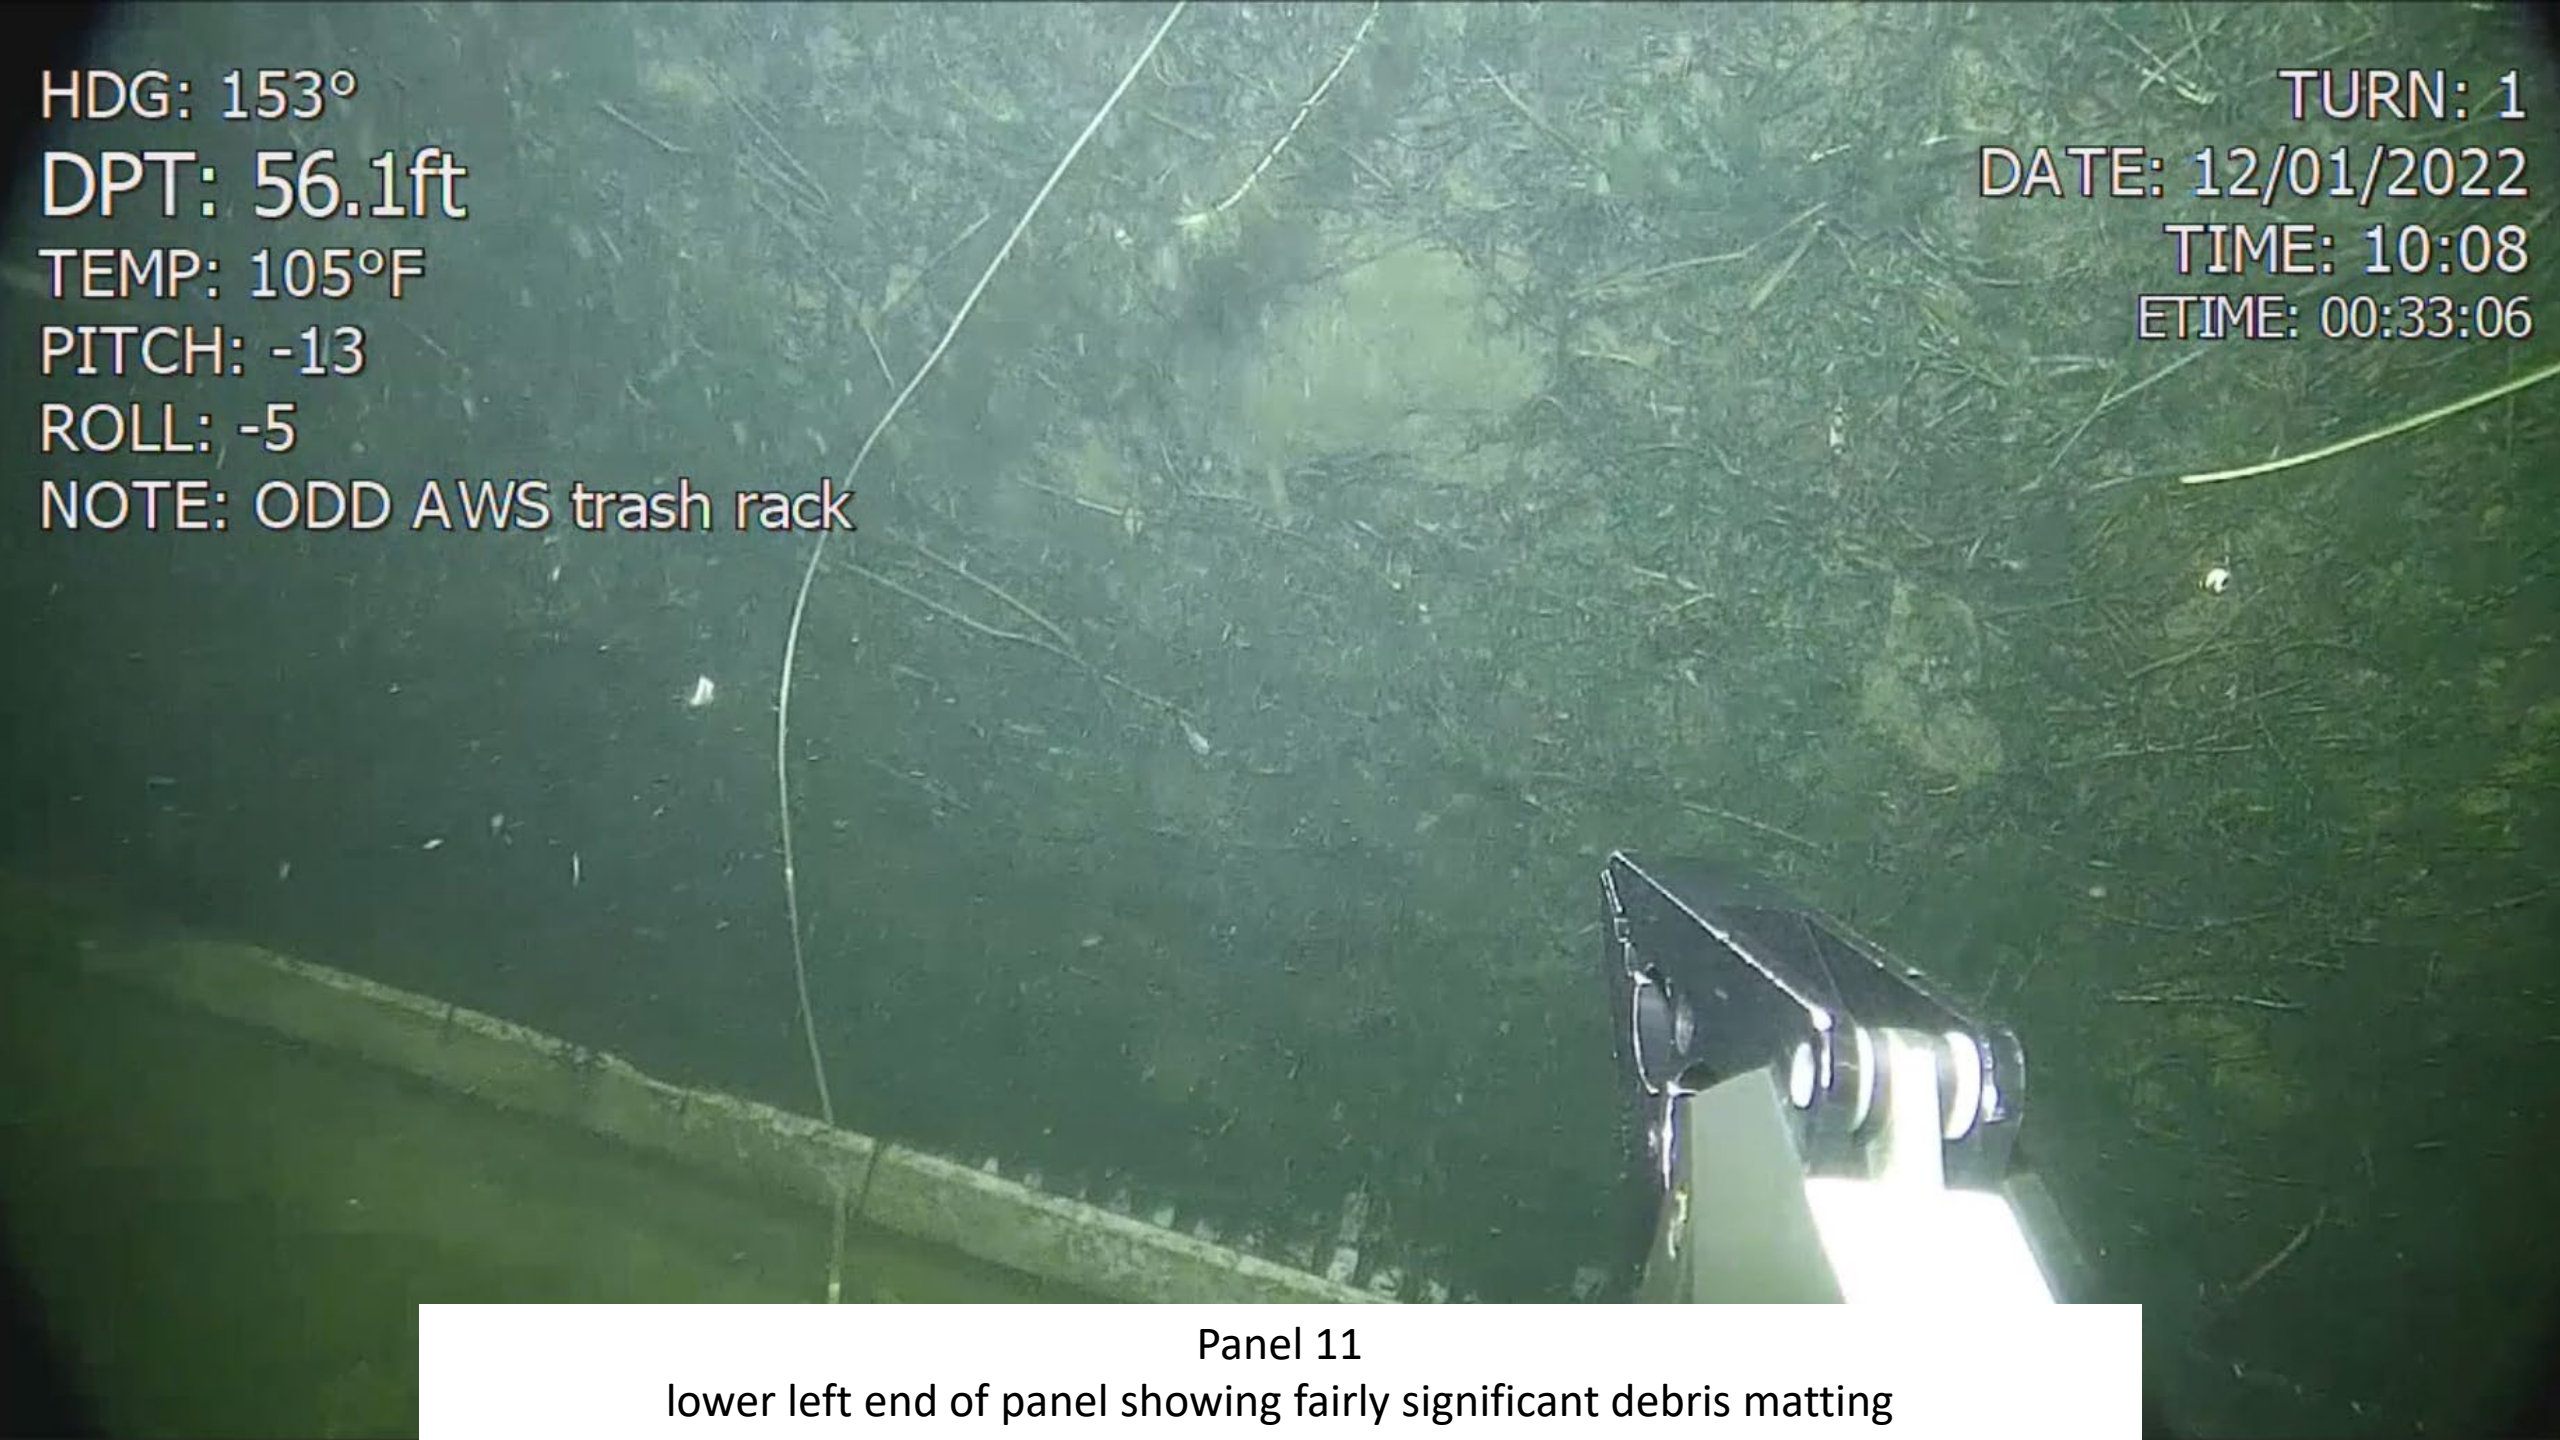
Panel 11

lower left end of panel showing fairly significant debris matting

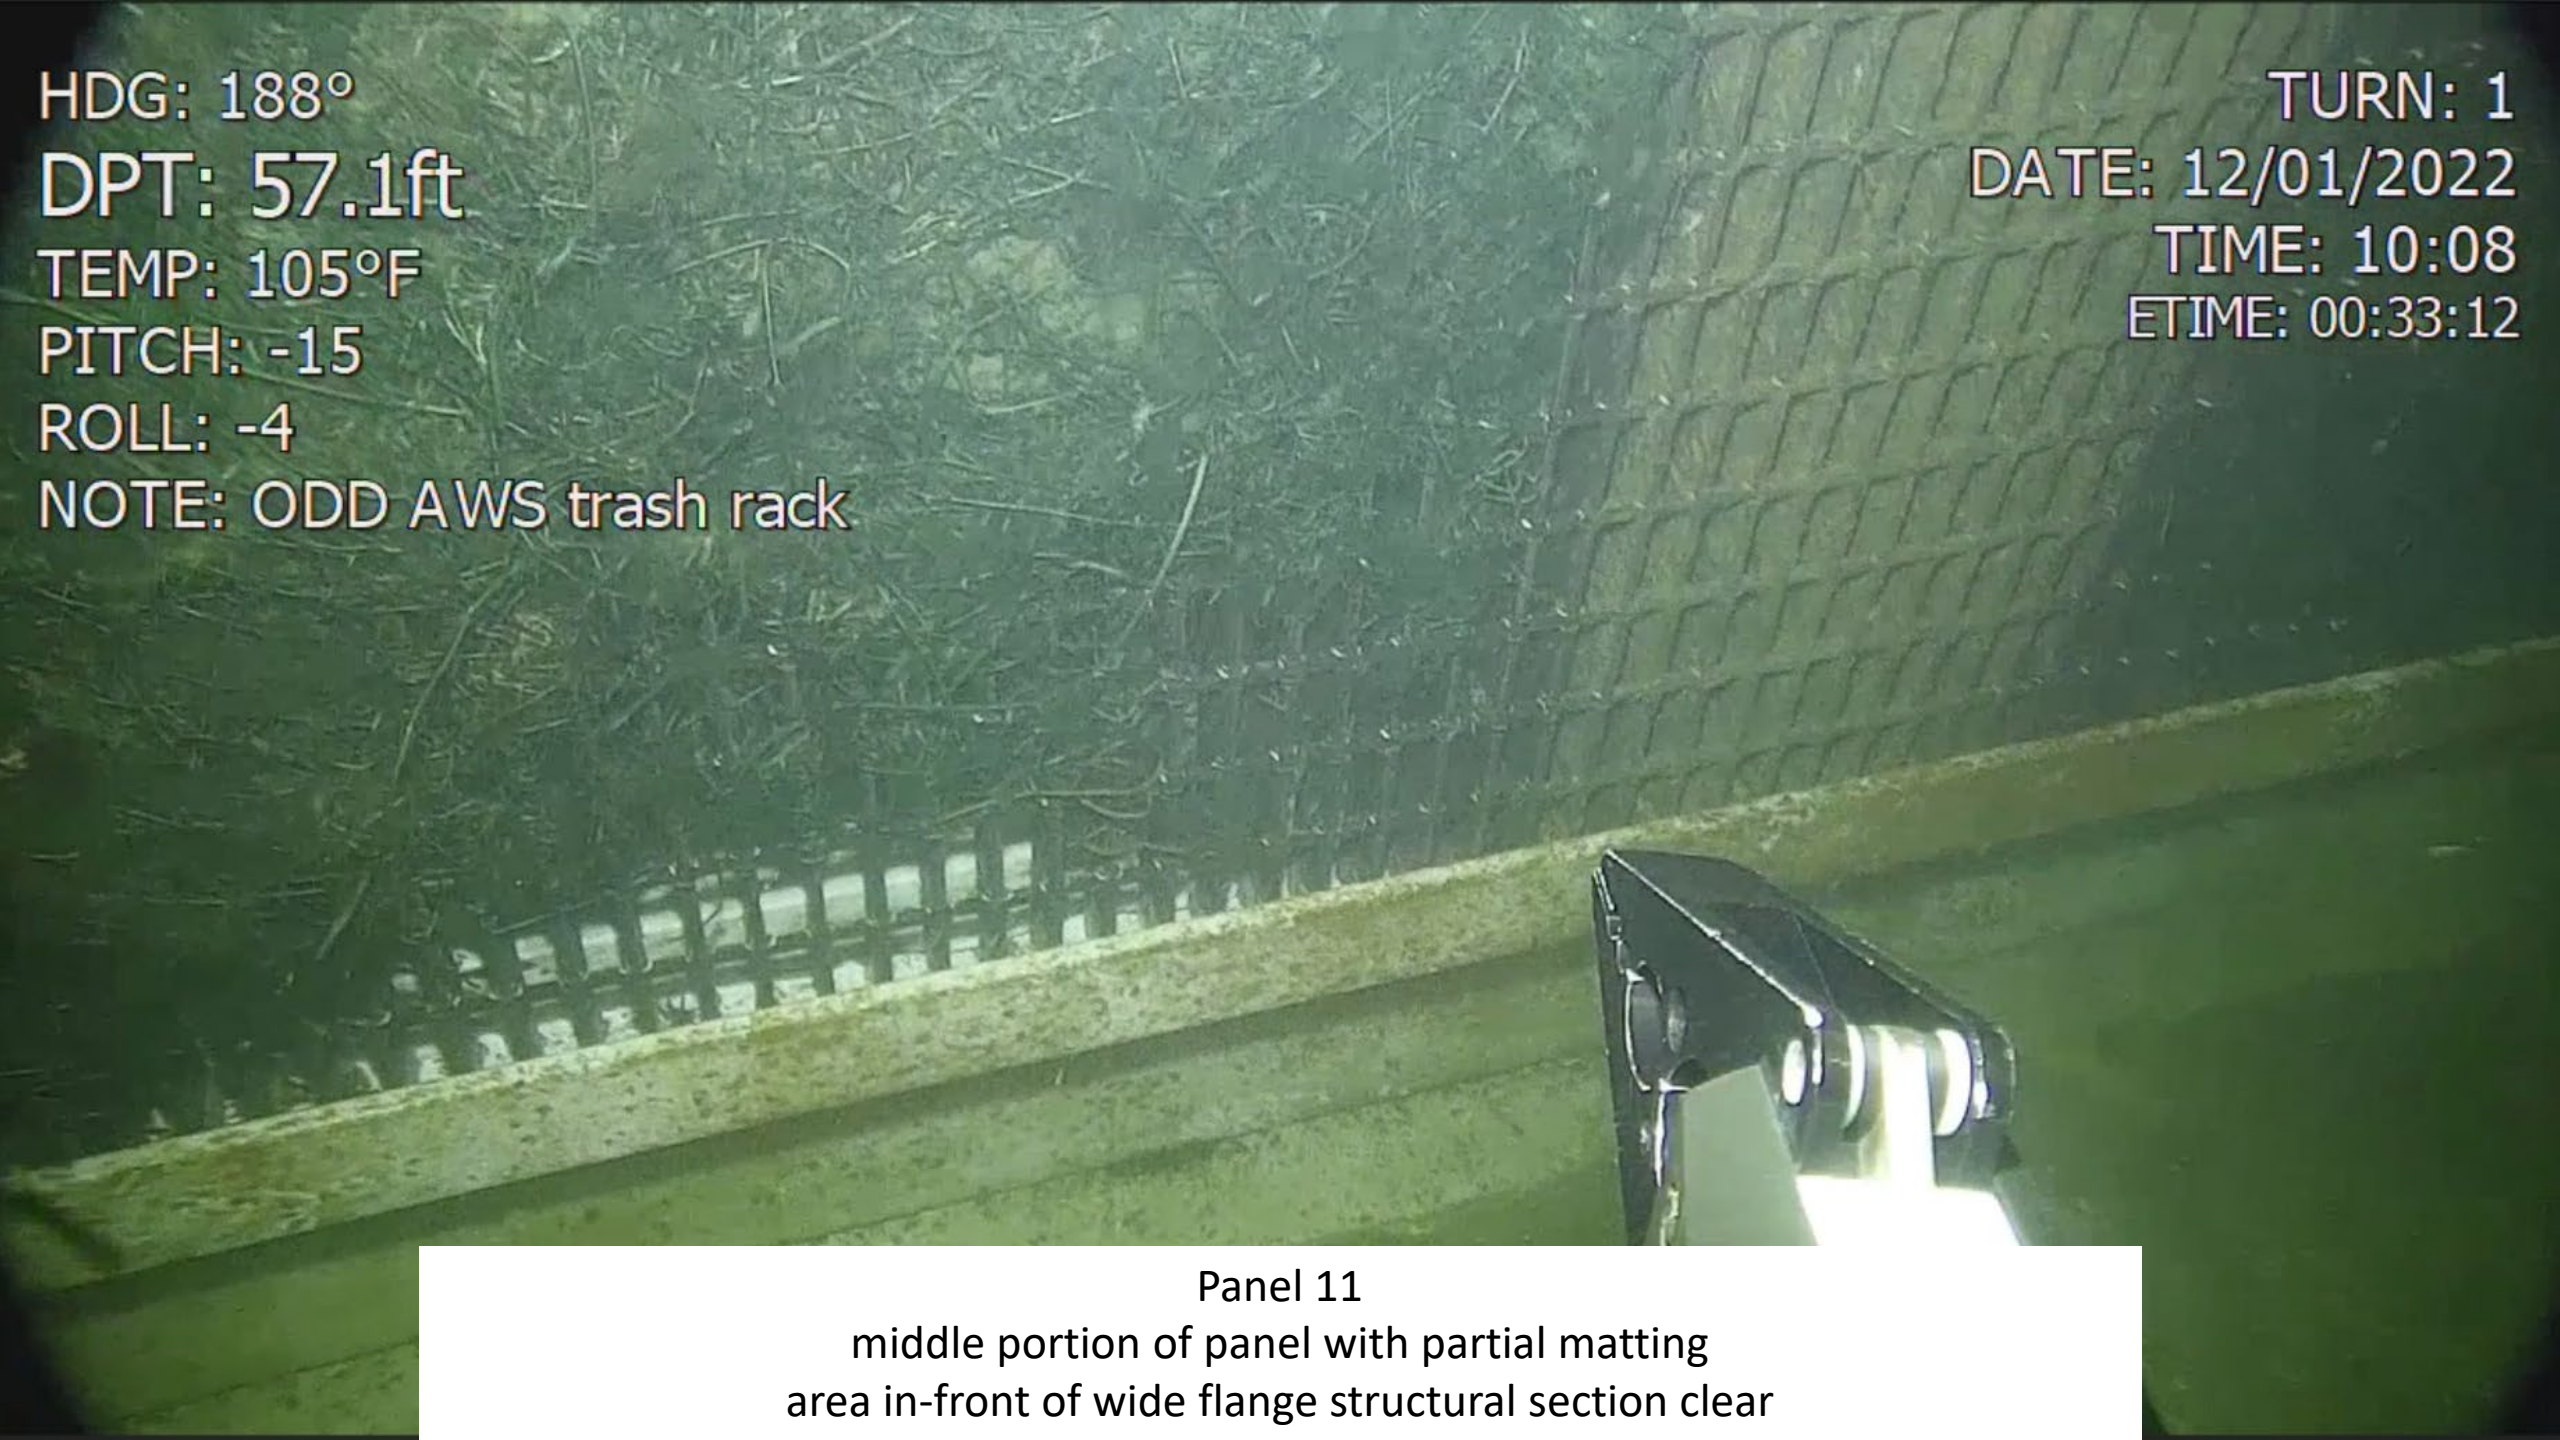
Panel 11

middle portion of panel with partial matting
area in-front of wide flange structural section clear
