MEMORANDUM FOR THE RECORD

SUBJECT: 13BON91 MFR Updated– Steelhead and Chinook jack mortalities at Bonneville’s Juvenile Monitoring Facility (JMF).

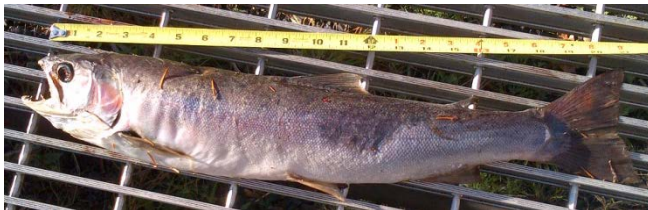
Photo 1. 21” unclipped steelhead.

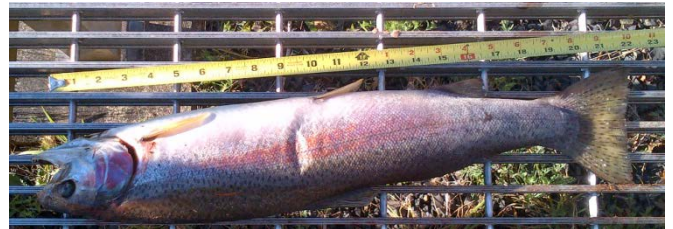
Photo 3. 22” clipped steelhead.

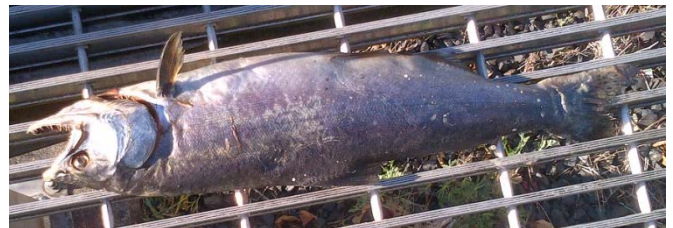
Photo 4. 18” unclipped Chinook jack.
