Bonneville Dam Adult Fish Facility Improvements
Fish Passage and Sample Equipment Improvements, 2011-2015

U.S. Army Corps of Engineers
Portland District
September 2015

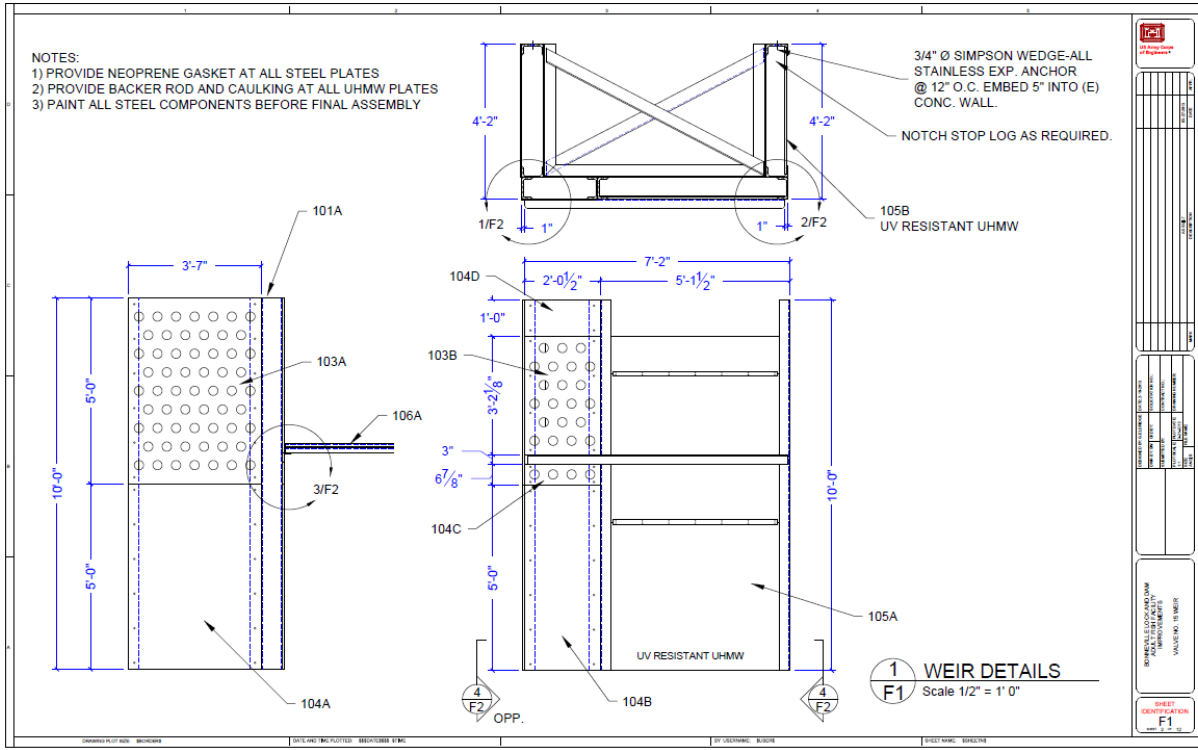
- A. Modifications to the drain valve 15 weir occurred to improve hydraulic flow distribution. Replaced 4.5 feet opening width of stoplog weirs (out of 12.5 feet total) with low porosity (3-inch holes at 20% porosity) perforation plate to distribute hydraulic flow along the entire water column (Figure 1). Replaced existing stoplog weirs with new members and added ultra high molecular weight polyethylene (UHMW) plate to minimize leakage. A new stoplog guide was added to divide the remaining 4.5 feet open section of the south weir and new 1.5-foot open section of porosity plate. The remaining sum open weir length is 7.5 feet, accounting for the guide. The remaining weir crests were raised 4 inches to reduce outflow.

Figure 1: Valve 15 weir details.

Hydraulic testing following installation showed insignificant reduction in velocities upstream of the valve 15 trashrack. The momentum of the high velocity jet, ~4.5 ft/s, coming off the 2-foot deep channel ledge was too strong to be influenced by the porosity plates. After conference with FFDRWG and FPOM subcommittee members, a new hydraulic improvement was developed. A prototype baffle was designed to be positioned in the surface flow and UHMW floor plates installed in the return pool.

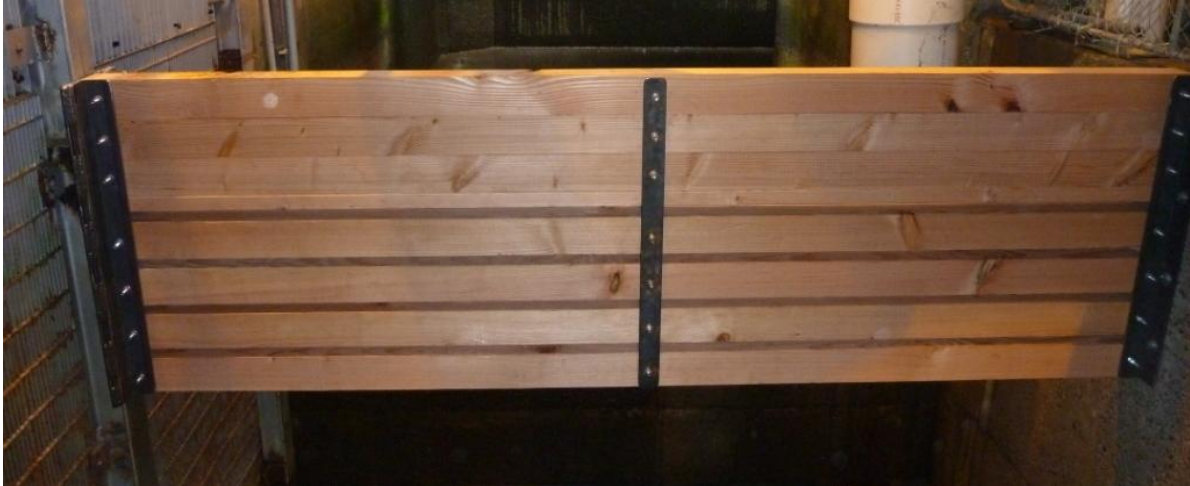
The baffle was secured across the channel perpendicular to flow and located above the recessed area outside the brail pool upstream of the brail pool exit. UHMW floor plating was installed at the bottom of the return pool to determine the best configuration to keep the velocities low in the return pool at the brail exit and reduce velocities in the upper water column at the trashrack (Figures 2 and 3). The baffle was set to 18 inches into the water (at nominal 5 feet flow depth) in 2013.

Figure 2: Baffle constructed in the AFF return pool looking upstream from the valve 15 trashrack.

After installation of the baffle and floor plating, velocity measurements upstream of the valve 15 trashrack showed improvement to the flow distribution through the water column. The average velocity just upstream from the valve 15 trashrack was reduced from 1.7 ft/s to 1.1 ft/s. Prior to the modifications, the velocity averaged of 2.8 ft/s at the surface and 0.7 ft/s at the bottom (range of velocities within 2.1 ft/s). With the 18-

inch deep baffle, the velocity distribution was reversed with an average of 0.5 ft/s in the top 1.5 feet of flow and an average 2.2 ft/s near the bottom (range reduced slightly to 1.7 ft/s).

The baffle successfully reduced surface velocities. However, the velocities near the floor were considered excessive suggesting that the UHMW plating on the grating floor of the return pool needed to be modified and the baffle depth might need to be reduced. During the following winter, prior to the 2014 season, roughly one-third of the plating was removed and the baffle depth was investigated to help mitigate the high bottom velocities.

- K. Continued improvement of velocity distribution in the return pool upstream of the trashrack for permanent configuration:
 - a) The baffle was raised from 18-inches to 10 inches deep (nominal flow depth = 5 feet) to reduce the velocities on the bottom and improve uniformity of velocities throughout the water column.
 - b) Replace the prototype wooden baffle with a permanent fixture.
 - c) Due to the still-elevated velocities at the bottom of the valve 15 trashrack, a portion of floor plating to improve hydraulics in the return pool was to be removed. The combination of the baffle and new floor plating scheme was predicted to lower the velocity upstream of the valve 15 trashrack in the lower depths.

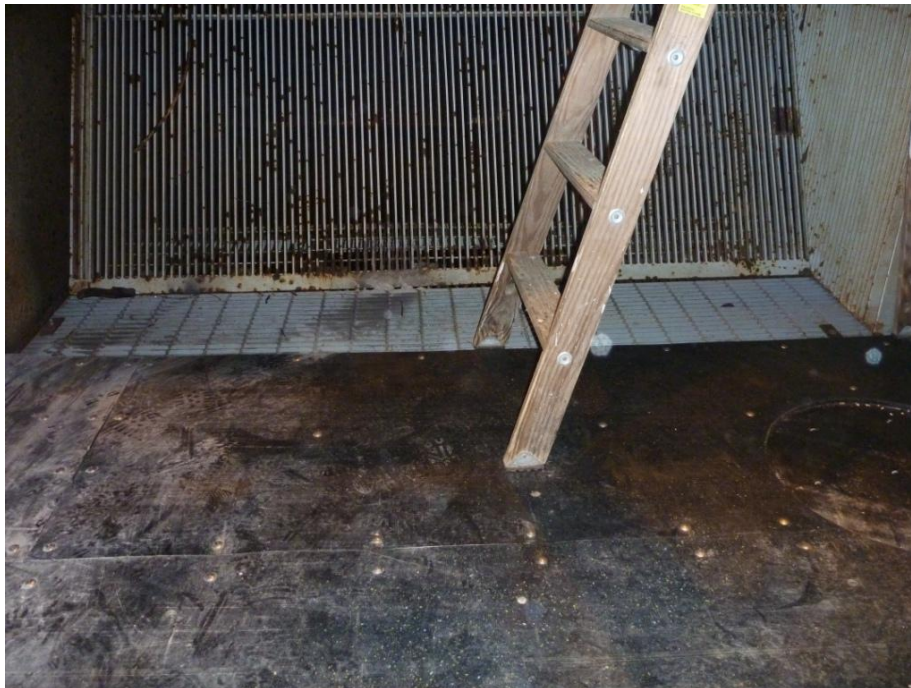
Figure 3: UHMW floor plating fastened to the return pool floor grating

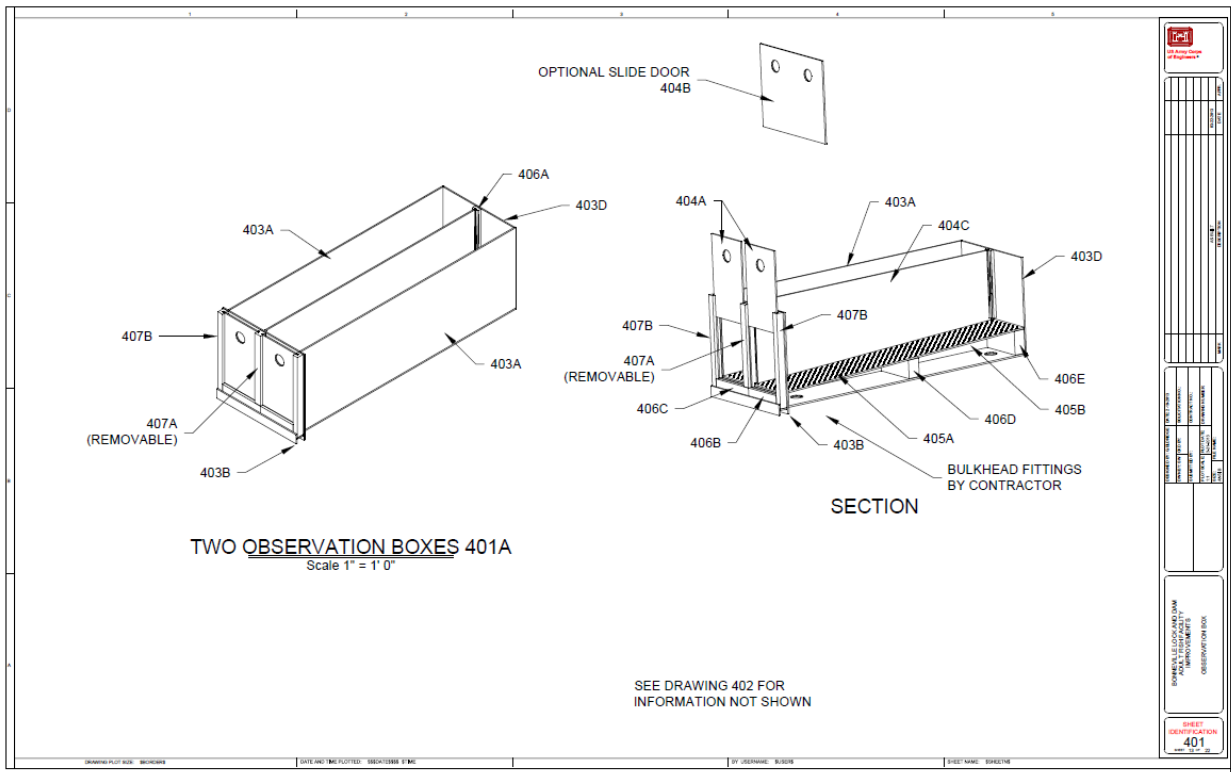
B. Two “hands on” recovery tanks were constructed to hold up to four fish for duration of 20-30 minutes as a transition for sample fish between the anesthesia tank and the brail pool (Figure 4). This allows fish greater recovery time from anesthesia, lest fish that struggle to do so become more susceptible to impingement on the valve 15 trash rack. Researchers also have the opportunity and ease to physically help a recovering fish if needed as the ability to recapture them, without the use of a cumbersome and potentially damaging net, was unavailable with direct release to the brail pool. Only one tank was installed along the south wall due to space limitations (Figure 5). The other tank is being stored onsite.

Figure 4: Observation and recovery tank detail.

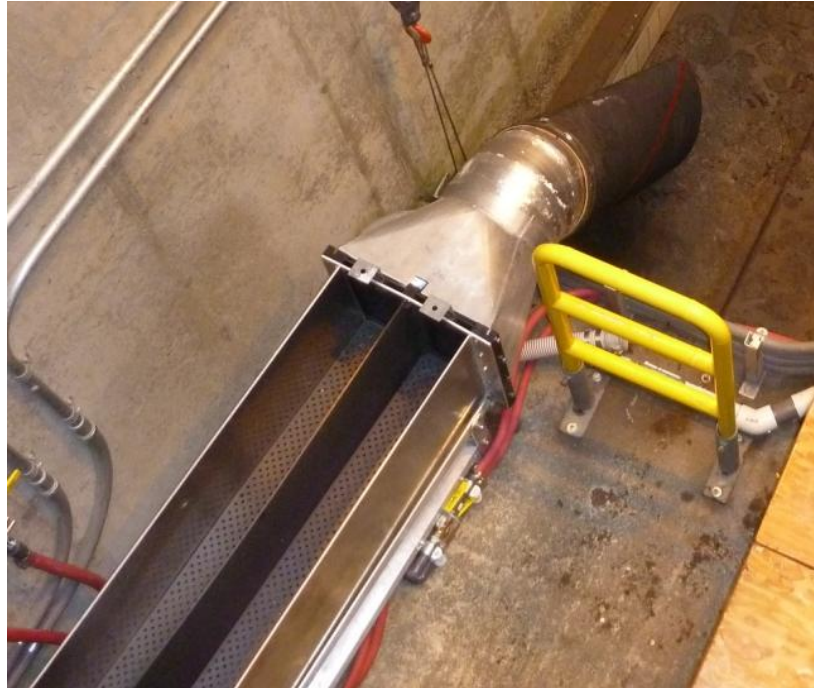
Figure 5: Observation and recovery tank with exit chute to brail pool.

CRITFC researchers reported the addition of anesthetic recovery tank worked well and continued to be used with no plans for significant modifications other than replacing the center divider with stiffer aluminum in 2014.

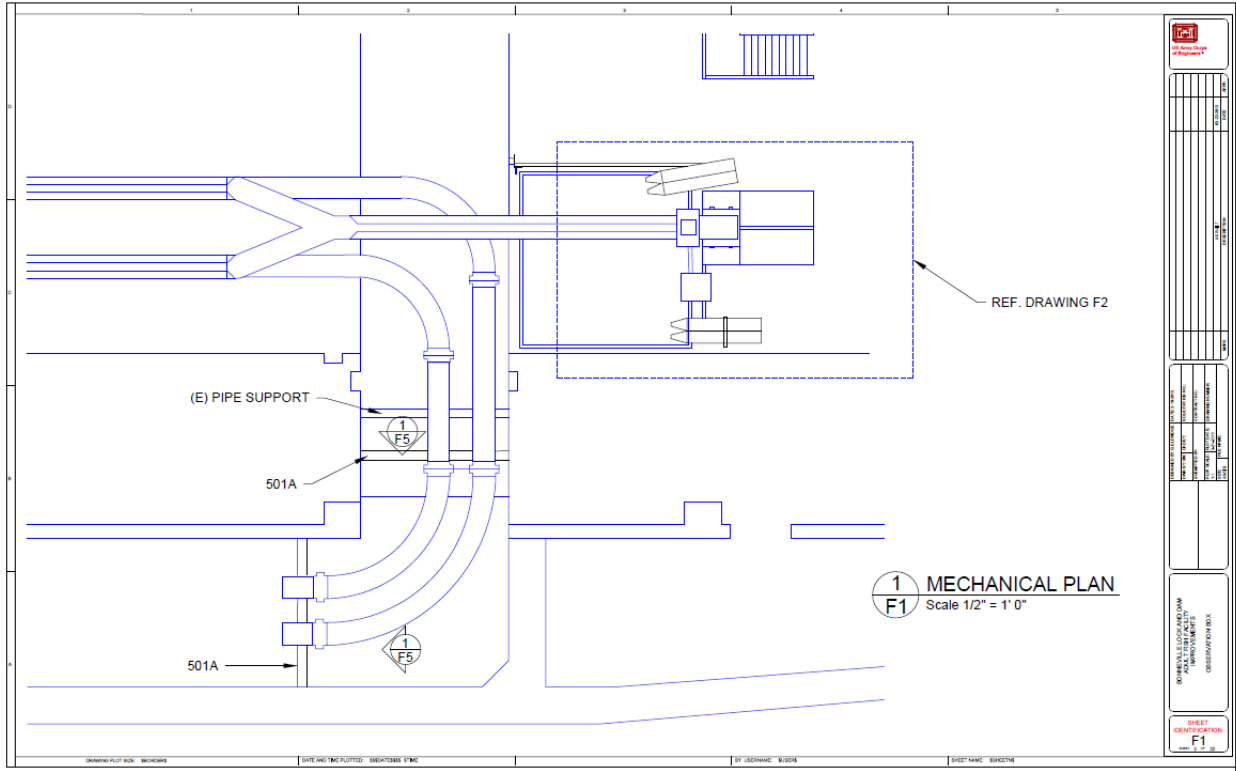
- C. The existing 14" diameter bypass pipes were extended approximately 30 feet at 10% slope with a bend around the corner in the exit channel to increase the distance between the point of fish entry and the valve 15 trashrack allowing the fish more time to orient in swift flow (Figure 6 and 7). The drop between invert and water level in exit channel was reduced to about six inches.

Figure 6: Plan view bypass flume modifications.

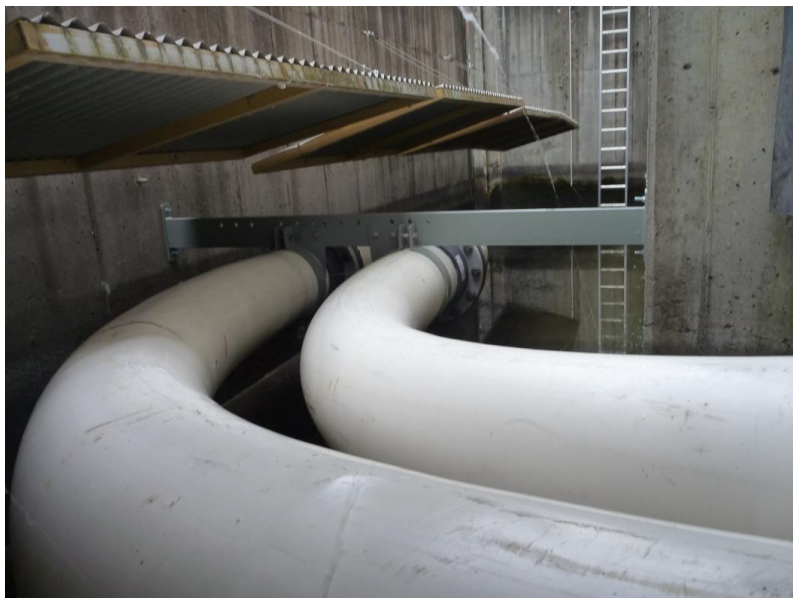
Figure 7: Extended bypass pipes outside the lab following installation.

CRITFC researchers and Bonneville Dam (BON) project biologists reported during the spring of 2013 that the newly installed bypass pipes invert elevation was at the water

line and fish were not exiting as intended resulting in holding, thrashing, and potential injury near the end of the bypass pipe. Mortalities continued to be retrieved from the valve 15 trashrack. The decision was made to remove the bypass pipe extensions in-season on June 17, 2013 and return the exit location inside of the lab. Reconnecting the pipe extensions was discussed at the end of the 2013 season but were not modified and installed for the following reasons:

As agreed upon at the February 5, 2015 FFDRWG meeting, the bypass pipes will remain removed but will be stored onsite should future evaluations deem them necessary.

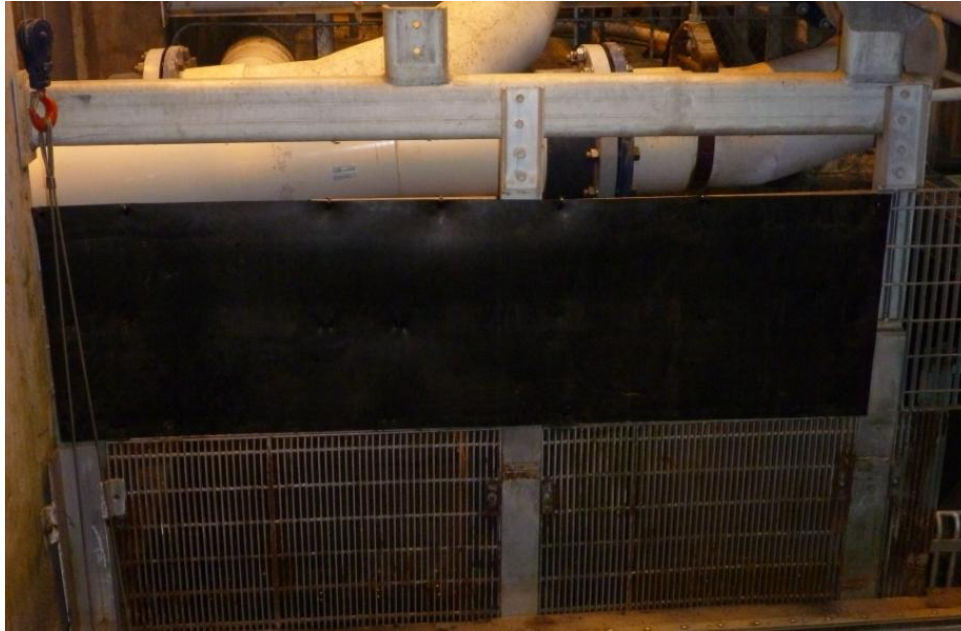
F. Added a neoprene panel to upper brail pool fencing to minimize fish injury should they jump (Figure 8).

Figure 8: Brail pool fencing with new neoprene panel.

The neoprene added to the upper brail pool fencing to minimize fish injury was a preventative measure with no reporting of problems by researchers. The modification remains in place.

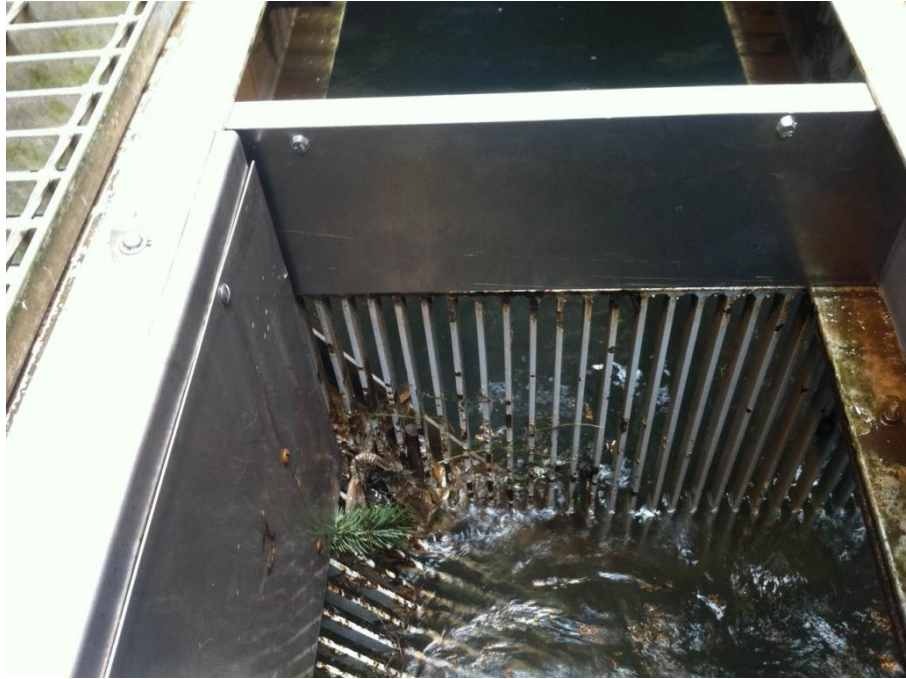
- H. Trash raking conditions were improved to allow researchers to safely and efficiently reach mortalities through the water column to the bottom of the valve 15 trashrack.
 - a) Better access was provided by enlarging the access hatch in the floor grating and removal of the splash shield on the lamprey test flume.
 - b) Provided longer-handled, user-friendly rake.
 - c) Installed staff gauge indicator next to trashracks to measure water level in response to debris loading.
 - d) Improved transition from trashrack to walkway grating to make fish removal easier and more efficient (Figure 9); the added plating also

Figure 9: Improved raking transition from trashrack to walkway grating.

The enlarged access, new rake, and plating placed above the valve 15 trashrack grating improved raking conditions and the researchers are successfully cleaning the valve 15 trashrack. In addition, closing down the valve 15 drain increases the water levels in the facility; the plating prevents fish from swimming over the trashrack and becoming trapped in the area behind the trashrack. The modifications for cleaning are safer and more efficient so no further changes are deemed necessary.

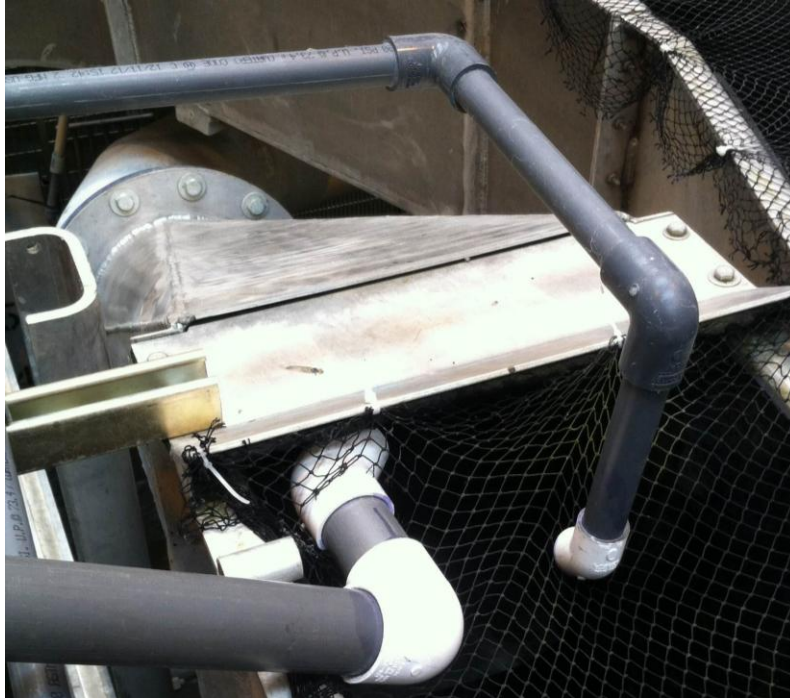
- I. A large water supply increase was added to the north bypass pipe in an attempt to reduce the ability of fish to swim upstream if the pipes were re-connected and routed outside the lab (Figure 10).

Figure 10: Additional water supply to north bypass flume (larger left pipe).

The water supply was increased to the north bypass flume at the switch gate. It has been difficult to quantify how much benefit the additional water has been for improved passage through the pipe with the pipe exit location inside the lab. It was determined that reconnecting the pipes would not occur in 2014 due to the results from 2013 and reasons identified in Section 4.C.

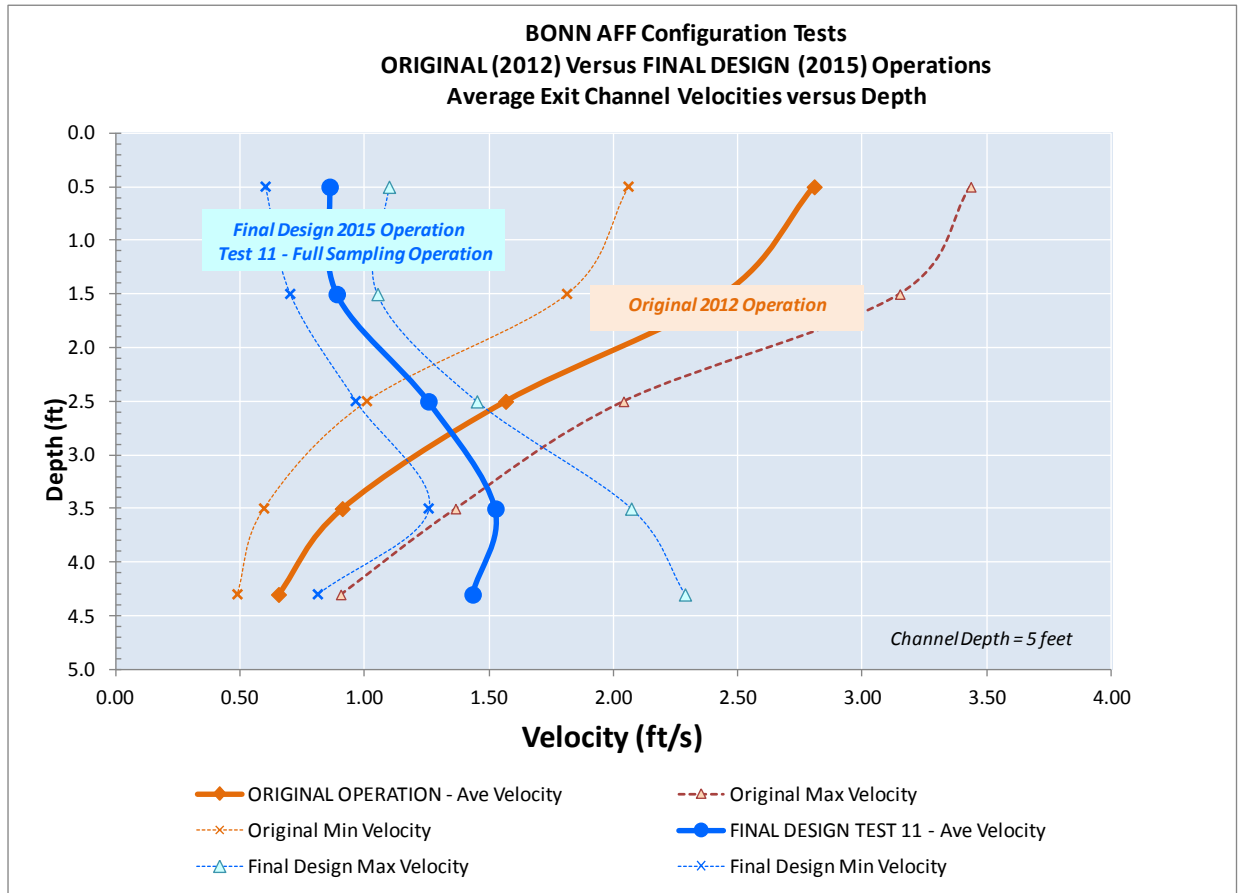
A comparative graph showing the velocity versus depth in the deep section of the Exit Channel is shown in Figure 11. The comparison is between the original operation (Table 3 - brown) and final design full sampling operation (Table 3 – blue, Test 11). The heavy lines in Figure 11 represent average velocities. Maximum and minimums are shown in

the dashed lines. Aside from a reduction in average velocity from 1.7 to 1.2 ft/s, the salient result is that the location of maximum velocity has been shifted from top to bottom.

Figure 11 – Comparison of Velocities versus Depth in Final Design (Test 11) and Original Operations

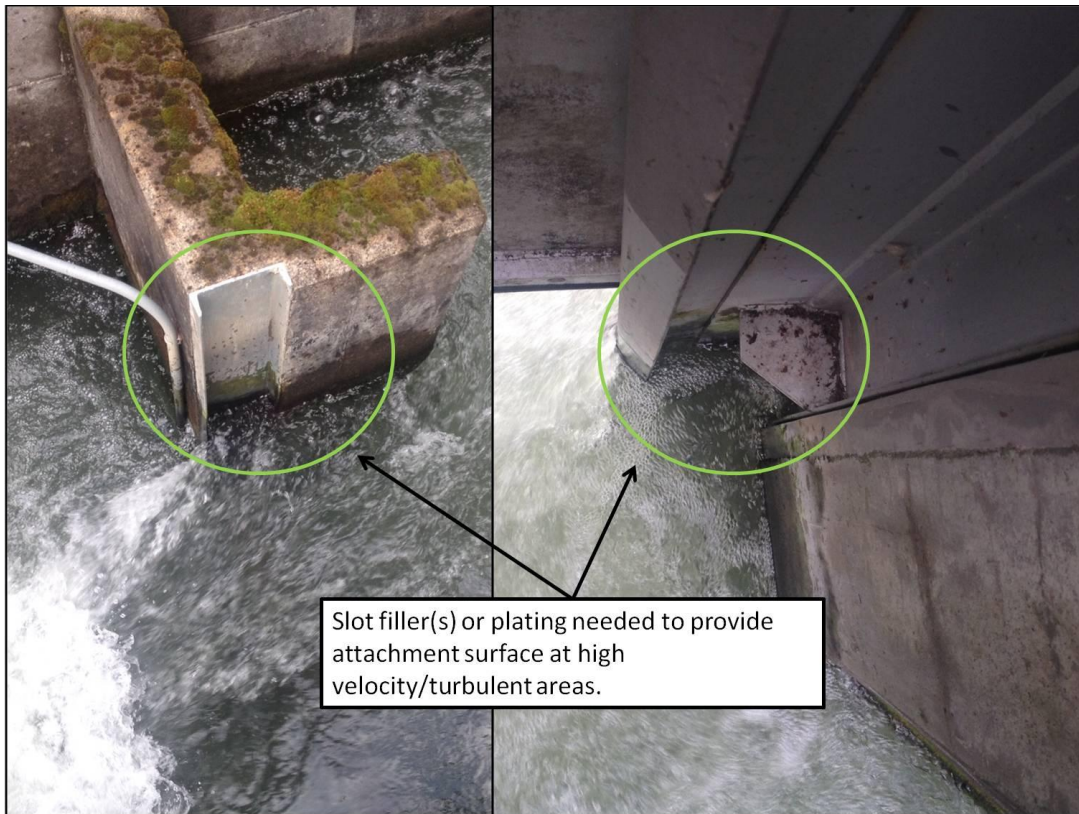
Figure 12 shows the bulkhead guide slot and the irregular shaped framework at the water surface. These locations are located in swift flow and present challenging attachment surfaces during upstream movement such as sharp angles and narrow edges.

Figure 12 – Bulkhead guide slot (left) and irregular shaped frame (right).

Lamprey passage and condition may be improved by modifying the structures identified in Section 7 to aid ease of migration. The Lamprey Minor Mods PDT has included these locations in their draft scope. Upstream movement during the bypass operation, downstream movement as a result of impediments to passage, or milling behavior may result in fish continuing to enter the return pool area. Mortality may continue to be observed at this location for the same reasons as salmon. Lamprey mortality will be evaluated following any additional AFF modifications in the future.
