**OFFICIAL COORDINATION REQUEST FOR
NON-ROUTINE OPERATIONS AND MAINTENANCE**

COORDINATION TITLE- 16BON02
COORDINATION DATE- 25 January 2016
PROJECT- Bonneville Dam
RESPONSE DATE- 11 February 2016

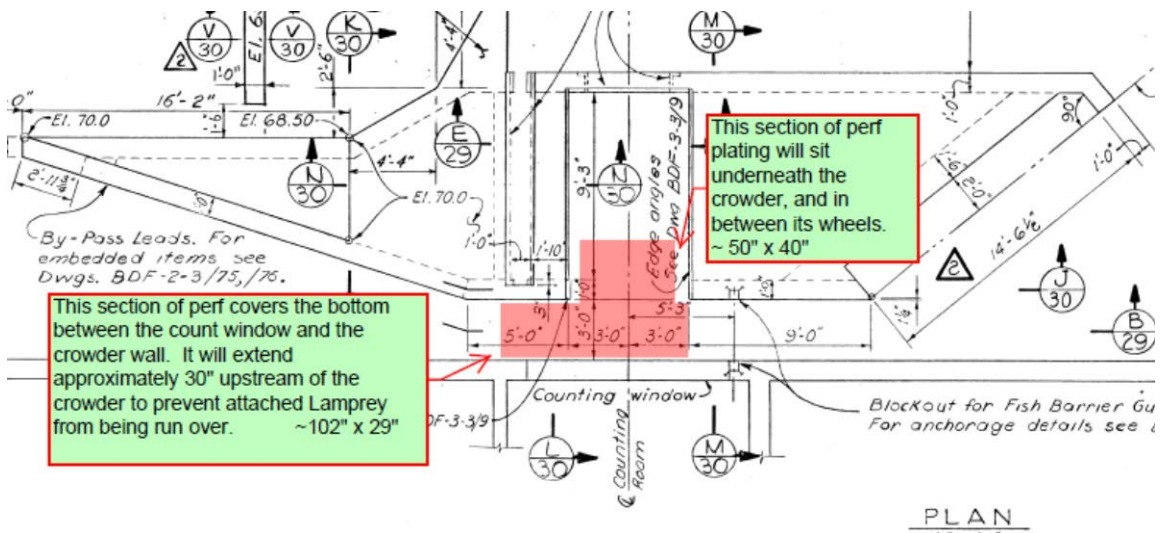
Description of the problem- The crowder at Bonneville’s Bradford Island Count Station has a gap of approximately 1.5” underneath it. The crowder is cycled through its range daily and operated by the counters on an as-needed basis during passage season. Lamprey have regularly been observed suctioned to the ladder floor immediately in front of the crowder. They then get run over by it during routine crowder operations, causing injury or death. Smaller lamprey have a tendency to wiggle under the crowder and then get trapped in the area behind it. In addition to injuring lamprey, fish counters report that lamprey suctioned to the ladder floor in the crowder area interfere with their ability to count accurately.

Figure 1. Area where the Bradford Island count station modifications will be occurring.

To address these issues, we are in the process of installing perforated aluminum plating to the bottom of the fishway in front of the crowder and a rubber strip to the bottom of the front of the crowder (Figures 1 and 2). The plating (1/8” thick, 1/8” holes staggered at 3/16”) prevents lamprey from being able to suction to the bottom. Thus they will have to swim through the counter window area, ameliorating the counting issue and preventing lamprey from laying in the path of the crowder. The rubber strip will prevent lamprey from getting underneath the crowder. It will be cut from ~1/2” thick heavy duty rubber, will be bolted to the front bottom of the crowder using rounded top bolts (same as those used on the rest of the front of the crowder) to avoid any sharp edges. The ends of the strip will be rounded off, also to avoid sharp edges. It will sit flush on the perf plating. All perf plating edges will be rounded or beveled.

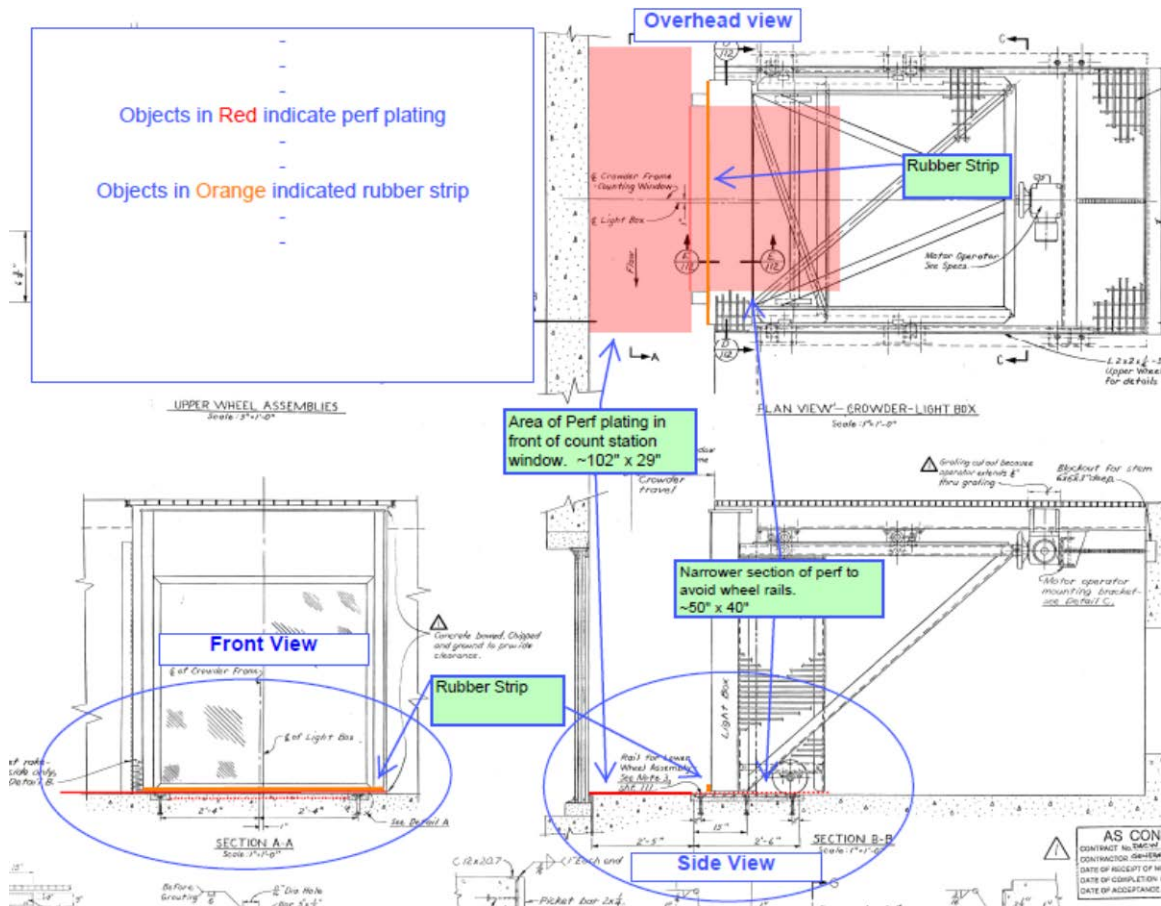
Figure 2: Close-up view of the proposed count station modifications.

Recommend small holes with high porosity, and taper the upstream and downstream edges.

Recommend some at least some extension (2'?) past the count window so that the edges are not in the vicinity of the crowder zone.
