B-Branch Adult Fish Way - Erosion Repair
Design Document Report
October 2016

99% DDR

B-Branch Adult Fish Way - Erosion Repair

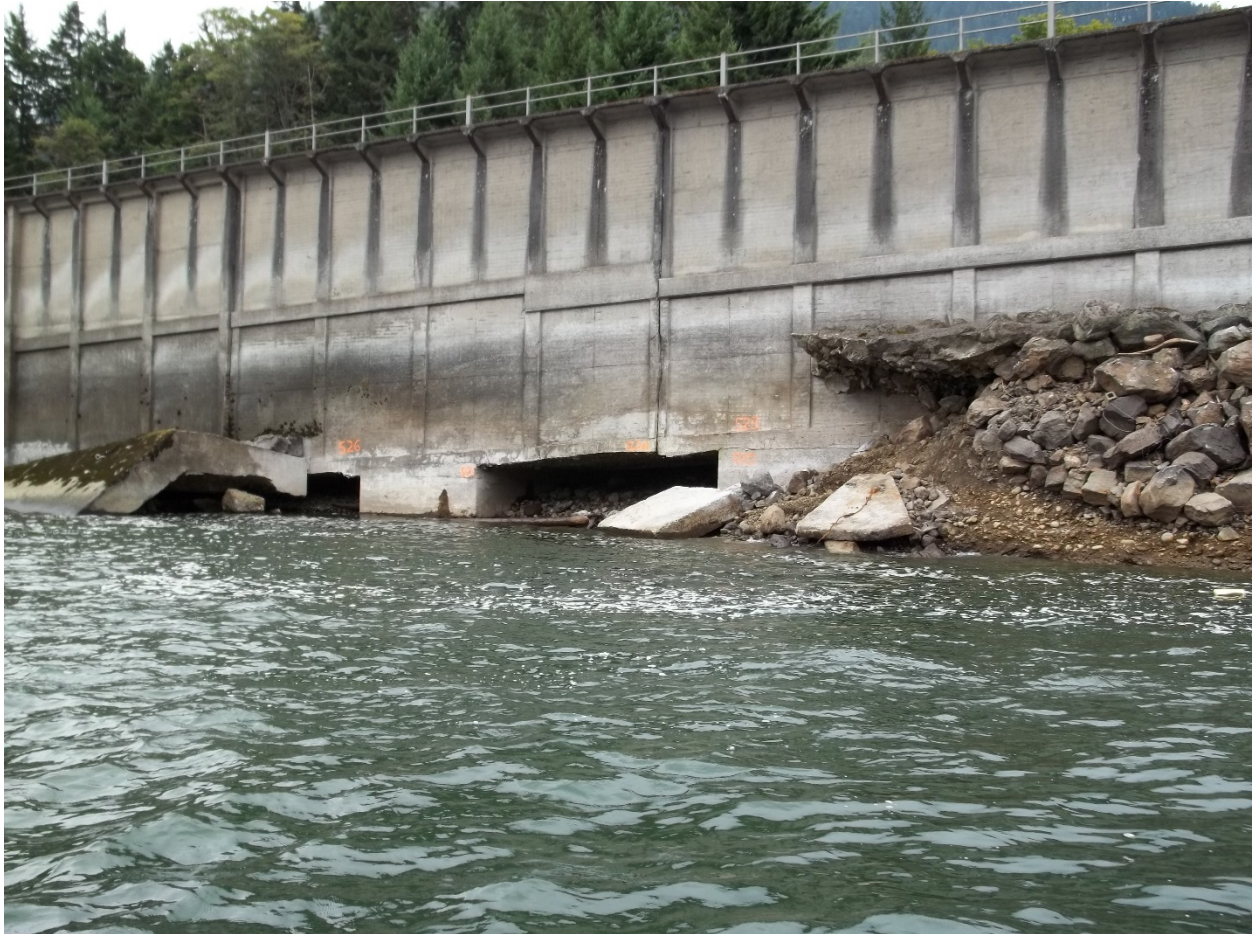
Figure 2 – Photo of 2011 Eroded Area during 2012 Repair

In 2011, unusually high summer flows with extended duration resulted in erosion under the B-Branch Fishway at the south shore of the spillway. This erosion resulted in an emergency repair contract which required the B-Branch Fish Ladder to be dewatered to allow for repairs. The foundation of the fish ladder was compromised and the remedy involved grouting through holes in the bottom of the ladder. A photo of the eroded area during repair is shown below;

The voids under the fish ladder were filled with grout and the slope in front of the ladder was repaired with riprap, see paragraph on repair history for lessons learned.

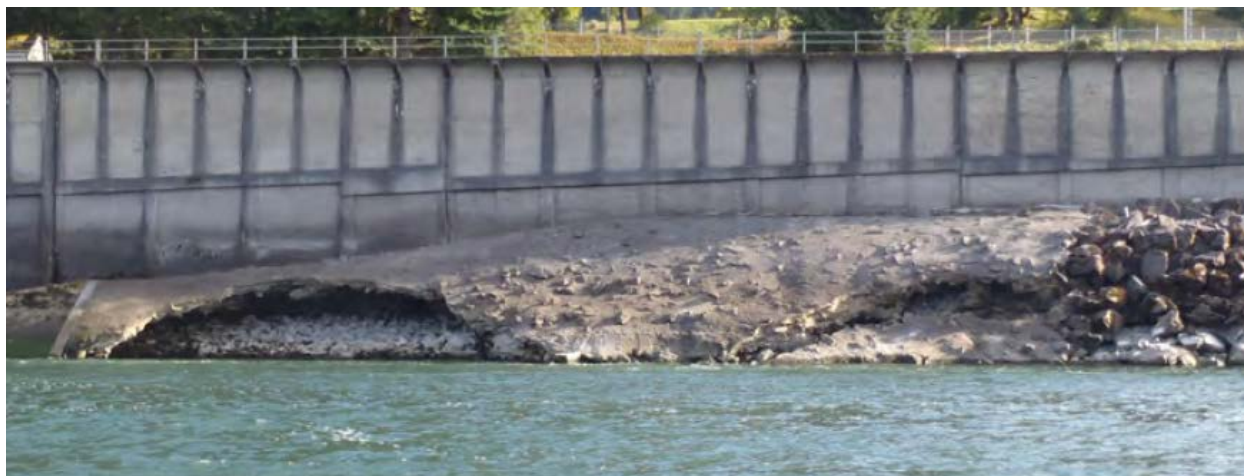
Figure 3 – Photo in 2016 of Area Repaired in 2012

Erosion was discovered again in June 2016 at the B-Branch Fishway at the south shore of the spillway.

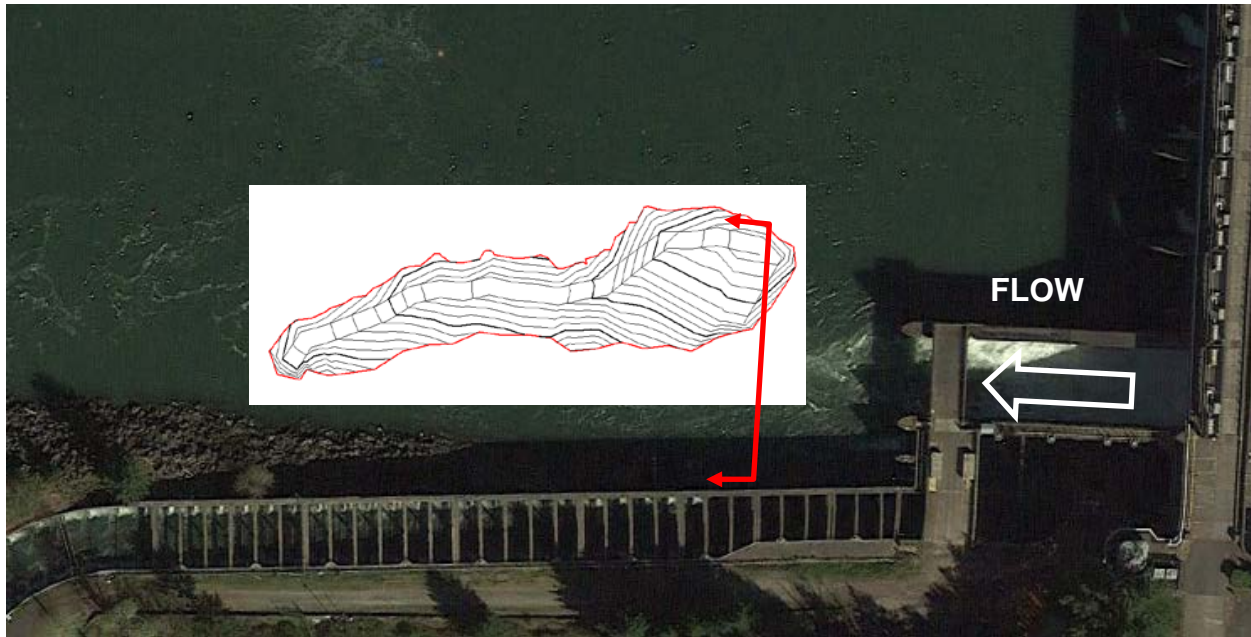
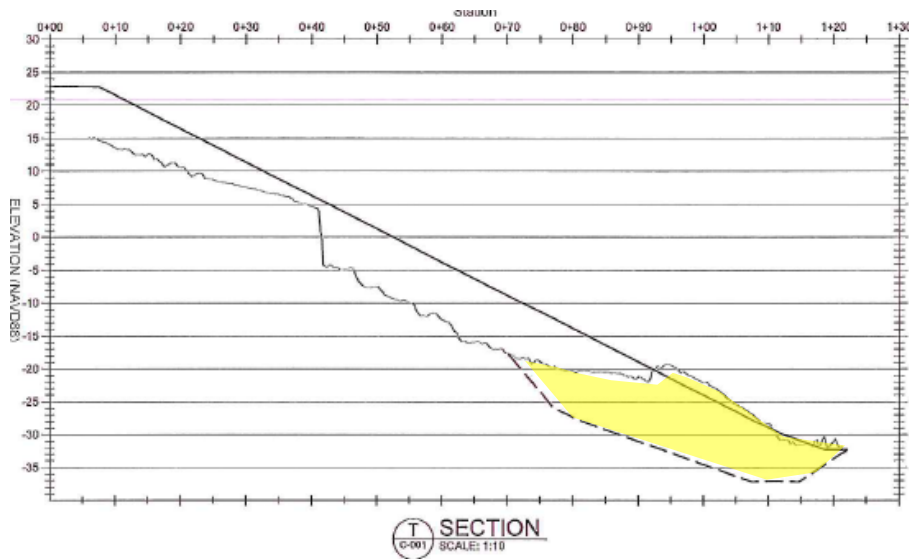
Figure 7 - Plan and Section View of Excavation

Rip-rap material must be keyed into the toe of the slope. This requires the excavation of existing material as illustrated below.

The tolerance on excavation should also be based on the nature of the foundation and the desire to get a minimum layer thickness. Recommend + 0 feet and minus 1 foot.

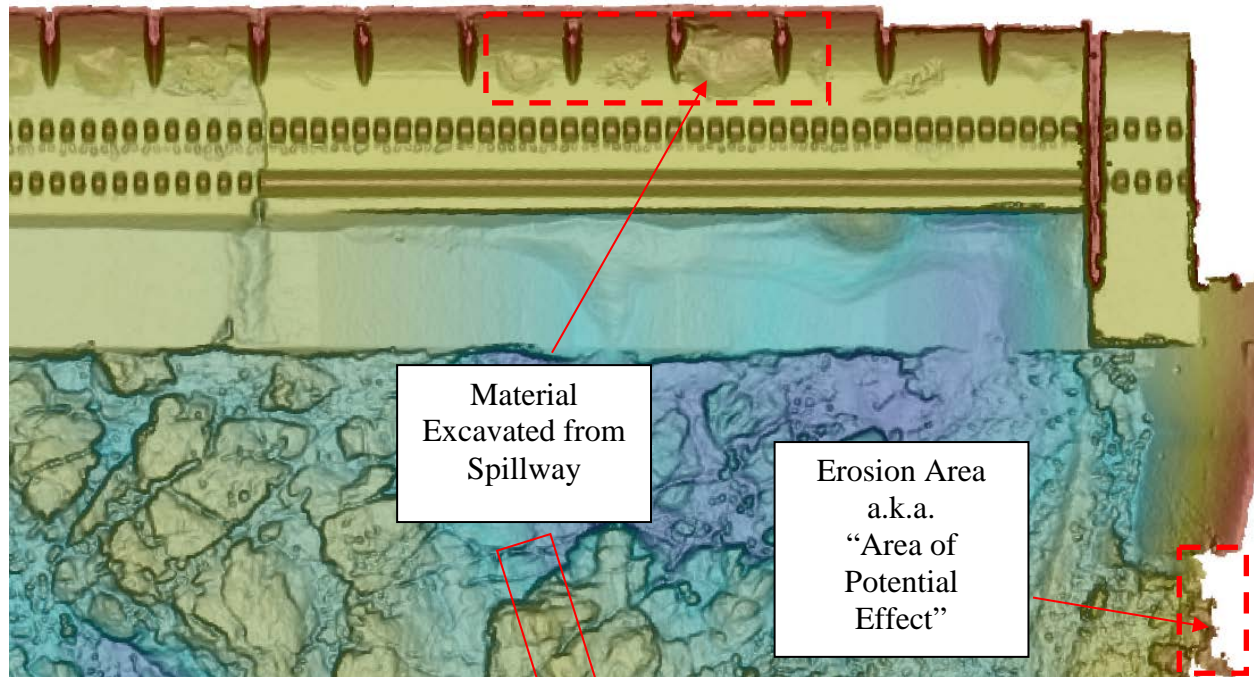
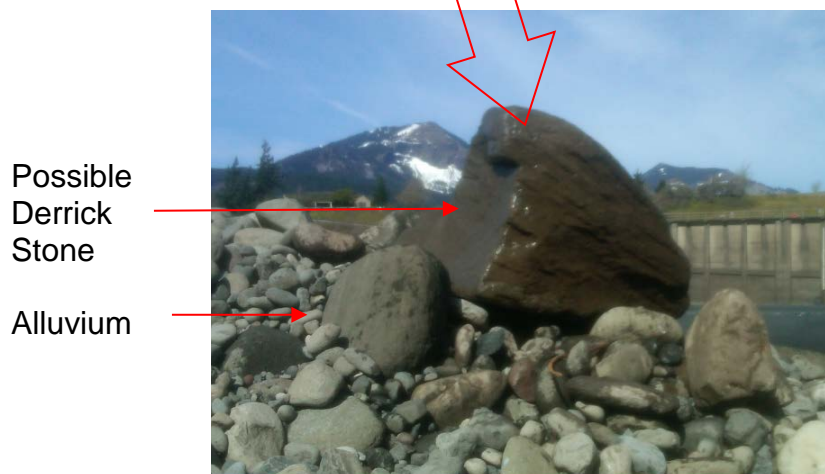
Figure 8 - Materials Excavated from the Spillway in 2011

The proposed excavate material is probably a combination of some alluvial material that is moving through the spillway, and rip-rap placed in 2012 that failed. The excavation shown is about 1,580 cubic yards. There is also a chance of encountering derrick stone placed in 1965. An example of alluvial material excavated from the spillway is shown below.

The alluvium is probably loose boulders with some cobbles and gravels. The large angular stone may be a piece of derrick stone placed in 1965.

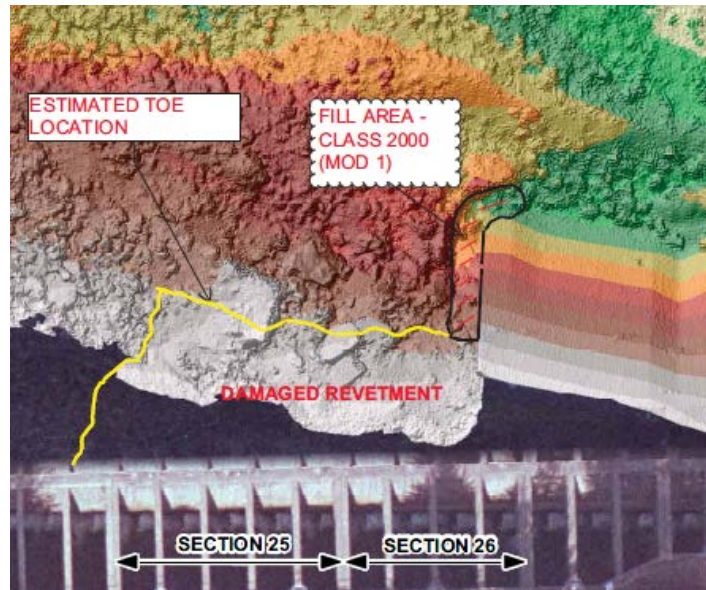
Figure 16 – As Built Hydrosurvey 2012 with Classified Elevation Part 1

- Interviews with the PDT from 2011/2012 indicates the Contractor coordinated with Reservoir Control to limit sudden increases in tail water elevation on a daily basis. Photos of the 2016 erosion indicate the grouted layer thickness was not a full 36 inches thick near the top, however actual measurements could not be safely made. Therefore, the Contractor may have been rushed by rising tail water and the repair probably failed to meet spec.

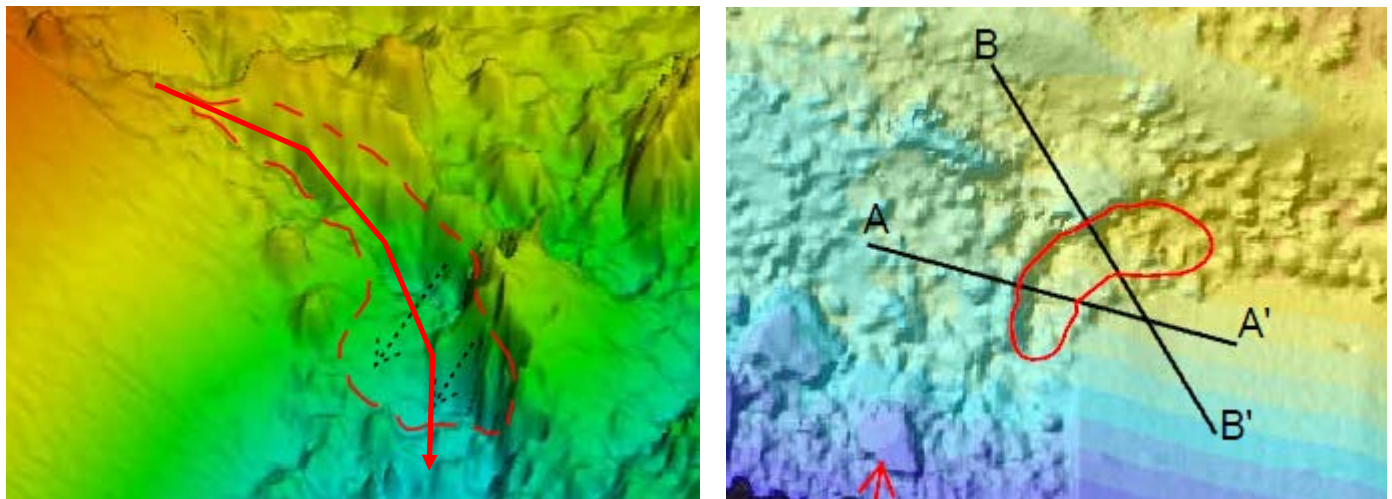
Figure 17 – As Built Hydrosurvey 2012 with Classified Elevation Data Part 2

- See Tabs “2012 As-Built - Repair Section” and “2012 As-Built - 3d Projection”. The files are titled as-builts because they captured what was completed under the contract. They also contain redlines for a design modification that never happened (pers. Comm Jerry Otto).

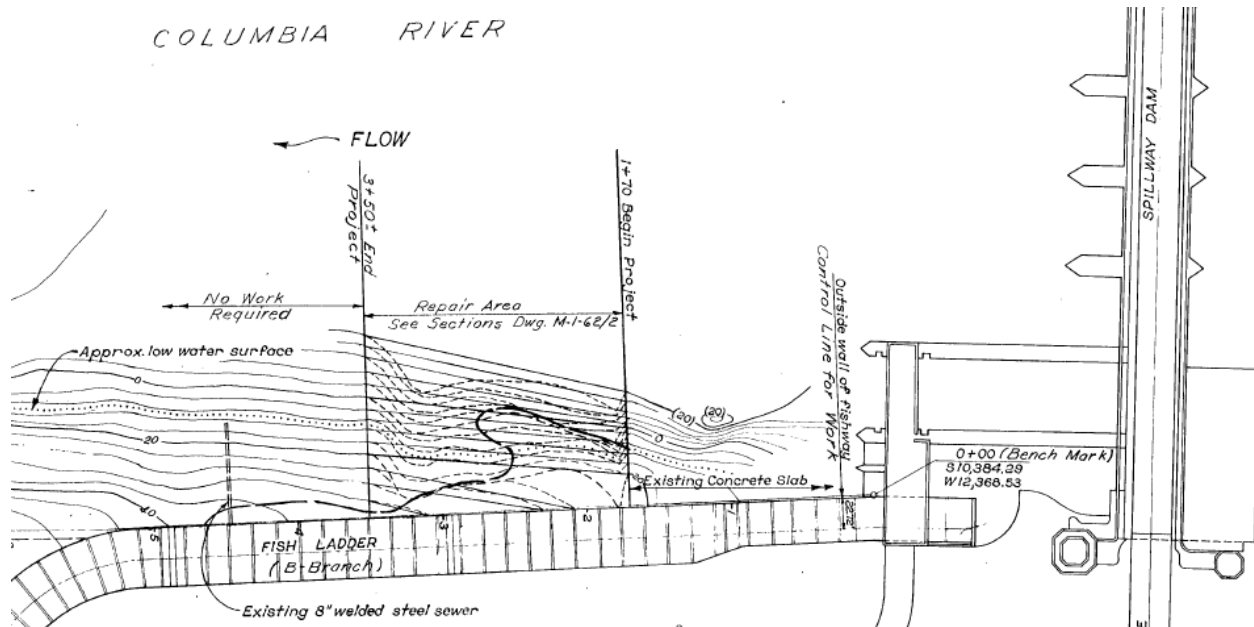
Figure 18 – Plan View of Repairs in 1965

Sections views stamped as as-built also exist. There are no specifications other than what is on the plans. The area was repaired with derrick stone- size not specified on the design drawings.

- Repaired slopes start at 1V:1.5H and increase gradually to meet the slope of the existing concrete apron 1V:1.25H.
- The size of the derrick stone is not specified on the drawings, however chances are the designers did not account for slope steepness explicitly because the research on that was not published by WES until 1988.

- The design drawings show that some grouted riprap was already in place prior to 1965 and that is what failed. The design drawings indicated they intended to grout in place the derrick stone above the water line and end dump below.
- The 1965 repair appeared to use 12-inch “spall bedding course” beneath the derrick stone. No indication that grouting was actually done on the as-constructed plans.
