MEMORANDUM FOR THE RECORD

SUBJECT: 16BON11 MFR – Adult salmonid mortalities in the PH1 unit 8B tail log slot.

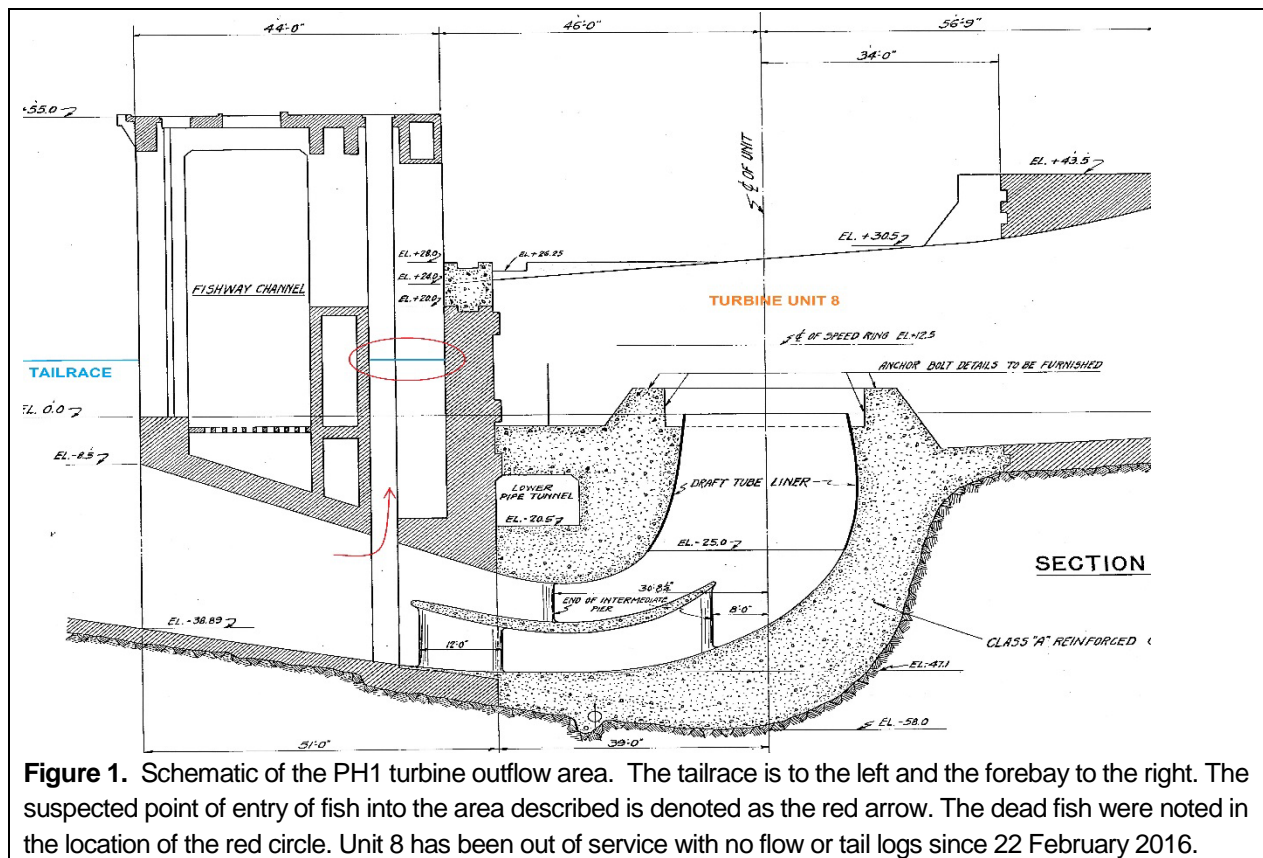
Figure 1. Schematic of the PH1 turbine outflow area. The tailrace is to the left and the forebay to the right. The suspected point of entry of fish into the area described is denoted as the red arrow. The dead fish were noted in the location of the red circle. Unit 8 has been out of service with no flow or tail logs since 22 February 2016.

On 9 May, the first available work day, the structural crew removed the roadway deck plates located above the tail log slot at the request of Project Fisheries in order to allow a clear visual inspection of the area. Project Biologists estimated ~70 dead adult salmonids were floating in the unit 8B tail log slot. The slot for 8A was also investigated; no mortalities were found but at least two salmonids were noted swimming in the slot. No means of entry to the area was noted other than the tail log slot itself (red arrow in Figure 1).

- B. Origin – Unknown
- C. Lengths – Unknown
- D. Tags – Unknown
- E. Marks and Injuries found on carcass – Unknown
- F. Cause and Time of Death – Unknown. Dead fish odor was present one week prior.
- G. Future and Preventative Measures – Under investigation. The mechanism causing this incident to occur is currently unknown. The HVAC cooling water for PH1 discharges a small amount of water into tail log slots 8B and 9A. This could potentially have provided attraction water. The cooling water is now only being discharged into unit 9, which is running. Other measures are actively being pursued.
