CENWP-EC Site Visit Trip Report

Report Prepared by: Christopher Manley & Terrina Smith
Report Reviewed by: David Hamernik & Matt Hanson, CENWP-EC-DS
Office: CENWP-EC-DS & CENWP-EC-DG
Date: 6/17/2016
Location: Bonneville Dam
Project: Bonneville Bradford Island B-Branch Fish Ladder Erosion Inspection

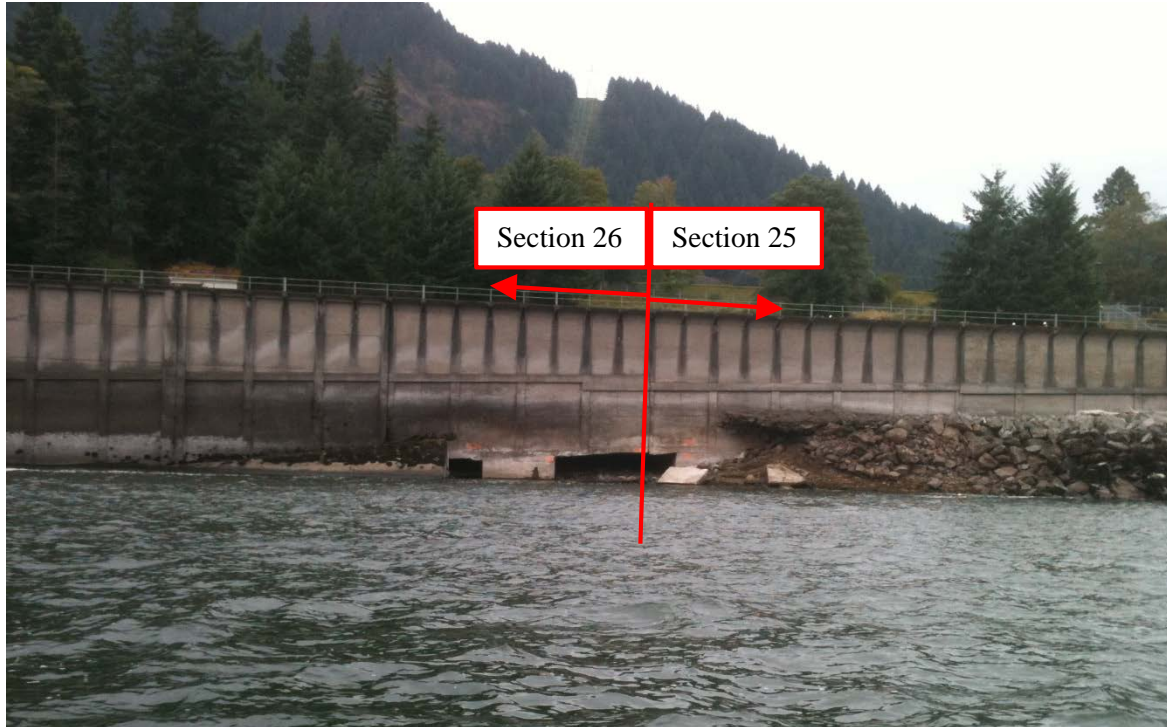
In 2011, it was found that the rip-rap revetment had been eroded between Sections 25 through Section 27 as can be seen in Figure 2-1. A team was formed to determine the extent of the erosion and decide if the B-Branch fish ladder could still be operated under the current conditions at that time. The erosion in 2011 had completely undermined the fish ladder at Sections 25 through Sections 27 and at Diffuser 21,

Figure 2-1: Bonneville B-Branch Fish Ladder 2011 Inspection Looking South

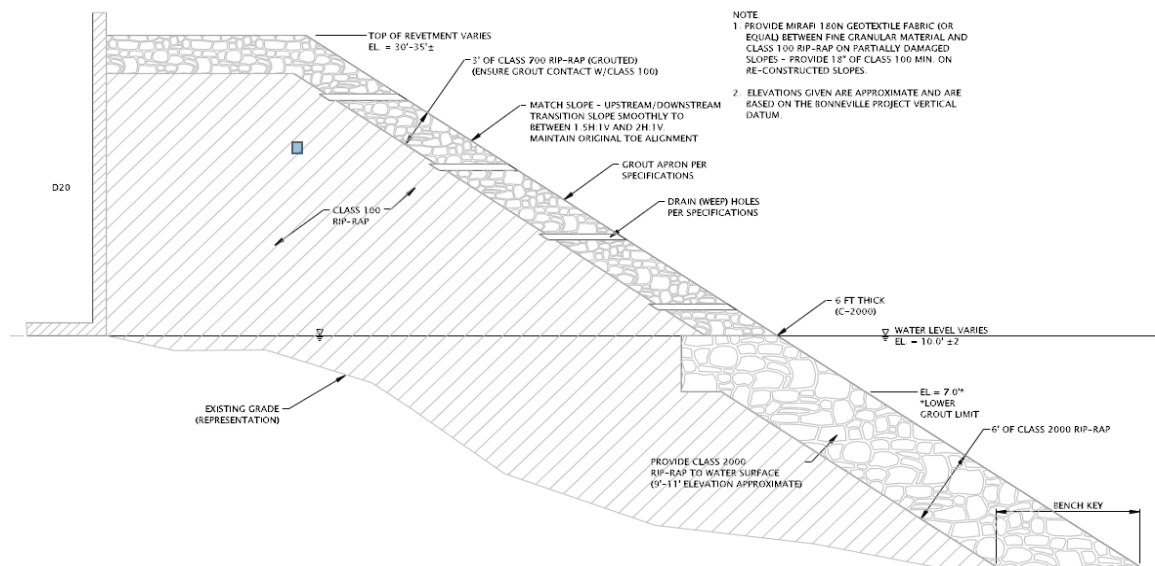
Figure 2-2 Bonneville B-Branch Fish Ladder 2011 Repair

To protect the area from future erosion, a combination of rip-rap and a grout apron was created to protect the area from any potential scour. The rip-rap that was utilized was a combination of Class 2000 rip-rap at the toe of the eroded area along with Class 100 rip-rap that extended up against the fish ladder wall. This Class 100 rip-rap was then protected with a 3' grouted apron that contained Class 700 rip-rap. This revetment that was designed and built covered the entire erosion area, with an approximate 50' extra extending downstream, resulting in approximately 200 linear feet of protected revetment by this grout apron. A cross section of the original design of the 2011 repair plan can be found below in Figure 2-2.

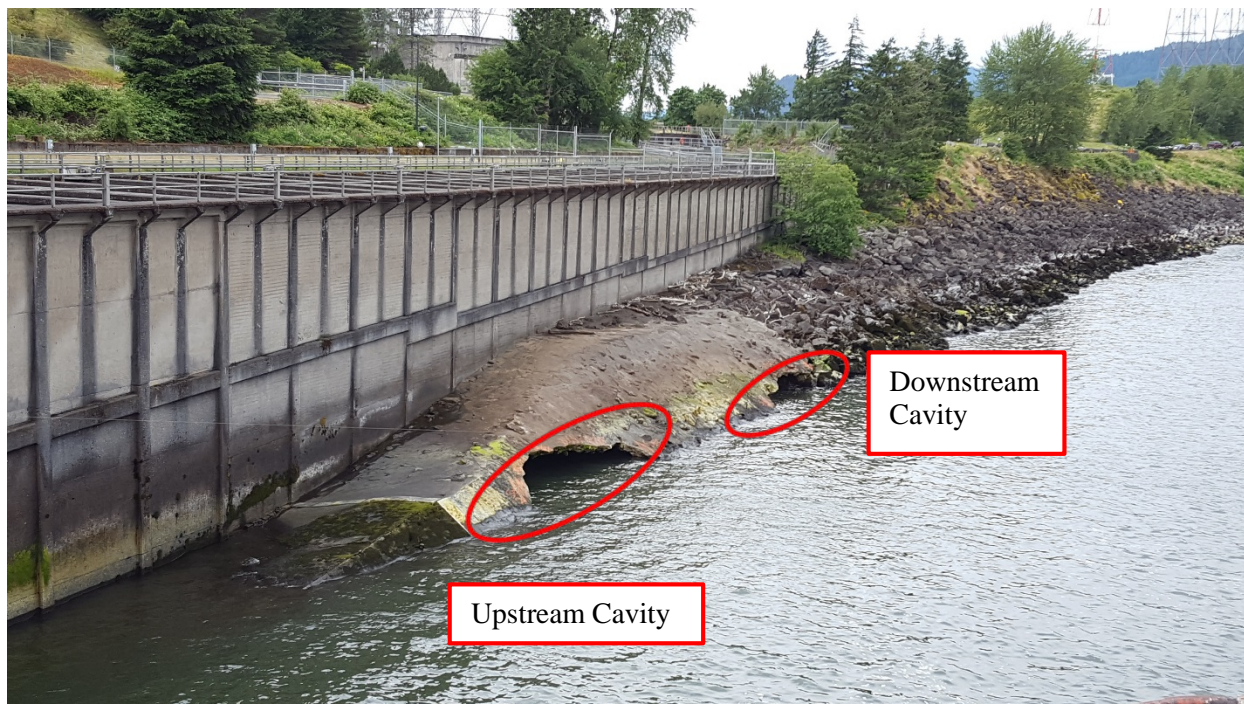
Two erosion cavities were found in the grouted apron repair that was performed in 2011. The first cavity was at the joint of Section 25 and Section 26 which is in the direct vicinity of the original revetment lost in 2011. The 2nd cavity was approximately 80' downstream of the 1st cavity at approximately the joint of Section 24 and Section 23. See Figure 3-1 and Figure 3-2 for an overview of the erosion found and a comparison of the erosion patterns between 2011 and 2016.

Figure 3-1: Bonneville B-Branch Fish Ladder Erosion Overview Looking West

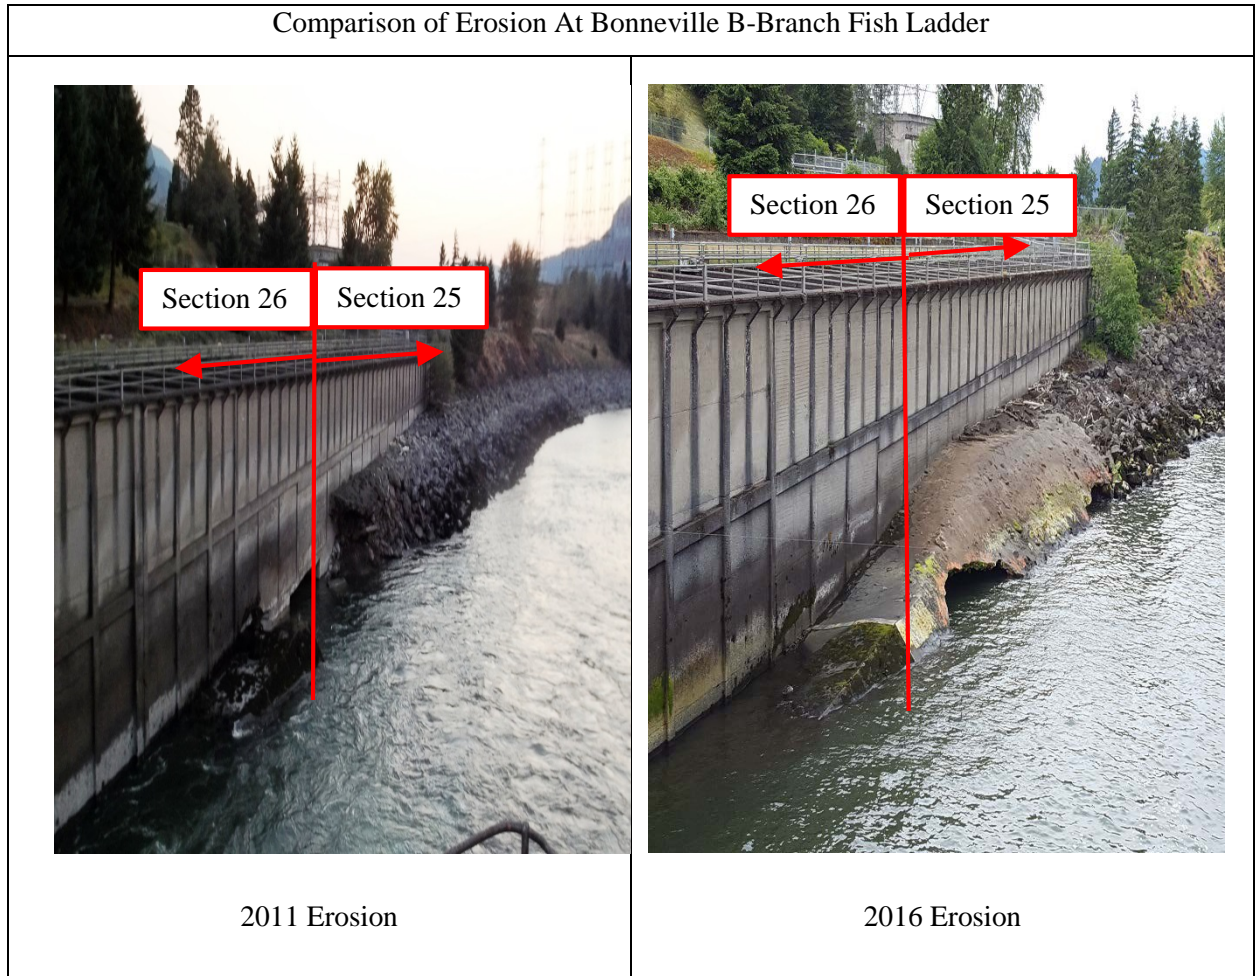
Figure 3-2: Bonneville B-Branch Fish Ladder Erosion Comparison

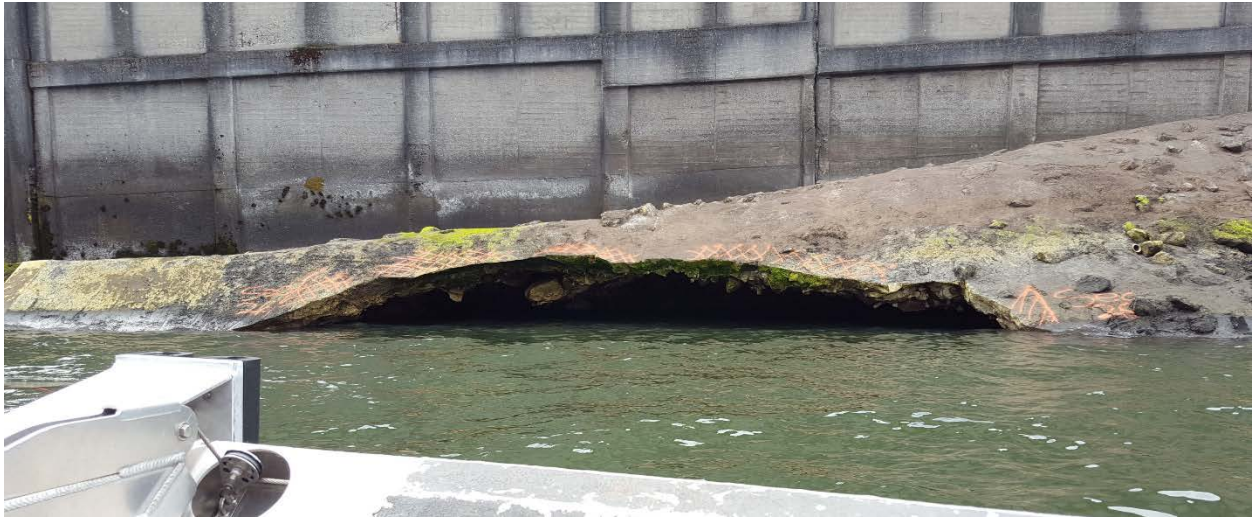
The upstream erosion hole was the more severe of the two cavities found, with an approximate 30' long opening in the grouted apron, see Figure 3-3. The top of the opening inside the cavity was approximately 4' above the water surface, with an approximate elevation of 20'. Erosion of the rip-rap was in a ½-oval shape, extending approximately 10' upstream and 10' downstream beyond the exposed grout apron opening.

Figure 3-3: Bonneville B-Branch Fish Ladder at Section 25-26 Looking South

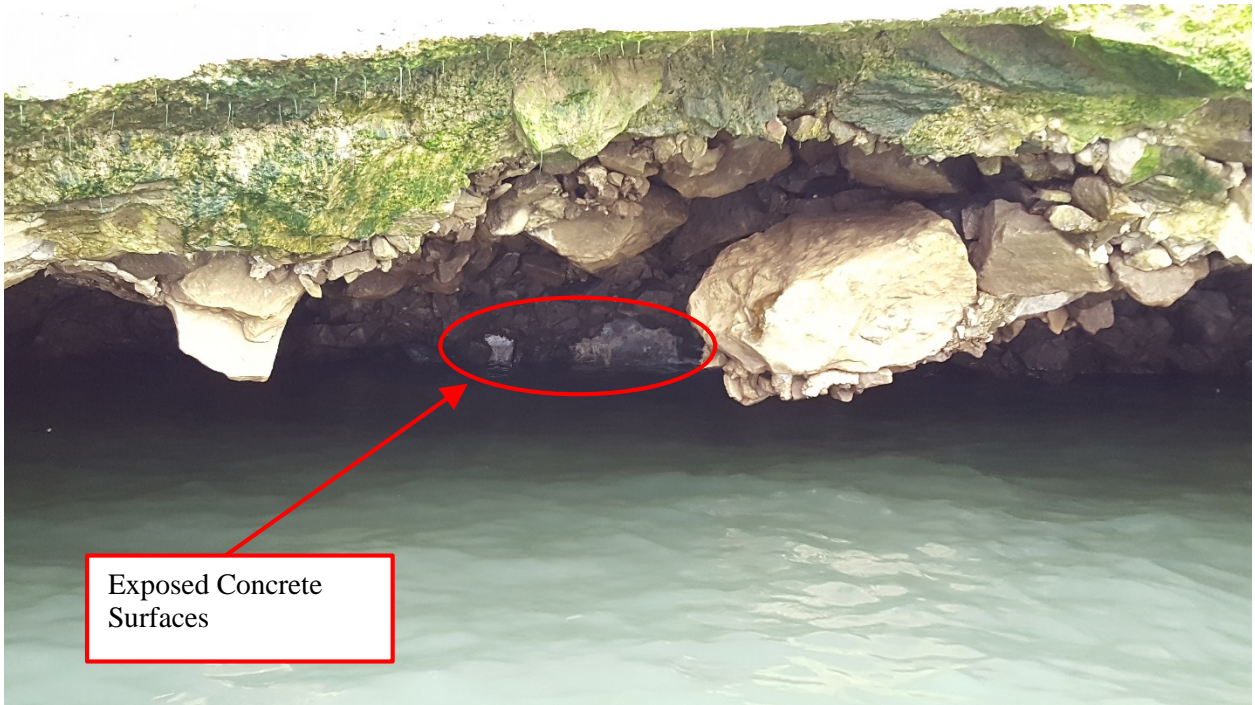
Erosion has exposed approximately 6' to 8' of what first appeared to be the fish ladder wall, see Figure 3-4 and Figure 3-5. Upon further discussion, the exposed surface is likely the concrete wedge placed below the fish ladder floor during the 2011 repair. This area is the only region during the inspection that showed that the erosion extended all the way to the fish ladder wall.

Figure 3-4: Upstream Erosion Looking Inside at Fish Ladder Wall

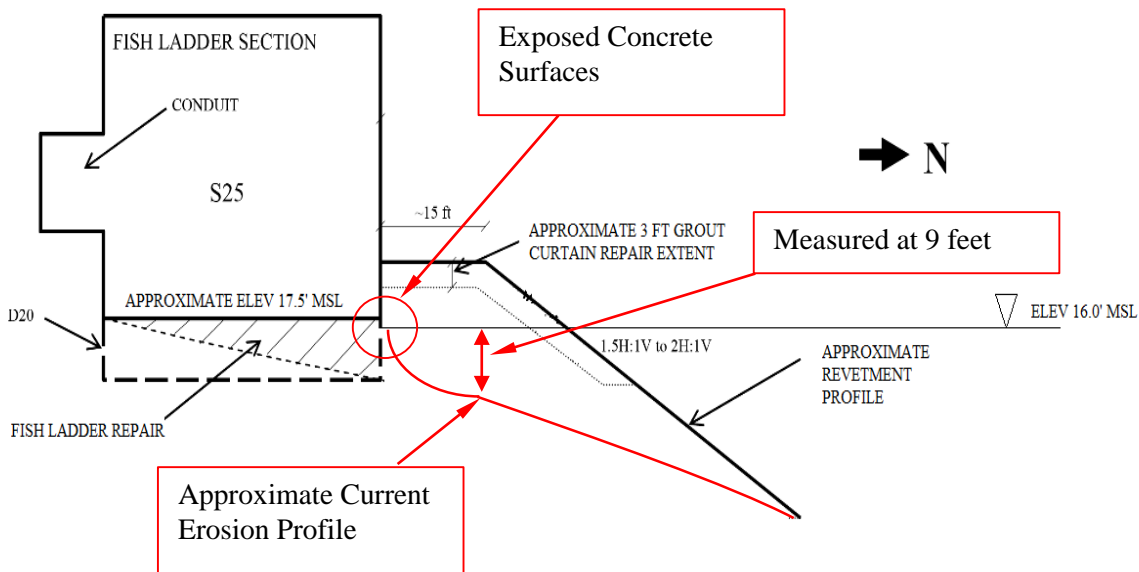
The erosion profile sloped downward away from the fish ladder towards the rip-rap toe, see Figure 3-5 for an approximate surface profile of the erosion. The maximum vertical depth that was measured was approximately 9' below the water surface (approximate El 7') at the center edge of the intact grout apron. No other depths were able to be measured, and no indication of undercutting of the fish ladder was noted.

Figure 3-5: Bonneville B-Branch Fish Ladder Erosion Cross Section at Section 25-26 Joint

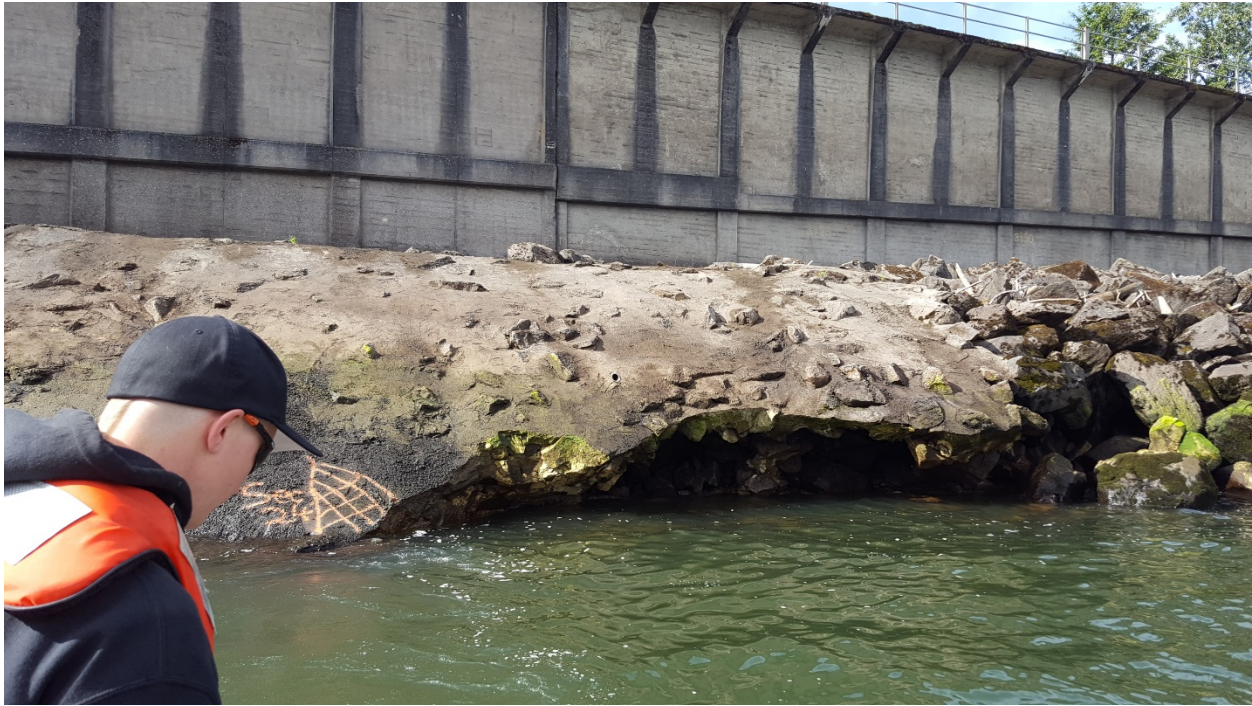
The downstream erosion hole was less severe with an approximate 20' long opening in the grouted apron, see Figure 3-6 for an image of the erosion pattern. The top of the opening inside the cavity was approximately 3' above the water surface, with an approximate elevation of 19'. Erosion of the rip-rap was in a ½-oval shape, extending approximately 3' upstream and 3' downstream beyond the exposed grout apron opening. Erosion has progressed approximately 5' into the slope (towards the fish ladder), with a vertical depth of 3' to 4' which was measured at the edges of the intact grout apron. No other depths were able to be measured and there were no fish ladder walls exposed and no undercutting of the fish ladder was noted.

Figure 3-6: Bonneville B-Branch Fish Ladder Downstream Erosion at Section 24 Looking South

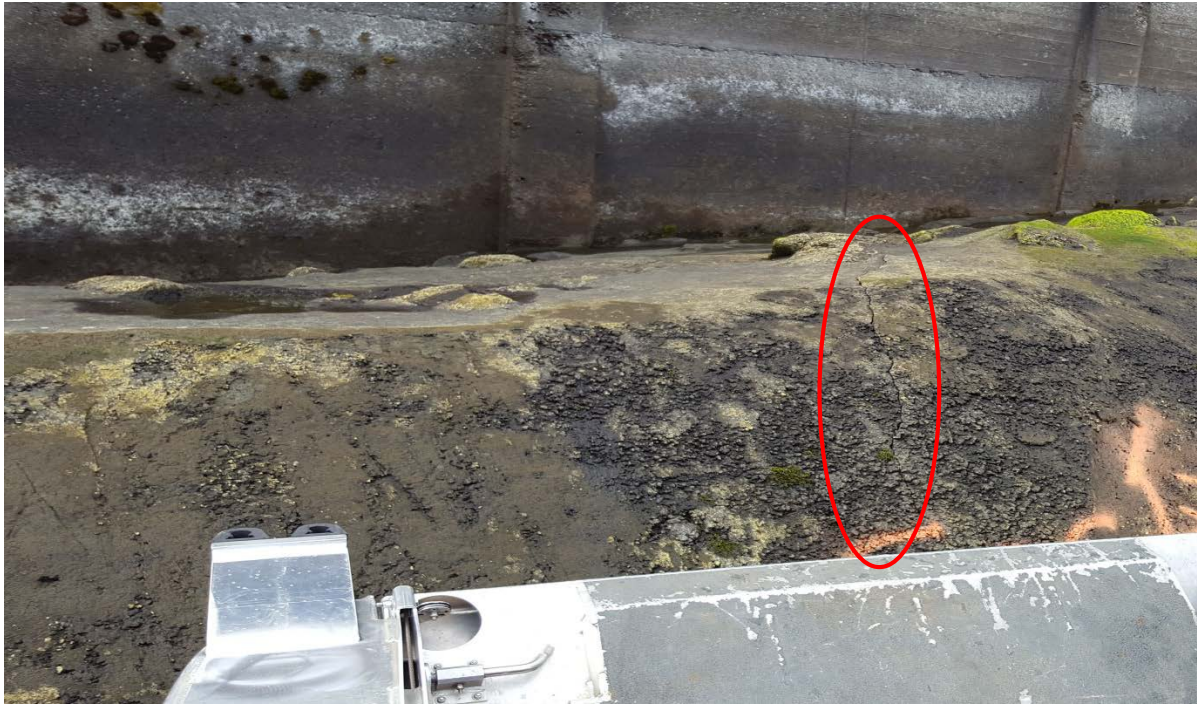
As shown below in Figure 3-7, there were areas of the grout apron that had large perpendicular cracks, as the grouted apron is no longer being supported by the rip-rap revetment. As the apron is no longer being supported, the concrete is being loaded in an unintended manner which is leading to fracturing of the cemented material.

Figure 3-7: Bonneville B-Branch Fish Ladder Grout Apron Stress Fracture
