OFFICIAL COORDINATION REQUEST FOR NON-ROUTINE OPERATIONS AND MAINTENANCE

COORDINATION TITLE- 16BON49 summer spill change

COORDINATION DATE- 29 June 2016

PROJECT- Bonneville Lock and Dam

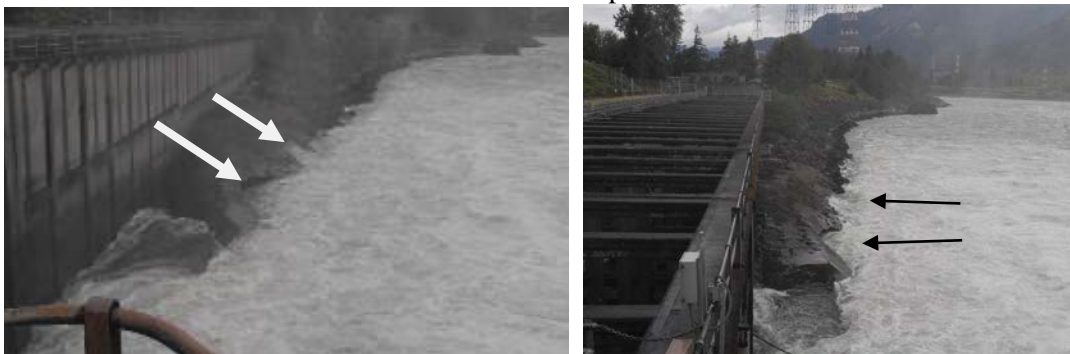
Description of the problem - Erosion holes have been observed in the previously repaired area of the B-Branch riprap. These holes were not observed during the May spillway inspection. Due to the water movement in the eroded areas, there are concerns that the undercutting may extend further beneath the ladder structure. Please see the photos of the erosion areas below.

Ebner explained there are growing concerns because the holes appear to be getting larger. She explained that the survey will provide a baseline for monitoring erosion as well as provide information for planning a repair. Lorz wanted to know how the holes were growing and what indicators are being used to monitor erosion.

Ebner explained the shot-crete cap is blocking the view of what is happening closer to the ladder. For the August inspection, she really wants eyes on what is going on under the cap. Chase noted that the shot-crete is chunking off and that is how he noticed the erosion is progressing. He also said the Project had painted areas on the shot-crete and riprap but the paint has either washed off or the painted areas have eroded.

With regards to the repair our expectation is it would have lasted longer than it did. Shot Crete isn't the most exact science but I don't think that is the problem. I think the underlying material vacated under the shot crete. The repair was completed about the time we started the contract to remove rocks in the stilling basin. As part of the stilling basin work we did a lot of hydro-surveys. In one of the surveys we saw some interesting rock features at depth below the repair area. From the hydro-survey we see what appears to be a steep rock chute. I believe this next repair would need to fill in the rock chute.

The erosion was identified either on Sunday or Monday June 12th or 13th. TW had average around 17 feet for a couple of weeks - see attached. With a 14 foot deflector and a 17 foot tailwater the flow is unsteady - what the water looks like when a person is swimming with the dolphin kick. My guess is the action dislodged material under the shot crete and is slipped down the rock chute.

In order to minimize the current rate of erosion, the Corps plans to modify the current summer spill operation (alternate every two days between 85 kcfs day/121 kcfs night and 95 kcfs 24 hours per day) to a constant 95 kcfs 24 hours per day effective 8 July through 31 August. Changing to a constant spill operation of 95 kcfs 24 hours per day is needed for the following reasons:

- 1) The expected effect of switching to a constant spill level will be the stabilization of hydraulic conditions that will likely minimize the rate of erosion and;
- 2) Stable hydraulic conditions are required for the Corps to evaluate and monitor the situation.

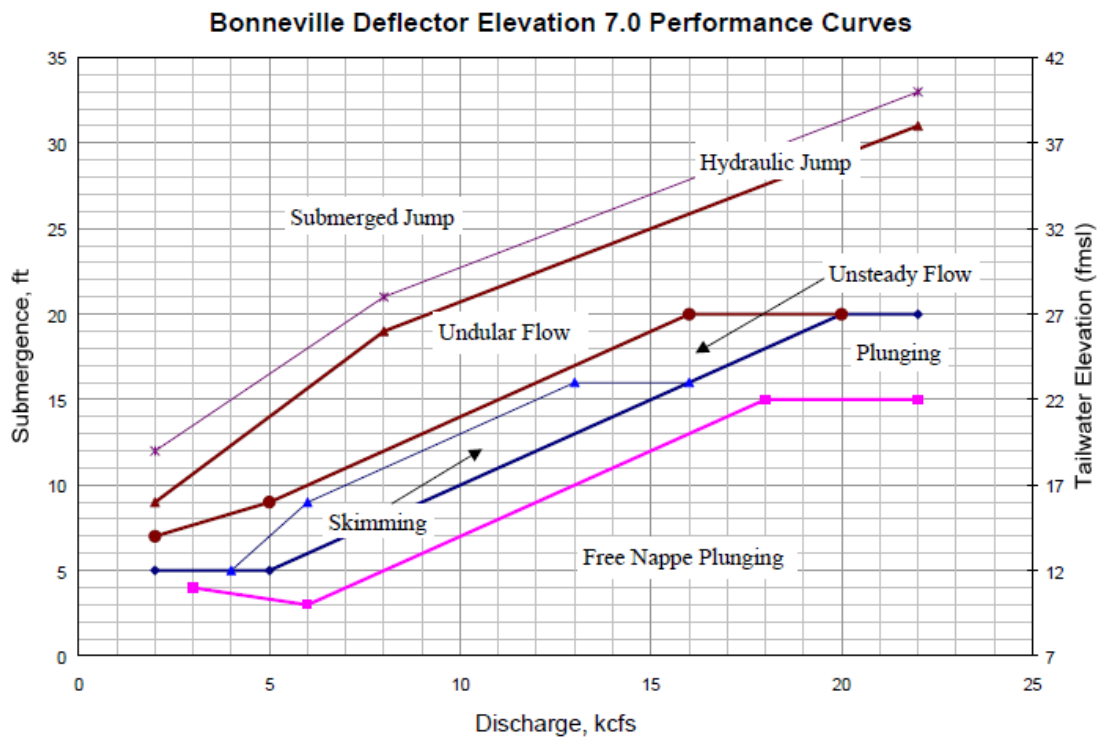
An investigation as to the cause of the erosion has just begun but there is too much energy being dissipated at the erosion locations. The attached diagram is from the Bonneville Deflector DM (2001). The diagram shows that the flow conditions off of the 7 foot deflector are unsteady (turbulent) for the conditions that have existed much of the past month (17 foot tailwater and about 6600 cfs through Bay 18). Tailwater is expected to drop as we move into July and August; the lower tailwater should help with the unsteady flow. Any change in discharge through Bay 18 also causes an increase in turbulence (energy dissipation). Using a constant spill operation eliminates the additional turbulence associated with gate changes.
