**OFFICIAL COORDINATION REQUEST FOR  
NON-ROUTINE OPERATIONS AND MAINTENANCE**

**COORDINATION TITLE-** 16BON78 spill pattern change

**PROJECT-** Bonneville Dam

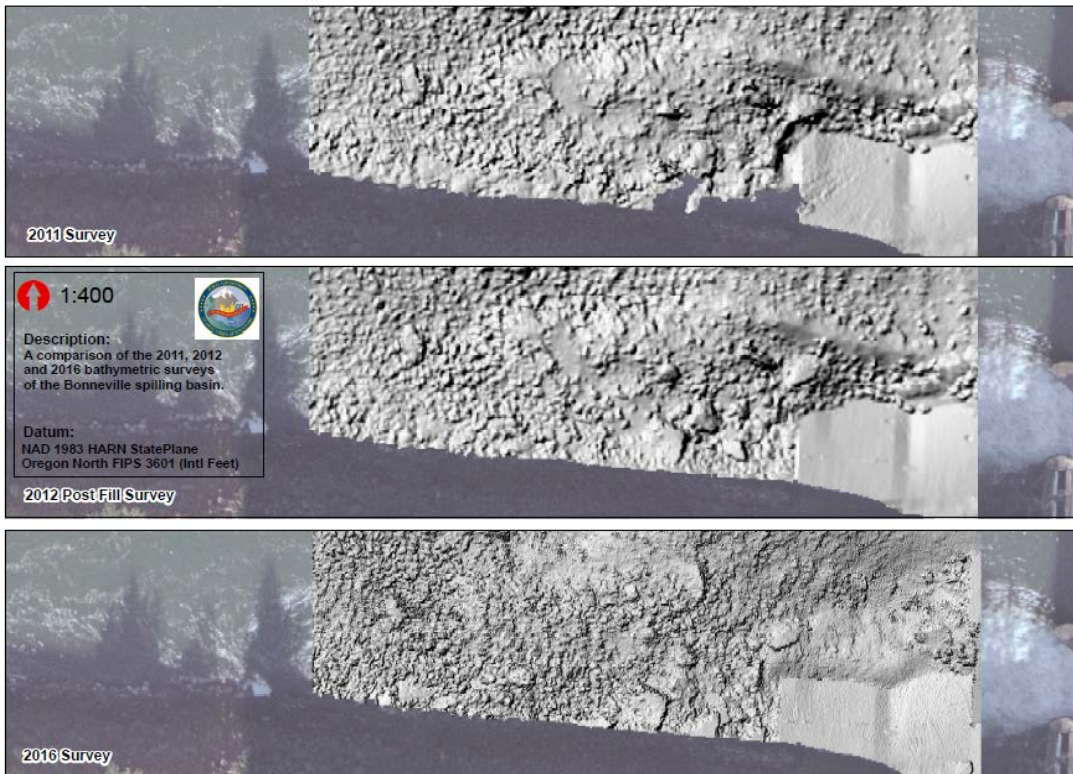
## Bonneville Survey Comparison

**Description of the problem-** Bonneville Dam is changing spill patterns in order to minimize the erosion of the previously repaired B-Branch riprap. The amount of spill will remain the same. A hydro survey conducted on July 7, 2016 (16BON47 MFR B-Branch erosion survey) confirmed the erosion was taking place. On July 20, a site visit was arranged to investigate the best spill pattern for fish while reducing the impact to the riprap area. Gary Fredricks, Scott Bettin, Ed Meyer, Ben Hausmann, Ida Royer, Jerry Carroll, Jon Rerecich, Jason Miller, Jake Macdonald and Laurie Ebner evaluated the spill parameters. The following pattern was considered the best alternative: Gate 18 open 1', gate 17 open 18", gate 16 open 3' and the remaining 3.5' distributed by 0.5' at a time through gates 5 -11. Although it was the best solution, it does create a stall out area downstream of Bay 17 & 18. Patterns have been developed for 97 Kcfs to 43 Kcfs depending river flow. A follow up hydro survey will be conducted after spill season not in August as previously suggested. Since most of the erosion is at or above water level, Gary Fredricks plans to take photographic updates of the area. Ebner noted that "If the modified spill pattern is insufficient at minimizing the energy dissipating occurring in the erosion hole protecting the ladder most likely will require shutting off the spill in the southern 4 or 5 bays." The erosion hole will be evaluated through the pictures.
