MEMORANDUM FOR THE RECORD

SUBJECT: 16BON80 MFR – Lamprey mortalities at the Bradford Island Crowder area picket leads.

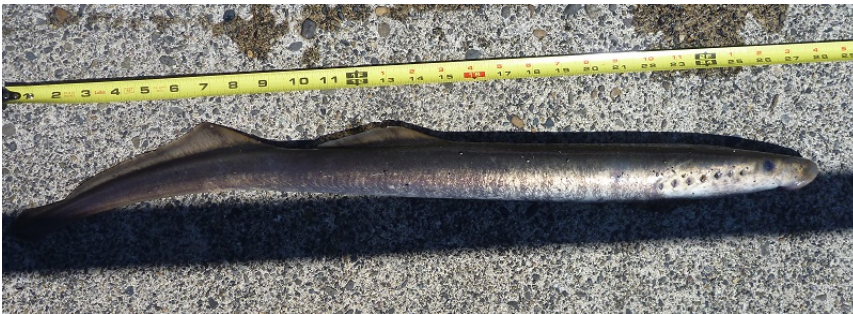
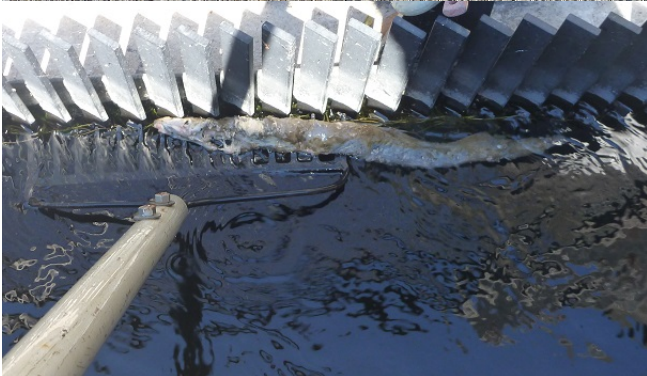
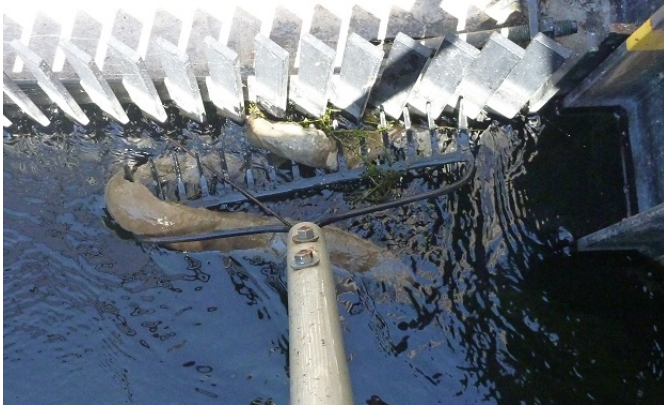
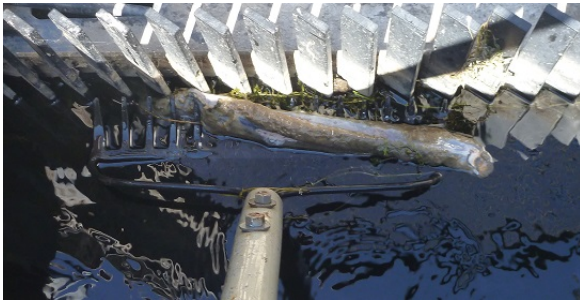
On 25 July, project biologist recovered five Pacific Lamprey from the Bradford Island crowder picket leads. Due to the decomposed state of most of the fish, only one was measured and saved for researchers. The other fish were returned to the river.

- A. Species – Pacific Lamprey (*Entosphenus tridentatus*).
- B. Origin – Unknown
- C. Length – up to 71 cm.
- D. Marks and tags – No marks and/or tags observed.
- E. Marks and Injuries found on carcass – No marks and/or injuries observed.
- F. Cause and Time of Death – Unknown.
- G. Future and Preventative Measures – Project biologists are attempting to trap Lamprey out of the area. The picket leads have a gap of 0.75” between the slats and a flattened diamond plate grating was installed on the downstream side of the picketed leads to reduce the size of the gaps even further, but it seems to have been ineffective at keeping lamprey out.

G. Future and Preventative Measures – Project biologists are attempting to trap Lamprey out of the area. Grating was installed on the downstream side of the picket leads (1.5”) to reduce incursion, but it seems to have been ineffective.
