MEMORANDUM FOR THE RECORD**SUBJECT: 17BON01 MFR – ROV inspection at Cascades Island Entrance Pool**

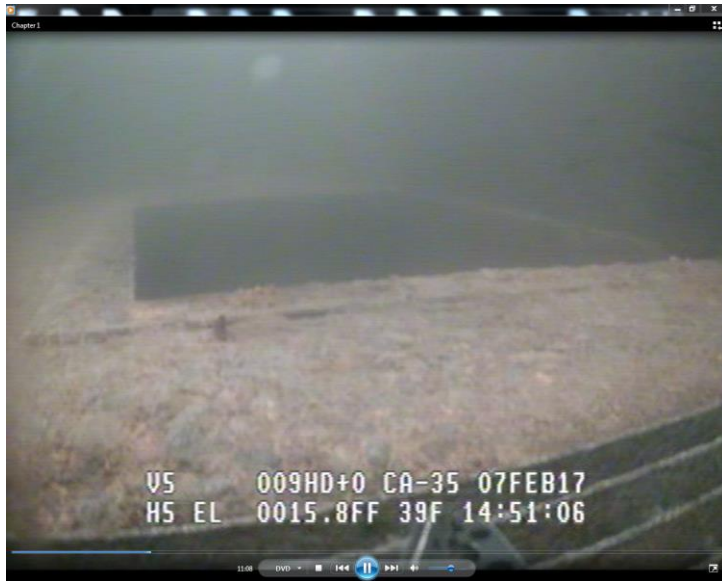
Figure A.

- 1) Diffuser pit access hatch across from FG6-18 is blown off (figure A).
- 2) The south elevator door has a screen opening at its base that is blown open (figure B).
- 3) One piece of grating at FG6-20 is blown off (figure C).
- 4) One of two channel keeper bars on the FG6-16 diffuser plate is blown off (figure D). These bars hold the diffuser plate in place. When the other bar goes, the diffuser plate will displace.

Update: BON project has made operational adjustments to the CI ladder to close the diffusers with blown gratings/hatches so there is no attraction flow to these holes. The next options are as follows.

- 1) Do nothing. Leave the problem diffusers closed and adjust with other diffusers until we can access the area for a proper fix. Two years from now unless we do an out of cycle dewatering.
- 2) Attempt to place material (plate steel, grating, etc.) over the open holes while watered up and then leave the diffusers closed to avoid displacing them. This could be in conjunction with a diver to facilitate placement. This would take one day

3) Dewater the CI ladder and fix the three issues properly, in the dry. This would take an estimated 4 days and 30K in labor.
