14 June 2017

MEMORANDUM FOR THE RECORD

SUBJECT: 17BON17 MFR – Mortalities in PH1 tail log slots.

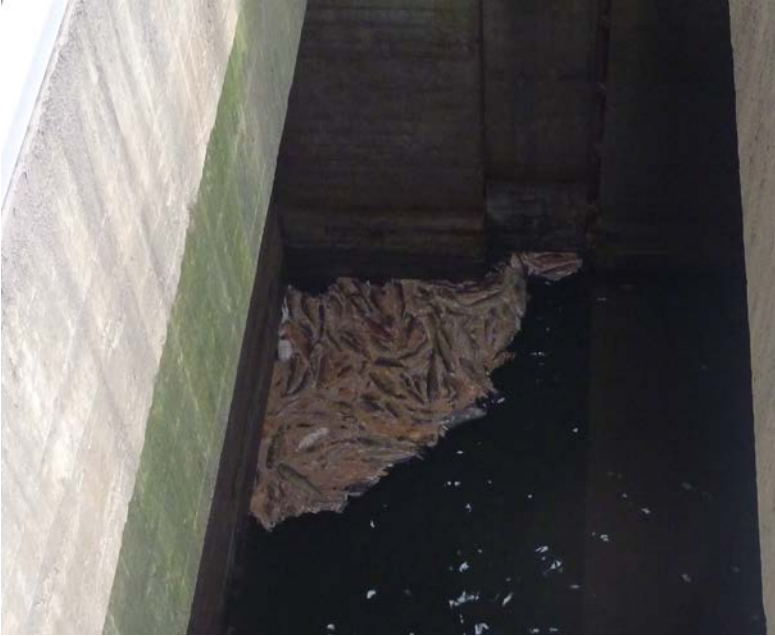
28 June update: Deck slabs were lifted over unit 8 for observation. Photos were taken and morts counted. Cooling water discharge into this slot has been shifted to the unit 9 tail log slot. Unit 9 is running, while unit 8 has not run in ~ 1 year. The unit 7 tail log slot was also inspected. Three live and seemingly healthy sturgeon were observed, with no mortalities. Due to poor lighting, photographs did not come out.

Figure 1. Unit 8 tail log slot from above, looking south.

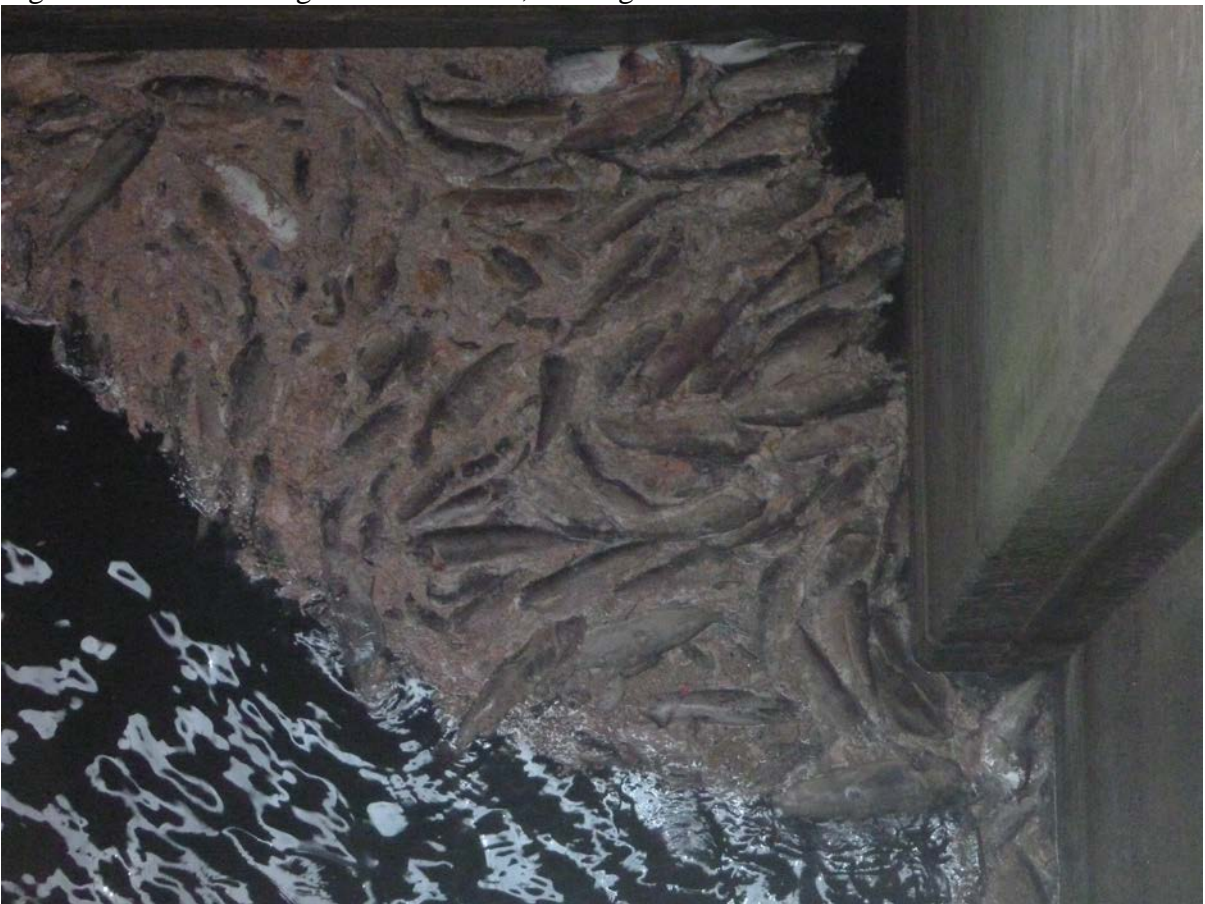
Date	Slot	Mortality	Response
6/12/17	8B	2 adult salmonids	
6/17/17	8B	2 adult salmonids	
6/28/17	8B	88 salmonids	A deck slab was lifted for closer inspection and observation. Photos were taken and morts counted. Cooling water discharge into this slot has been shifted to unit 9 tail log slot. Unit 9 is running, while unit has not run in ~ 1 year.

Figure 1. Unit 8 tail log slot mortalities from above.

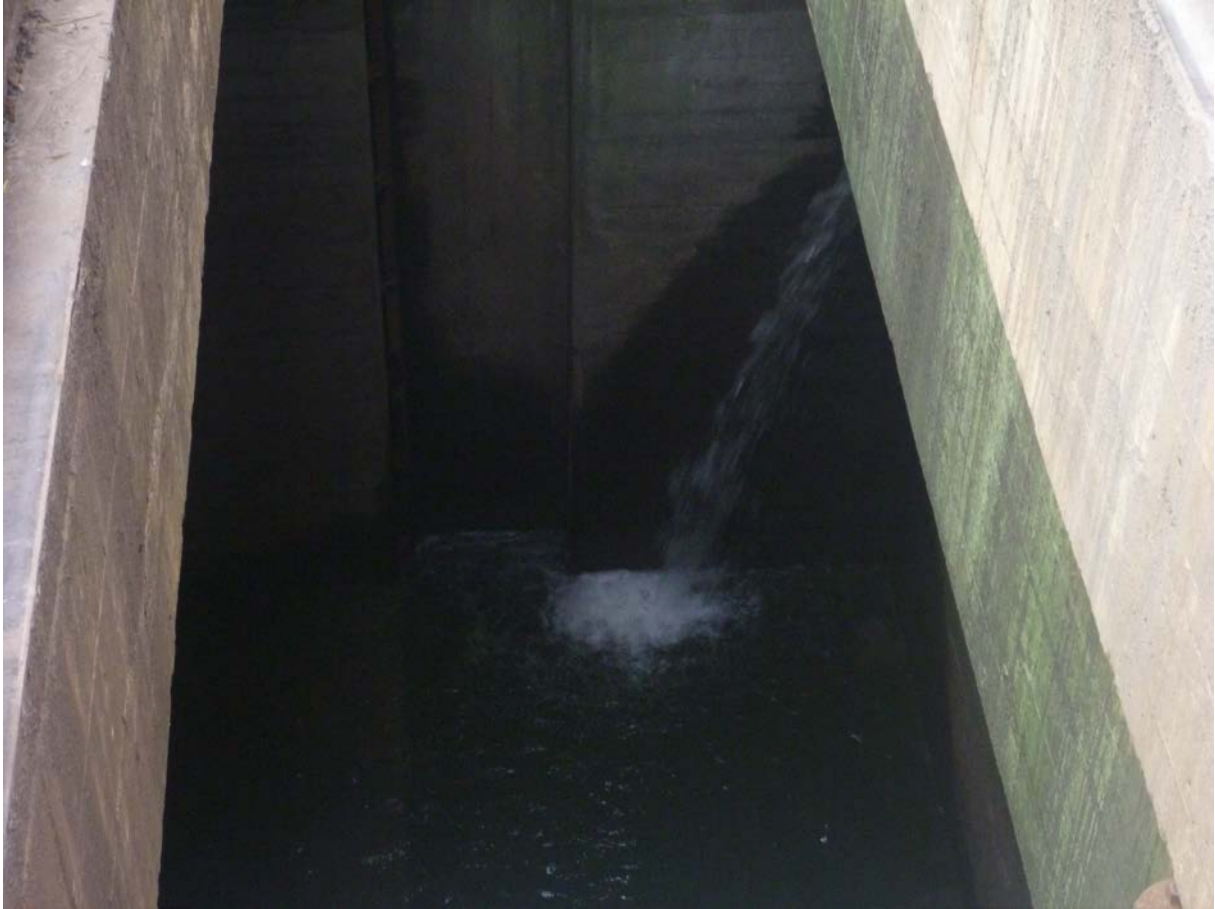
Bonneville is considering restricting light penetration into the tail log slots in order to reduce fish attraction. The cooling water has been routed to a running unit (unit 9). As it was only turned on 20 June, we do not believe it played a role in attracting fish to the area. However, it may have played a role in holding fish in the area and possibly increasing the water temperature.

Figure 1. Unit 8 tail log slot cooling water discharge from above, looking north. This discharge has only been running since 20 June.
