CENWP-OD-B

25 July 2017

SUBJECT: 17BON53 MFR - Sockeye mortalities at Bonneville's WA shore AWS.

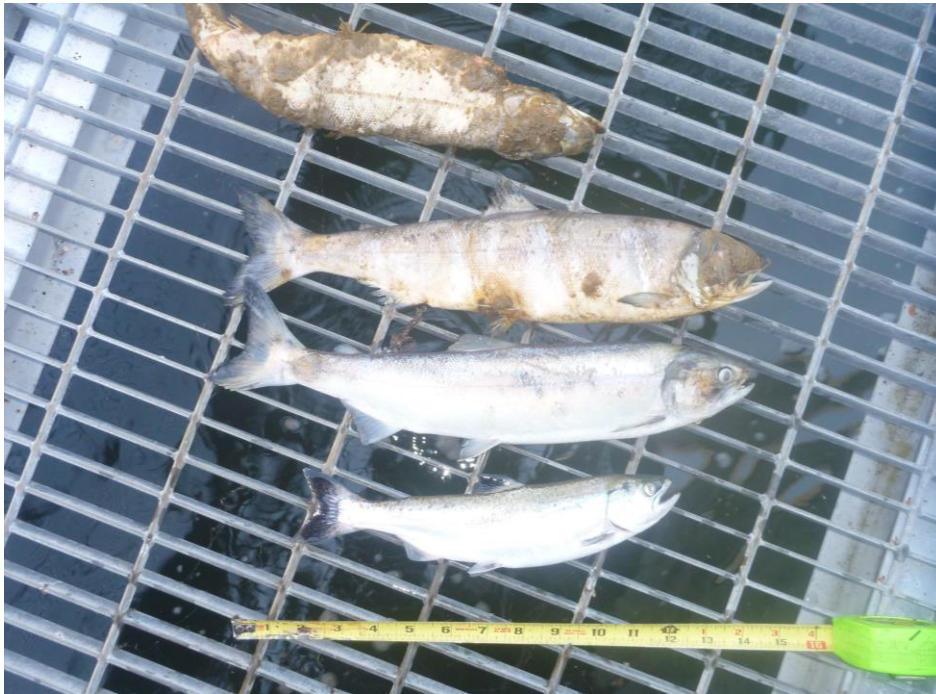
On 24 July 2017, Project Fisheries found 4 Sockeye mortalities on the picket leads in the WA shore Auxiliary Water System (AWS). The fish were largely decomposing, were not checked for tags, and were returned to the river. The information collected is provided below:

- A. Species – Sockeye salmon (*Oncorhynchus nerka*),
- B. Origin – Unknown
- C. Length – Unknown
- D. Marks and Tags – Unknown
- E. Marks and injuries found on carcass – None
- F. Cause and Time of Death – Unknown
- G. Future and Preventative Measures – Modifications were made to the picket leads during the previous winter maintenance in an attempt to minimize salmonid incursion to this area. Incursion and mortalities will continue to be monitored.
