OFFICIAL COORDINATION REQUEST FOR NON- ROUTINE OPERATIONS AND MAINTENANCE

COORDINATION TITLE- 17BON59 WA Shore LPS Flow Sensors Retrofit

COORDINATION DATE- 26 July 2017

PROJECT- BONNEVILLE Lock and Dam

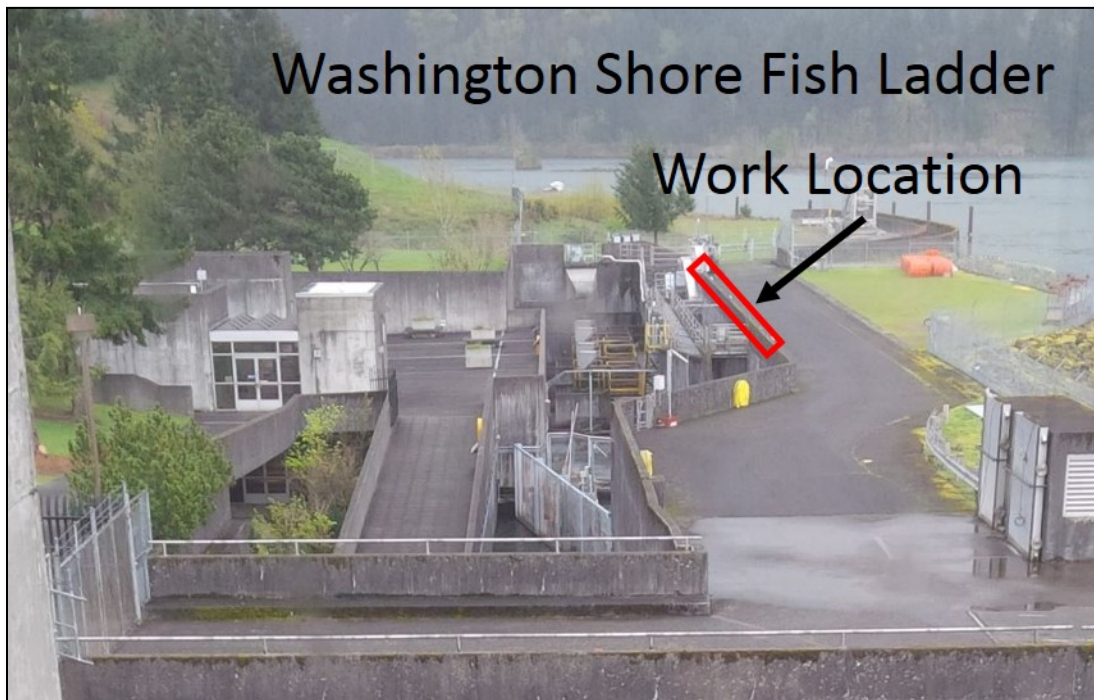
Figure 1. Bonneville Washington Shore Fish ladder exit. The location where new conduit will be installed to replace existing flow sensors.

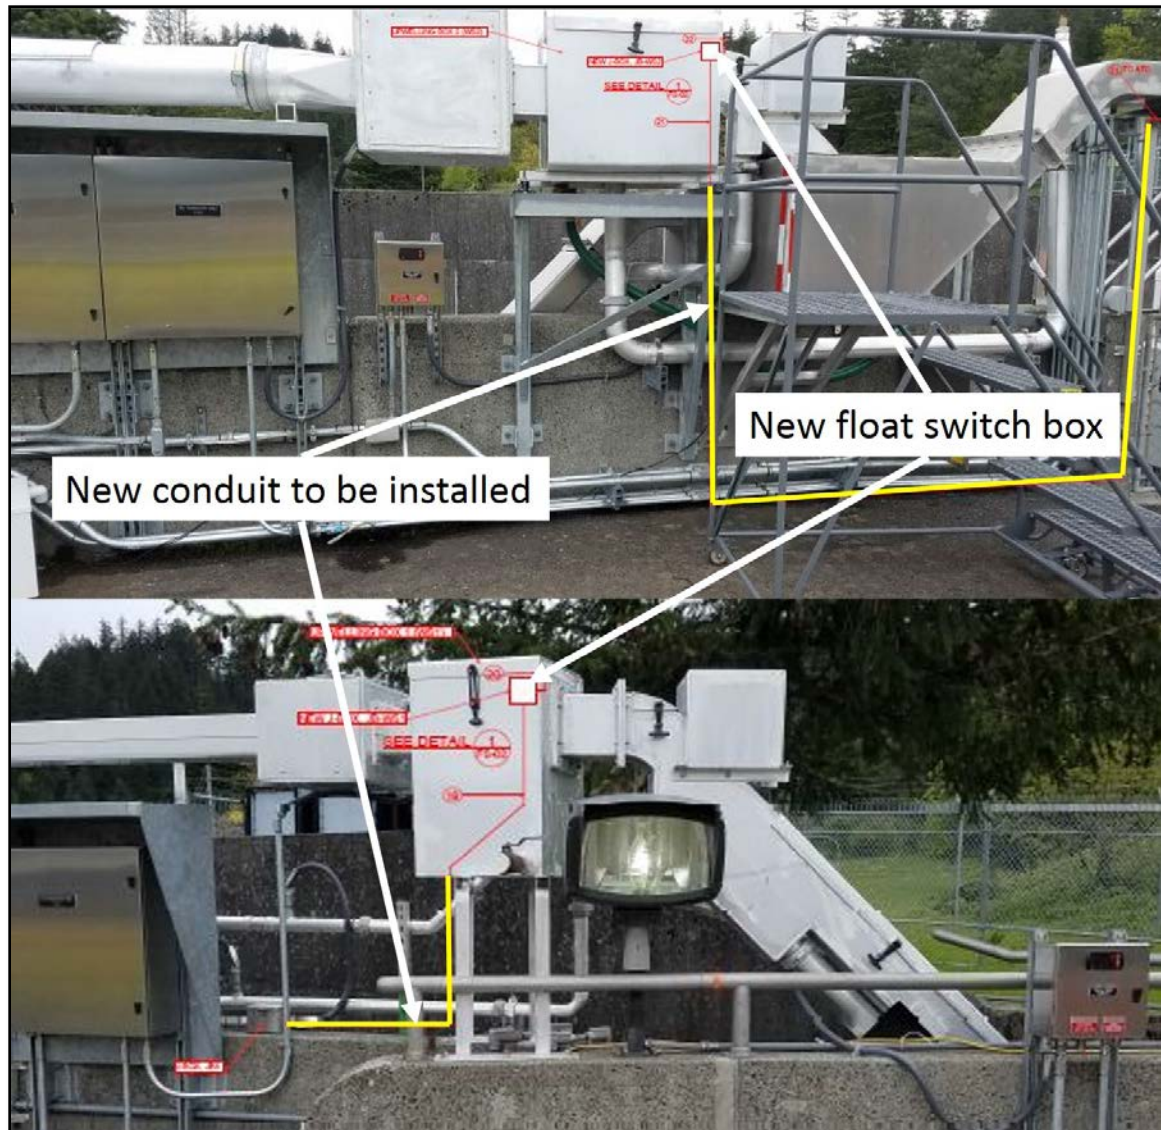
Description of the problem- Bonneville Powerhouse 2 Washington shore Lamprey Passage Structure (LPS) flow sensors need to be replaced. The flow sensors currently in place are not reliable and will be replaced with a new system to ensure proper notification to dam operators that a pump has failed. Currently there are two pumps that operate concurrently to provide design flow to the LPS and associated rest boxes. If one pump fails the system will provide enough water to maintain lamprey and allow enough time for replacement of the failed pump.

Figure 2. The Washington Shore LPS upwelling boxes to be retrofitted with new flow sensors (white boxes) and associated conduit (yellow lines) to be installed.

Upstream passage- Work within 50 feet of the fish ladder could impact adult salmonid passage. However impacts are expected to be minimal as the work consists of pulling wire, through mostly existing conduit, along the outside of the WA shore AWS adjacent to the fish ladder. Some spot welding will also occur on the outside of the LPS upwelling boxes, not directly over the fish ladder, to attach a mounting bracket for new flow sensor boxes (Figure 2). The welding will likely take less than a total of 1 hour (not consecutive) over the course of 1 day. Hand tools will be used on the outside of the fish ladder to attach a short piece of conduit that will require ~15 (.25 inch O.D.) anchors below the two upwelling boxes (Figure 2).
