CENWP-ODB 5/15/2018

MEMORANDUM FOR THE RECORD

SUBJECT: 18BON06 MFR – Mortalities in PH1 tail log slots

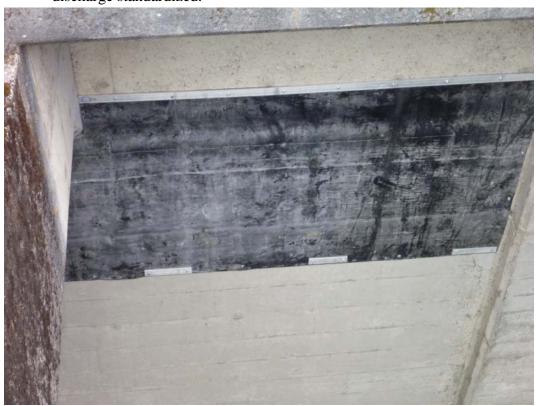
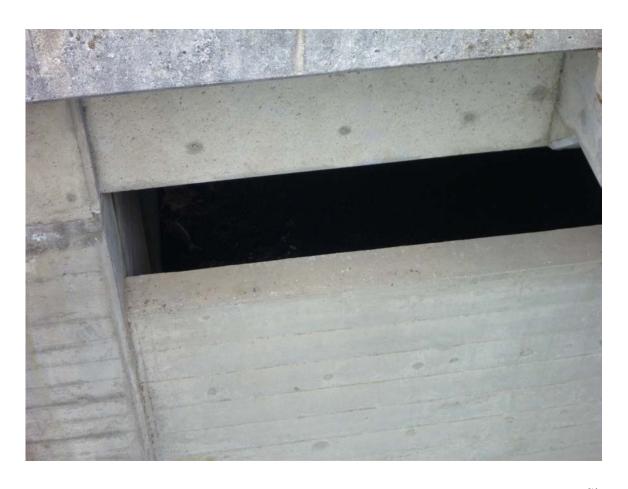
On Monday, 14 May, 2018, project biologists discovered adult Chinook mortalities in the PH1 unit 8B tail log gatewell slot. The previous day, during the course of a regular inspection, project biologists noticed the "chiller water" discharging into the Unit 8B slot. Discharge should only be going to Unit 9 (running unit) and the biologist immediately had operations switch discharge to the 9A slot. No mortalities were seen on Sunday. The following morning, biologist inspected the area and found the mortalities. Due to the decomposed state of the mortalities, it is likely that they were already there Sunday, but had drifted into an unobservable corner and had not yet given off a discernable odor. Upon investigation, the chiller was found to have been turned on Thursday, 10 May, and discharge was improperly routed. The intake water at the time of startup was 56° F, and the discharge was 78°. It is believed that discharge into the gatewell of a running unit (9A) provides enough mixing to negate the effects of the warm water. No mortalities were found in tail log gatewell slots of other units, running or not. This incident caught project biologists off-guard, as the chiller is not usually brought into use until early to mid-June.

- A. Species 28 Spring Chinook, with 1 or 2 other unidentifiable fishes.
- B. Origin tailwater
- C. Length N/A
- D. Marks and tags N/A
- E. Marks and Injuries found on carcass N/A

- F. Cause and Time of Death Assumed to be heat stress induced on 12-13 May.
- G. Future and Preventative Measures
 - -The addition of light blockers is expected to reduce entry and residence time in tail log gatewell slots. The installment of these had begun, but 8B was the last slot to be closed off.
 - -A placard has been made to be placed over the switching valves on the chiller water discharge in the Powerhouse, instructing equipment operators to not dump water into a non-running unit slot.
 - -Bon fisheries will be writing up an FPP change form to keep operation of chiller water discharge standardized.
