**MEMORANDUM FOR THE RECORD****SUBJECT: 18BON14 MFR - Cascades Island LPS Pacific Lamprey Mortalities**

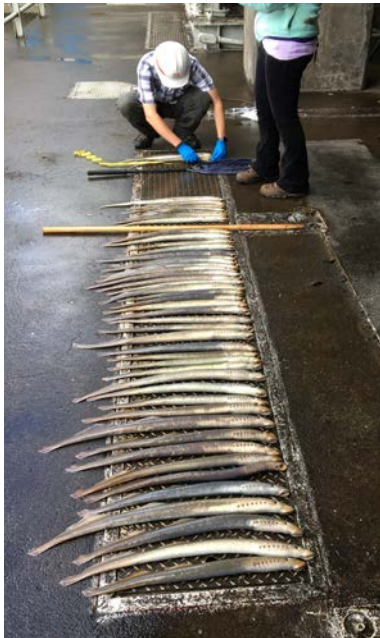
On the morning of 4 June FFU personnel found the climbing section of the CI LPS did not have water flow and lampreys were present in the rest boxes (RB). They were able to reset one pump's GFI, reestablishing flow.

FFU removed morts from RB3, RB4, no fish were in RB5, thirty five morts were removed from RB6 (top most). RB1 and RB2 were flushed using pneumatically controlled valve and four mort fell from RB1. There were thirteen live lamprey left to continue their migration through the LPS. Ten mort were frozen for later study by the Lower Columbia River Fish Health Center and the remainder were returned to the river.

Figure 1. Pacific Lamprey mortalities from pump failure at Cascades Island LPS. In coordination with the Lower Columbia River Fish Health Center (Ken Lujan) ten were frozen for later study, the remainder were returned to the river.

It is vital to implement necessary precautions to keep the adult lamprey out of harm's way as they are coaxed and shunted to use the LAPS. Future and preventative measures identified in the subject MFR include investigating using a lead pump and a lag pump vs. two in continuous operation, and investigating alarm systems.

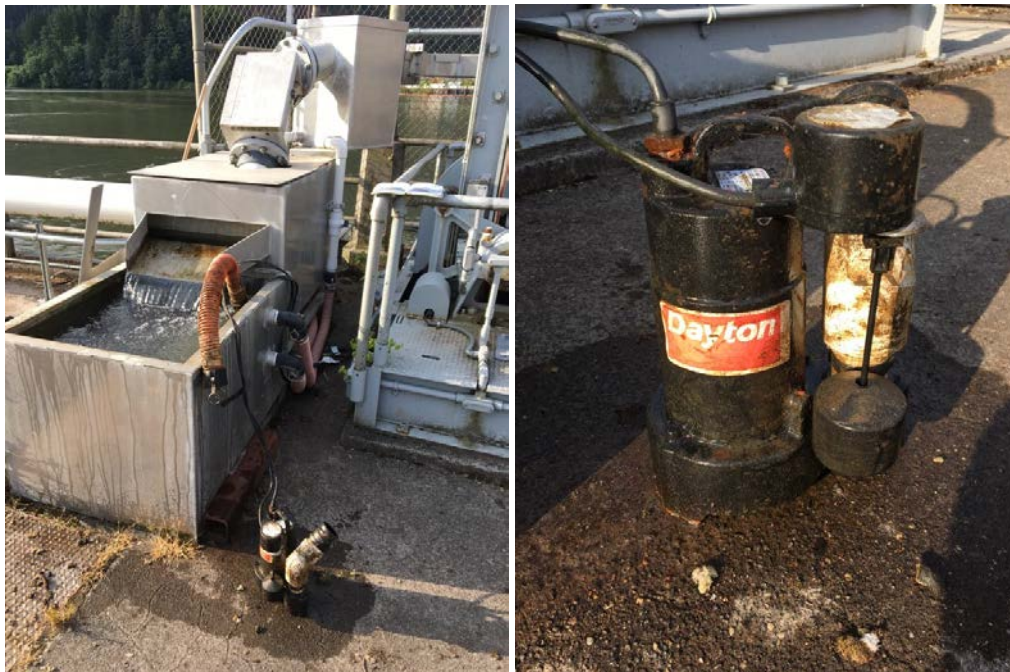
My question would be did the one pump failing cause the other pump GFI to trip? If the answer is likely yes then I would consider making sure the pumps are on isolated breakers / circuits. If they currently are on truly isolated circuits then we should investigate the likely cause of failure and correct the fault.

- 2) There are no checks at night. No bios on duty and Ops does their rounds in the daylight hours. Hence the need for a reliable alarm system.
- 3) There are two GFI's that the pumps plug into. It looks like they are wired into the same circuit (see attached photo).
