MEMORANDUM FOR THE RECORD**SUBJECT: 18BON15 MFR - Cascades Island LPS Pacific Lamprey Mortalities**

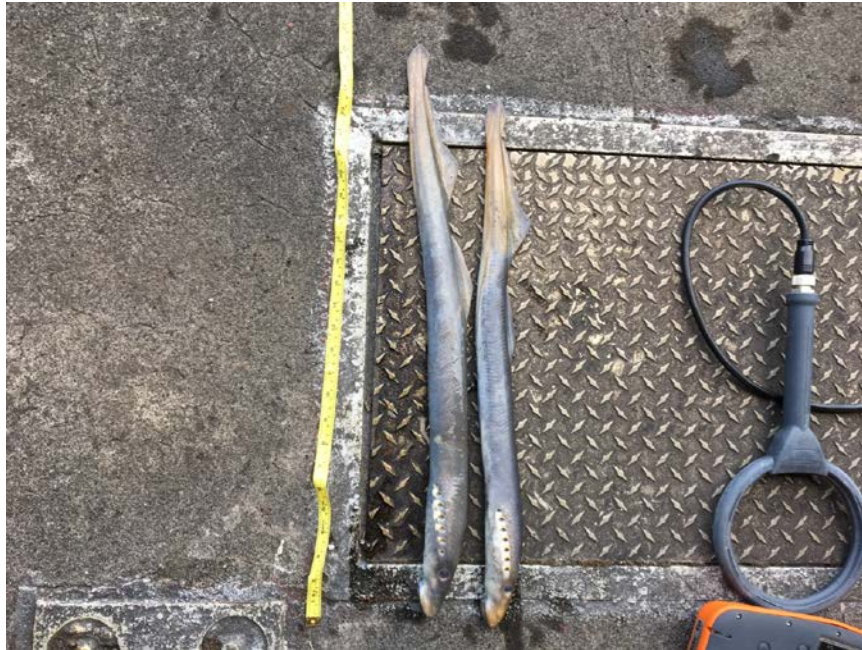
- A. Species – 2 Pacific Lamprey (*Entosphenus tridentatus*).
- B. Origin – Assumed naturally spawned
- C. Length –
 - a. 66.1 cm TL, Inter-dorsal 4.4 cm
 - b. 61.6 cm TL, Inter-dorsal 3.8 cm
- D. Marks and tags – No PIT tags (full or half duplex) or external tags discovered
- E. Marks and Injuries found on carcass – None
- F. Cause and Time of Death – Believed to be residual mortalities due to two pump failure reported in MFR 18BON14.
- G. Future and Preventative Measures – The climbing section of the Cascades Island LPS has been taken out of service until a second pump can be installed near the ‘pond’ junction box. We are investigating using a lead pump and a lag pump vs. two in continuous operation and alarm system to alert the control room.

Figure 1. Two adult lamprey mortalities removed from rest box 3 and rest box 4.

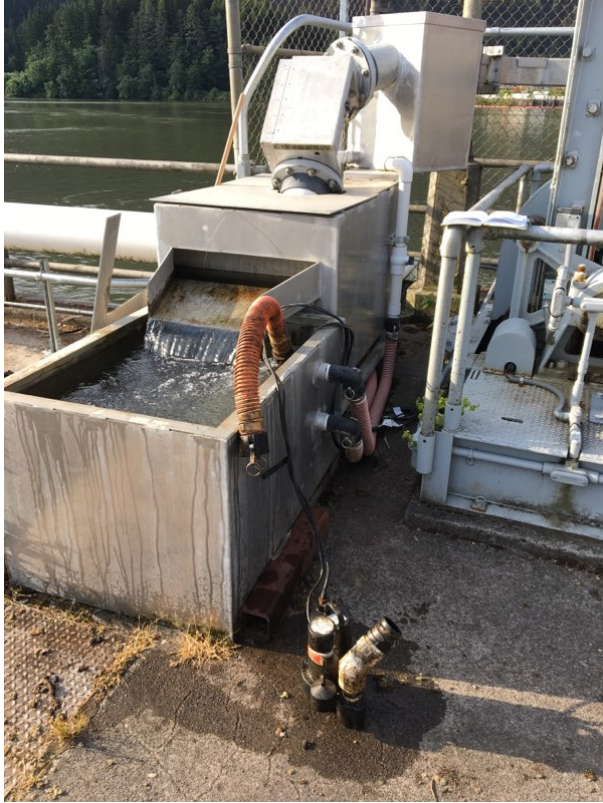
Figure 2. Two pump set up used to lift water from the new forebay extension to the older climbing section. Failed pump removed.

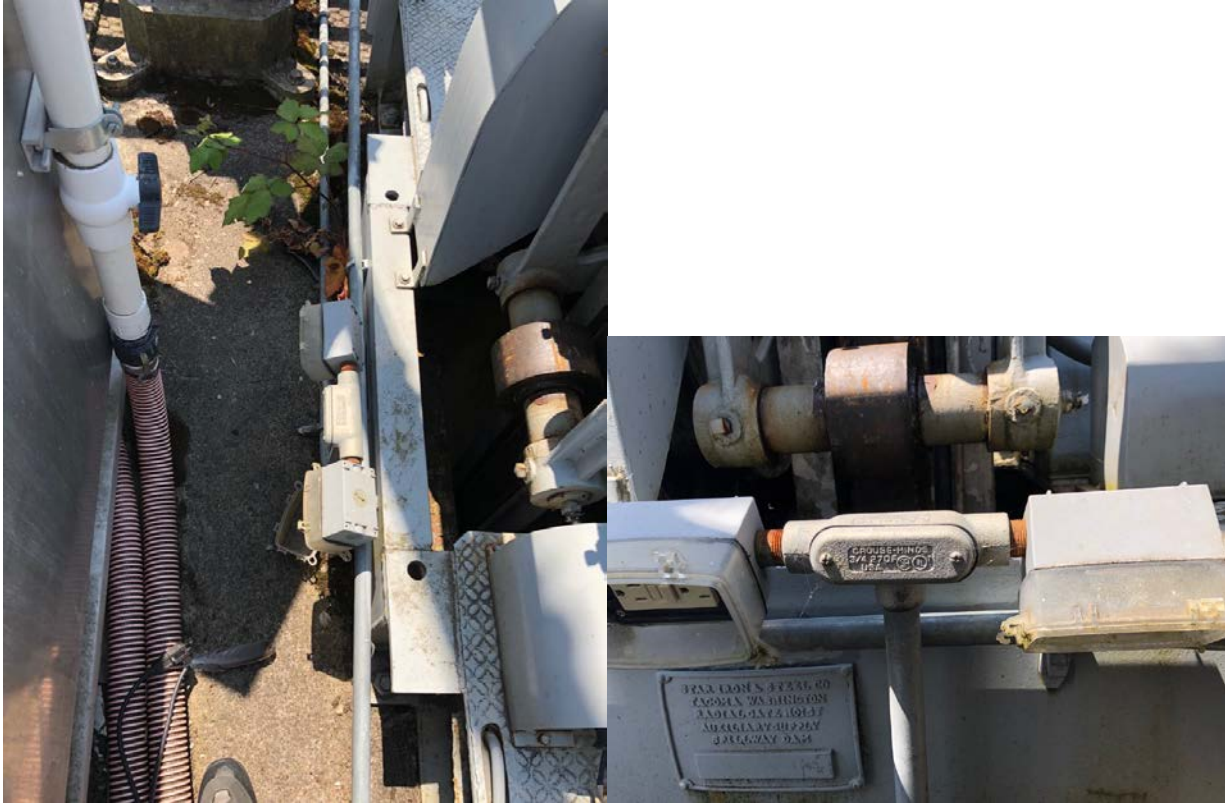
Figure 3. Two GFI outlets that power the 110 volt a/c pumps. Both were found tripped on the morning of 4 June so no water was flowing through the climbing section. The right one would reset and pump would operate, the left one would trip each time the failed pump was plugged in.
