MEMORANDUM FOR THE RECORD**SUBJECT: 19BON55 MFR – Emergency Dewatering Nav Lock 2 – Salmon Mortalities.**

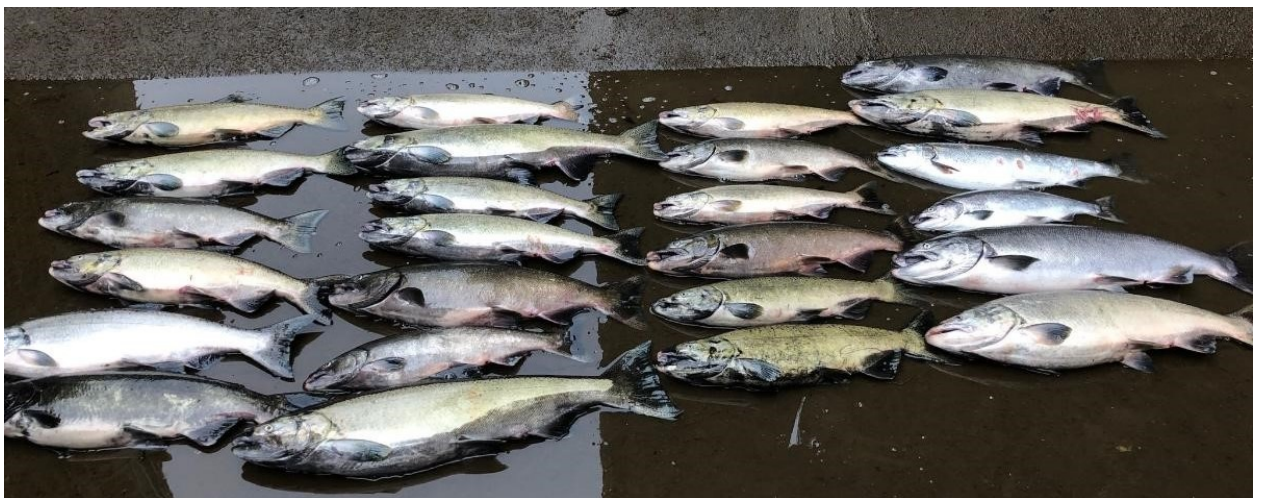
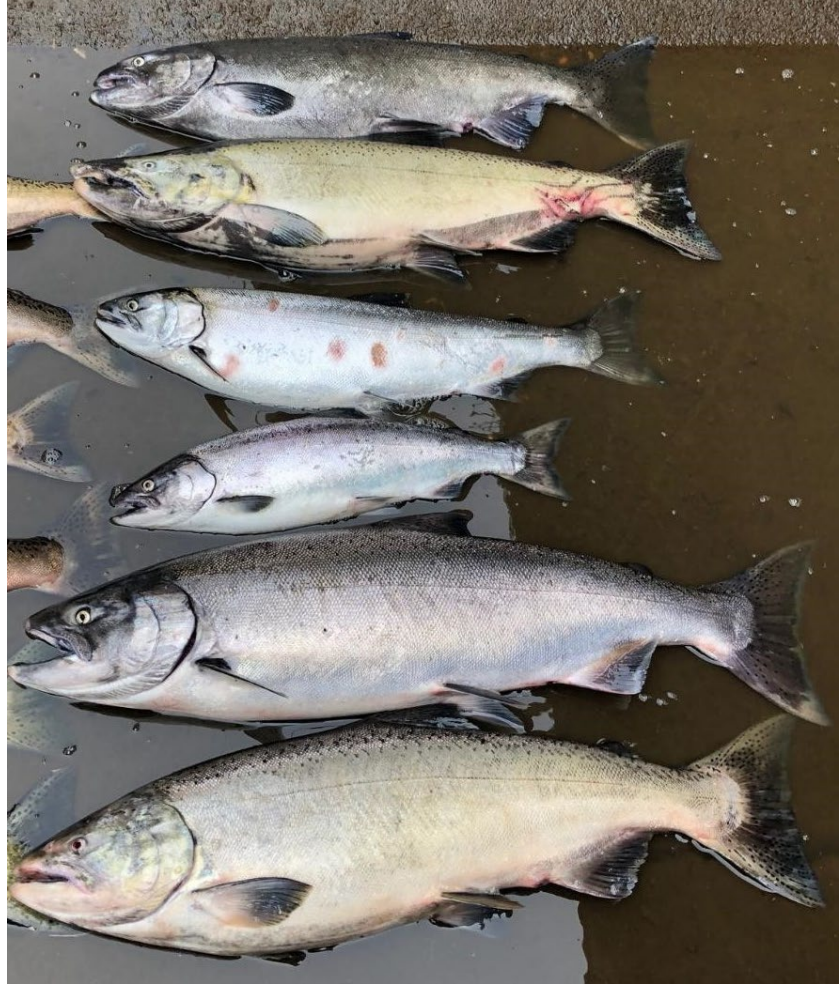
Bonneville's Nav Lock was taken out of service to all navigation traffic on 05 September after an ROV indicated significant structural damage to the downstream gate sill. A floating barge-crane was brought in on Friday, 06 September to install the downstream bulkheads and dewatering operations commenced. Due to the emergency nature of the dewatering operation, water was pumped throughout the night to allow access first thing Saturday morning. While cameras were trained on the area, at daybreak the water level was determined to be too low and twenty five mortalities were observed.

- A. Species – (25) Salmon (*Oncorhynchus species*). (21 Chinook and 4 Coho)
- B. Origin – (19) clipped and (6) non-clipped fish observed.
- C. Length – Lengths were not obtained.
- D. Marks and/or tags – No marks and/or tags observed.
- E. Marks and/or Injuries found on carcass – See photo, No marks and/or injuries observed.
- F. Cause and Time of Death – Morning of 07 September, human error.
- G. Future and Preventative Measures – Due to the emergency nature of this dewatering water was required to be pumped overnight. Ordinarily visual inspection occurs minimizing the risk of stranding fish.

I just want to clarify one point. The document that I was referencing in the FPOM meeting is the Nav Lock dewatering protocol. It is not supplied by Fisheries but it does make reference in multiple steps on when and where to hold water for fish. Why this document was not adhered to is my main question. I have discussed the issue one on one with several L-grade operators in order to get their feedback on what changes, if any, should be made to the protocol to assure this doesn't occur again. It has been the consensus of the operators that the process is proper and thorough but that it cannot prevent issues of human error and that's what ultimately caused these mortalities. I realize this explanation will not completely satisfy you and others concerned by this. Please know that those of us who are tasked with preventing these mortalities at Bonneville are very displeased and frustrated with this occurrence and will do everything in our power to insure it doesn't happen again. Process review and re-training and some of the steps we are currently taking.
