MEMORANDUM FOR THE RECORD**SUBJECT: 22BON016 MFR LFS Lamprey Mortalities**

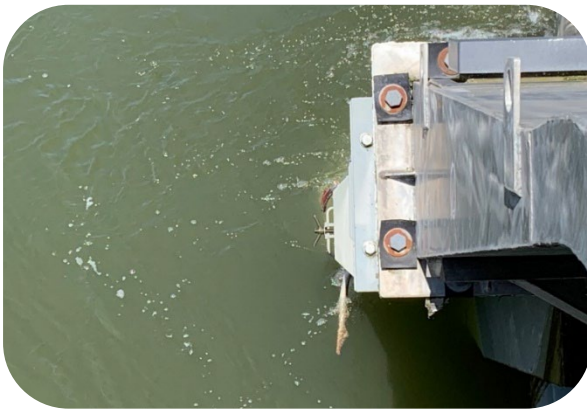
LFS 20%

On the afternoon of Tuesday 07 June, Project Biologists observed a “geyser” of water coming out around an upwards facing hatch on the lower section of the LFS. Project Biologists contacted Bonneville Control who then assisted in reducing add in flow to the system. As the geyser calmed down, three Lamprey mortalities were discovered, they appeared to have been squeezed out around the hatch. Add in flow was reduced from 60 to 20 to give any lamprey that might be inside the LFS a chance to reach the trap.
